NUMBER: 23-045-15 REV. A

Poor Adhesion Of The Chrome RAM Emblem Letters To The Tailgate

2015 (DS) Ram 1500 Pickup

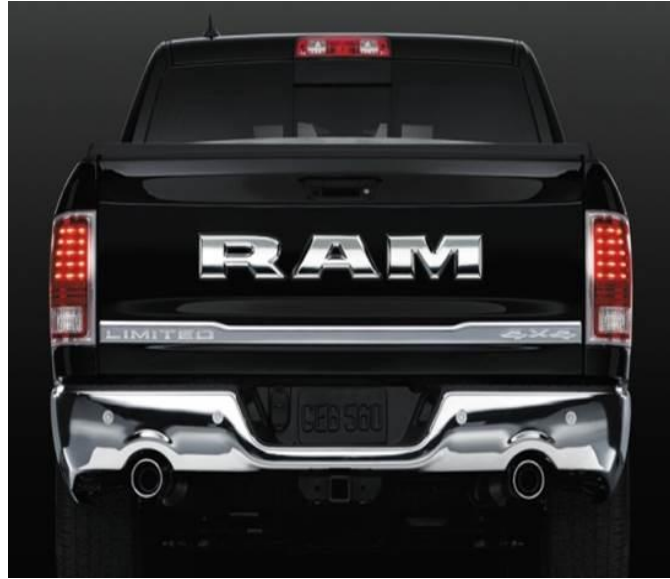
The customer may describe what appears to be a gap between the RAM lettering and the tailgate of the vehicle.

The RAM lettering emblems may separate from the tailgate due to insufficient adhesive bond strength.

Fig. 1 RAM lettering on tailgate
