NUMBER: 08-120-15

Intermittent No Start And/Or Instrument Cluster 4WD Indicator Lamp Illuminated

2014 - 2016 (KL)

Jeep Cherokee

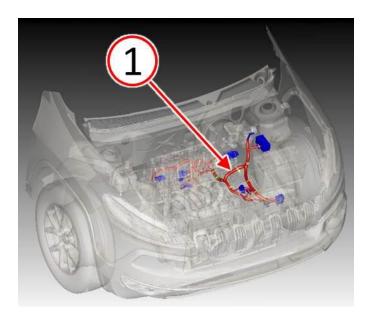
Fig. 1 Area Of Concern

1. Follow the transmission wire harness from the Power Distribution Center (PDC) towards the transmission (1) to locate the wire harness retainer clip positioned about 12 inches from the PDC connection (Fig. 1).

1 - Possible Contact Area

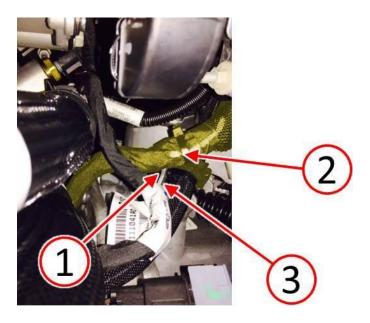
Fig. 2 Inspect For Harness Contact

2. Near the transmission harness retainer clip location, inspect for any contact (1) between the transmission shift cable bracket (3) and the transmission electrical harness (2) (Fig. 1).

- 1 Contact Between Wire Harness And Bracket
- 2 Transmission Electrical Harness
- 3 Transmission Shift Cable Bracket

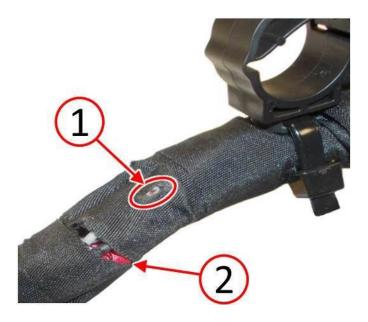
Fig. 3 Inspect For Harness Damage

- 3. Inspect the transmission electrical harness for any chafing damage (1) at the point of contact between the electrical harness and the shift cable bracket (Fig. 3).
 - If the transmission harness copper wires are exposed (1) or damaged due to chafing, replace the harness (Fig. 3). Continue to Step #4.
 - If the transmission harness copper wires are not exposed or damaged, repair the harness outer covering (2) with tape if needed (Fig. 3). Then proceed to Step #5.
- 4. If the transmission harness wires are exposed (1) due to chafing, replace the harness (Fig. 3).

- 1 Wires Exposed And Damaged Due To Chafing
- 2 Harness Covering Separation No Wire Damage

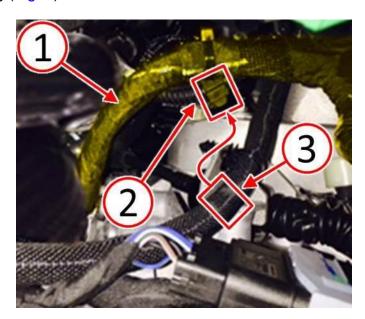
Fig. 4 New Harness Clipping Location

- 1 Transmission Electrical Harness
- 2 New Clipping Location
- 3 Previous Clipping Location

5. Relocate the transmission electrical harness (1) from the previous clipping location (3) to the new clipping location (2) on the battery positive cable in order to prevent harness chafing (Fig. 4).
