NUMBER: 23-052-15

Center Console Lid Binding

This bulletin involves adding a rubber bumper to the console lid.

2015 - 2016	(DS)	Ram 1500 Pickup
2015 - 2016	(DJ)	Ram 2500 Pickup

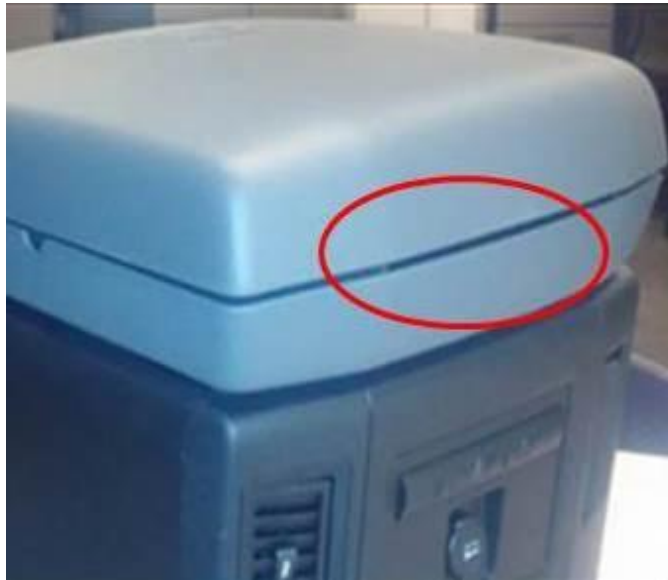
Fig. 1 Check Lid For Rubbing

1. Locate the center console inside the vehicle.
2. Slowly open the upper lid of the center console while checking the gap between the bottom of the upper lid and the top of the lower lid for rubbing together as shown in (Fig. 1).

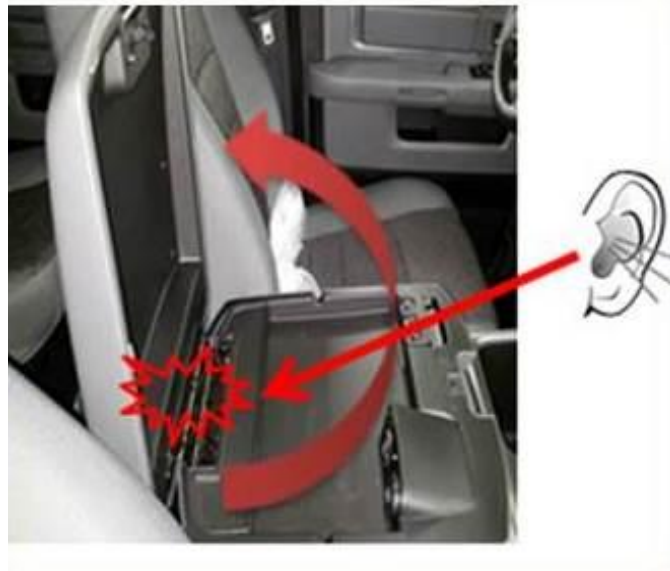
Fig. 2 Checking Lid Noise

3. Check the rear of the upper lid hinge for binding, hesitation or an audible clicking as shown in (Fig. 2).

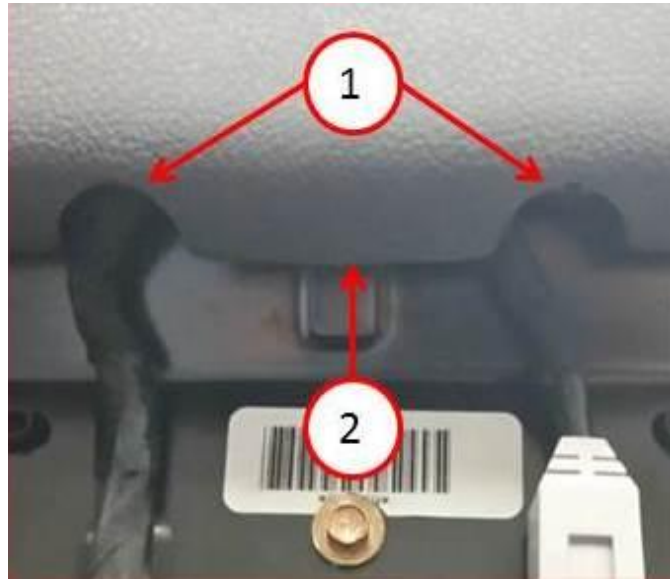
Fig. 5 Bumper Location

1 - Notches

2 - Location Of Bumper Installation

10. At the rear of the center console wall on the lower lid, identify the two notches as shown in (Fig. 5).

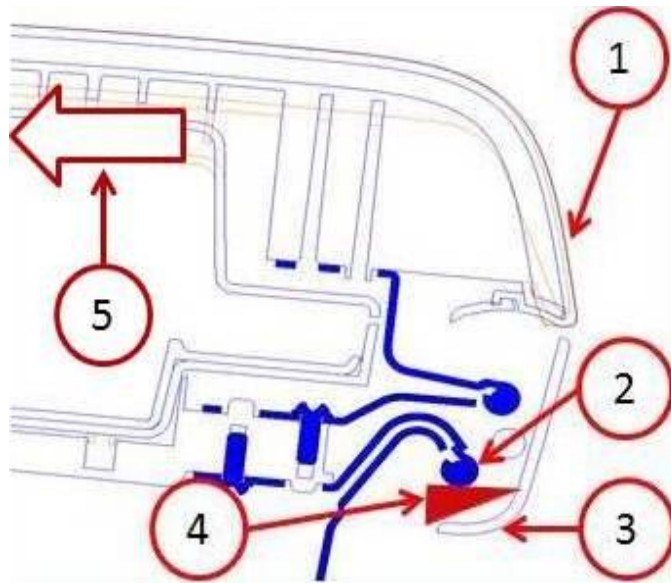
Fig. 6 Bumper Installation

- 1 - Rear Of The Center Console
 - 2 - Hinge
 - 3 - Lower Lid
 - 4 - Bumper
 - 5 - Front Of The Console
-

-
11. At the center of the console wall on the lower lid (as noted in the previous step), insert the bumper where the red triangle is shown. It will take some effort to push the bumper in flush with the edge of the lower lid as shown in (Fig. 6) and (Fig. 7).

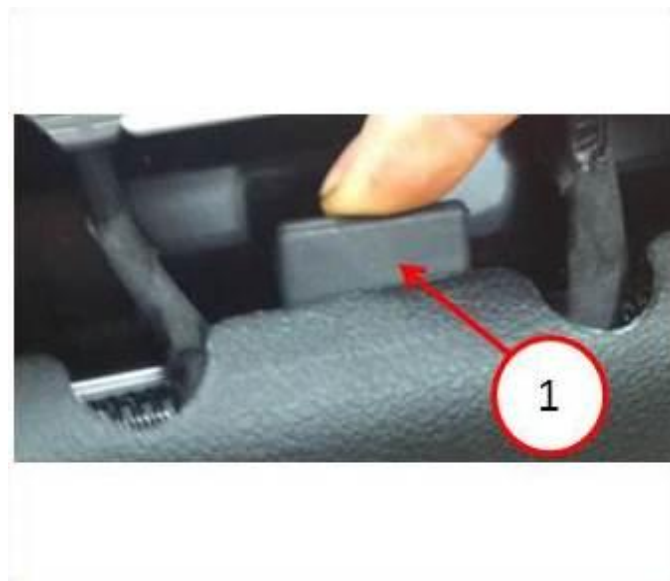
Fig. 7 Bumper Being Installed

- 1 - Bumper
-

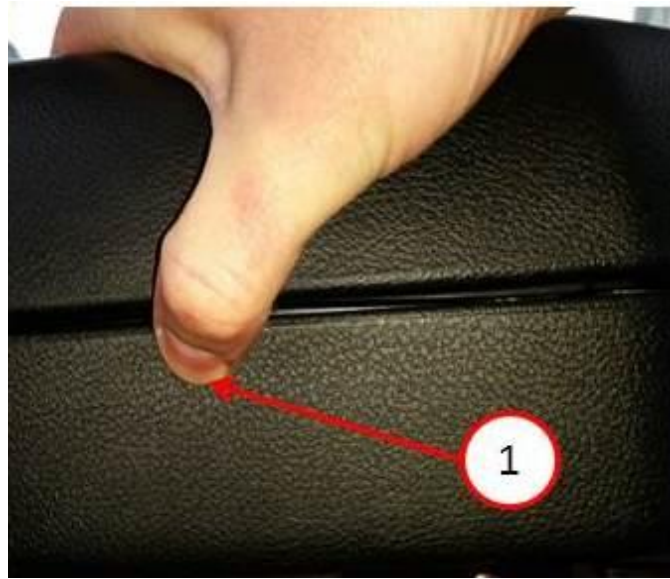
Fig. 8 Bumper Installation Continued

1 - Press The Back Wall

12. To assist the installation of the bumper, press the back wall of the lower lid to relieve some tension while inserting the bumper as shown in (Fig. 8).

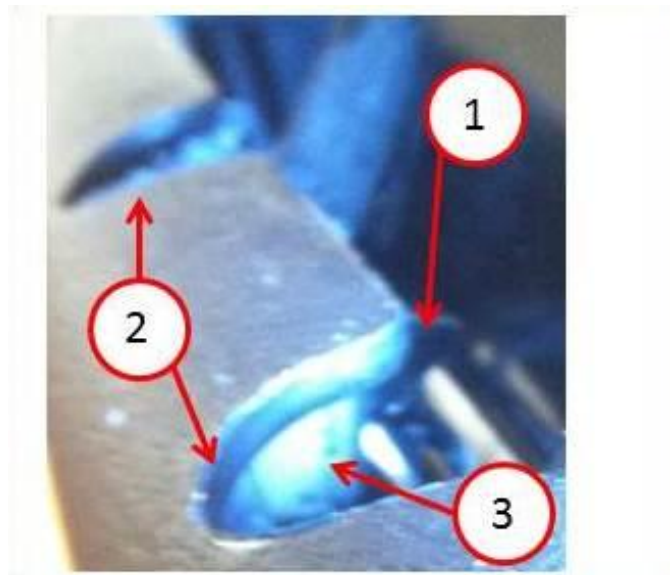
Fig. 9 Bumper Installed

1 - Metal Tab On The Lower Lid Hinge
2 - Notches
3 - Bumper Installed

-
13. Visually inspect the area of repair that the bumper is installed as shown in (Fig. 9).
