## Service Bulletin S/B 1012

### 8"x12" Lift Cylinders

### HYD CYLIND AEO

Date: 10/7/15

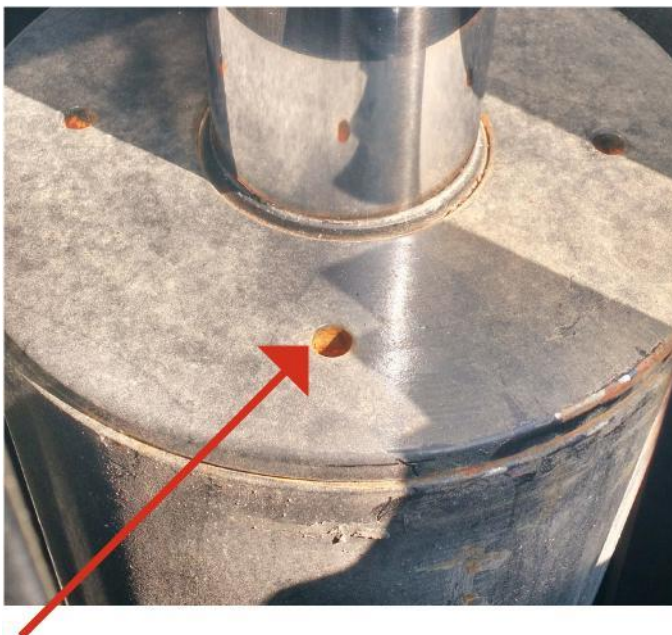
PHOTO #1  
CAP END RECESSED

Photo 1 to the left depicts cylinders that **are not** affected by the issue that is the subject of this service bulletin. These cylinders, which do not need to be replaced, can be identified by the cap end of main housing recessed.

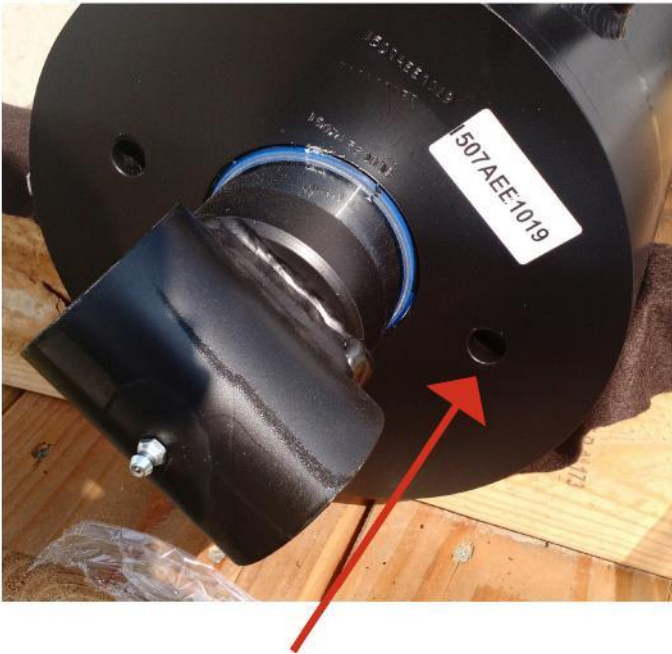
PHOTO #2  
CAP END FLUSH

XL Specialized Trailers, Inc. has created a product enhancement kit to address an issue that has been reported with certain 8" x 12" bore trailer lift cylinders. We recently switched to a new vendor for that component and have discovered that the cap end of the cylinders supplied by this vendor do not seat properly into the tube of the cylinder. This issue causes leaks which may affect the cylinder's performance. In one instance, the cap end disengaged from the tube, which completely disabled the hydraulic mechanism that raises and lowers the trailer.

Photo 2 to the left depicts cylinders that **are** affected by the issue that is the subject of this service bulletin. These cylinders, which need to be replaced, can be identified by the cap end being flush to the outside of the main housing.

1. REMOVE ALL 8"x 12" BORE CYLINDERS FROM PMB.
2. CAP OFF HYDRAULIC LINES.
3. INSTALL NEW 8"x 12" BORE CYLINDERS SUPPLIED BY XL.
4. REFILL HYDRAULIC FLUID AND RUN CYLINDERS TO TEST FUNCTION.
5. PALLATIZE FAULTY CYLINDERS AND NOTIFY XL TO SCHEDULE RETURN SHIPMENT.
