Technical Service Bulletin

SUBJECT:			No: TSB-15-13-001REV
ENGINE STALL/PCV HOSE DISCONNECTION (LOW ENGINE SPEED, HIGH AMBIENT TEMPERATURE)			DATE: July, 2015
			MODEL: 2014-15 Mirage
CIRCULATE TO:	<input type="checkbox"/> GENERAL MANAGER	<input type="checkbox"/> PARTS MANAGER	<input checked="" type="checkbox"/> TECHNICIAN
<input checked="" type="checkbox"/> SERVICE ADVISOR	<input checked="" type="checkbox"/> SERVICE MANAGER	<input checked="" type="checkbox"/> WARRANTY PROCESSOR	<input type="checkbox"/> SALES MANAGER

This bulletin supercedes TSB-15-13-001, issued March, 2015, to add PCV hose disconnection details. Revisions are italicized and indicated by ◀.

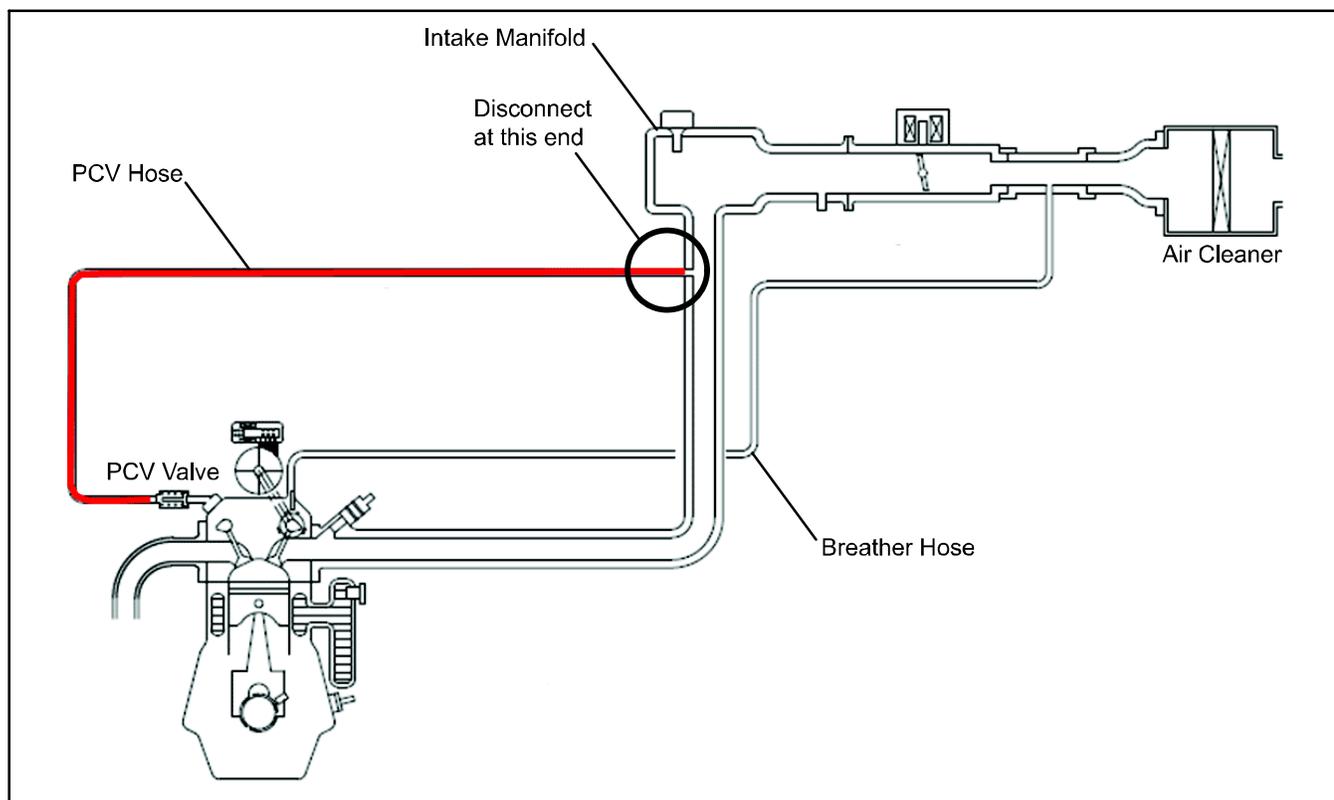
Due to a rich air fuel ratio, affected vehicles may experience engine stalling at low engine speed, just prior to stopping or during idling, when operated in high ambient temperature conditions, *which may lead to PCV hose disconnection*. If this condition were to occur, a stalled engine can immediately be restarted.

1. If the PCV hose is detached at either end (usually at intake manifold end), and is not damaged, reconnect it (red hose in illustration). Only replace the hose if it is damaged.
