Mitsubishi Concept XR-PHEV II

Vehicle Technical Info

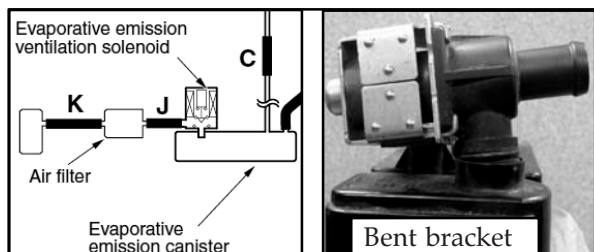
DTC P0442: EVAPORATIVE EMISSION CONTROL SYSTEM LEAK DETECTED (SMALL LEAK) — 2013-15 Outlander Sport/RVR. The vent solenoid bracket attached to the evaporative canister may be susceptible to bending and cause DTC P0442 to be stored in the ECM. During DTC P0442 troubleshooting, a visual inspection of the vent solenoid bracket may assist in proper diagnosis.

Also, inspect the hose clamps around the evaporative canister and ensure they are positioned correctly. If either of these conditions are present, repositioning the part(s) may correct the issue. You can force the monitor to run to determine if the repair was effective.

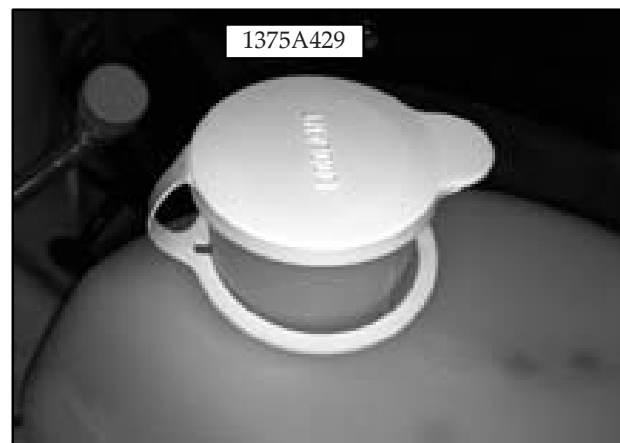
SUPERSEDED COOLANT OVERFLOW BOTTLE CAP — 2013-15 Outlander Sport/RVR. If a customer reports a lost coolant overflow bottle cap, be advised that the existing cap (no tether) has been superseded by a cap with a retaining tether (P/N 1375A429). This will prevent accidental loss or misplacement of the cap during coolant level adjustments.

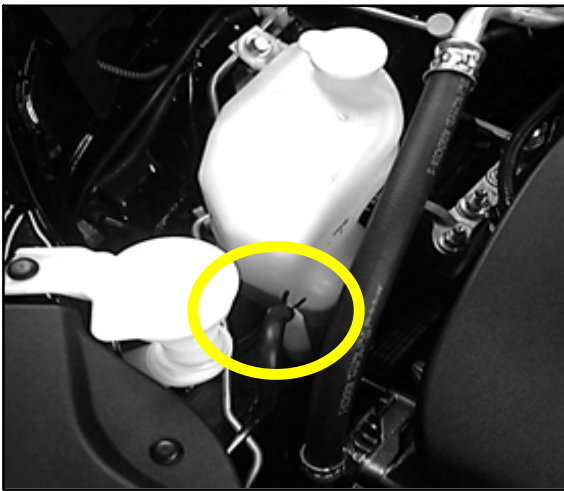
RADIATOR CONDENSER TANK HOSE FITTING COOLANT SEEPAGE/LEAK — 2013-15 Outlander Sport/RVR. If a vehicle is leaking coolant from the radiator condenser tank at the hose connection, remove the hose from tank and inspect the hose fitting for flash or other condition that inhibits the hose from sealing to the hose fitting. If necessary, repair the hose connection to ensure a good sealing surface. It is very important to obtain a good sealing surface between the hose and hose connection as the clip installed on the hose from the factory is for retention only, and not for sealing of the hose to hose connection. Once the hose connection has been repaired, reinstall the hose to tank using an appropriate hose clamp.

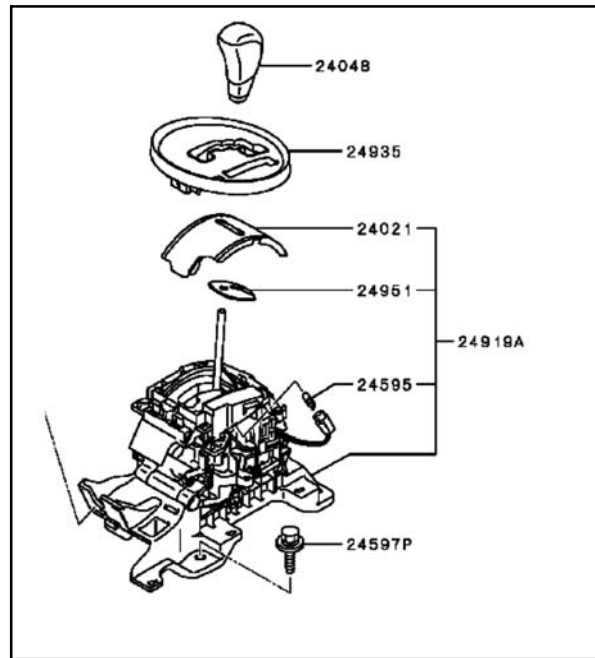
A/T SHIFT LEVER CHILD PARTS AVAILABLE AS SERVICE PARTS — 2013-15 Outlander Sport/RVR. It is no longer necessary to replace the complete shift lever assembly if the repair can be completed with replacement of the gearshift lever cover (P/N 2400A577) or A/T shift indicator slider (P/N 2400A578). These parts are available as child parts.

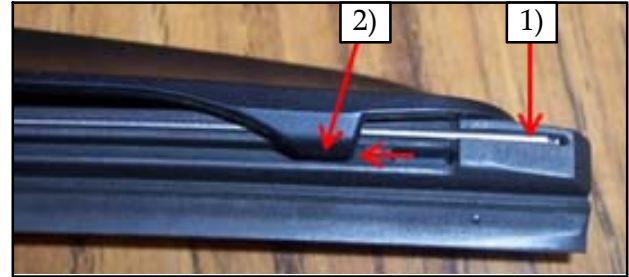
LOOSE WINDSHIELD WIPER BLADE — 2011-15 Outlander Sport/RVR. If a customer reports the windshield wiper blade (rubber) falls out of the wiper blade assembly, confirm the wiper blade is correctly installed: 1) Ensure the wiper blade backer (metal) is completely installed to the wiper blade. 2) Completely push the wiper blade until it engages the retaining tabs on both sides of the blade assembly.

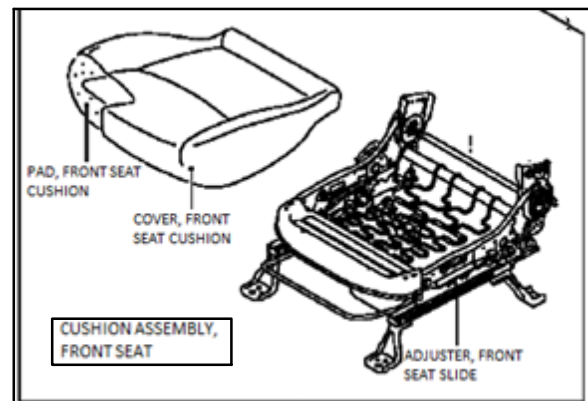
FRONT SEAT SLIDE ADJUSTER REPLACEMENT — 2013-15 Outlander Sport/RVR. If the front seat slide adjuster requires replacement for any reason (OCM or seat weight sensor failure, problems with manual/power seat adjustment, etc...), replace the front seat slide adjuster **only**. The front seat cushion pad and cover is transferable to the new seat adjuster.

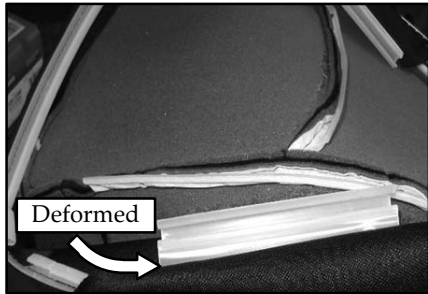
✓ **SEAT CUSHION COVER LOOSE, RETAINING CLIPS DETACHED** — 2013-15 Outlander Sport/RVR. If a customer reports the seat cushion cover (seat bottom) is loose, check under the seat to see if the cover retaining strips are detached. Over time, the white plastic “J hooks” can lose their shape and become detached, causing the cover to loosen. If you find that a loose seat cushion cover is caused by detached cover retaining clips, discuss the possibility of repair with a local upholstery shop to determine if the cover can be securely reattached using “hog rings” or some other suitable retention method. Do not replace the cover unless it cannot be successfully reattached by an upholstery shop.

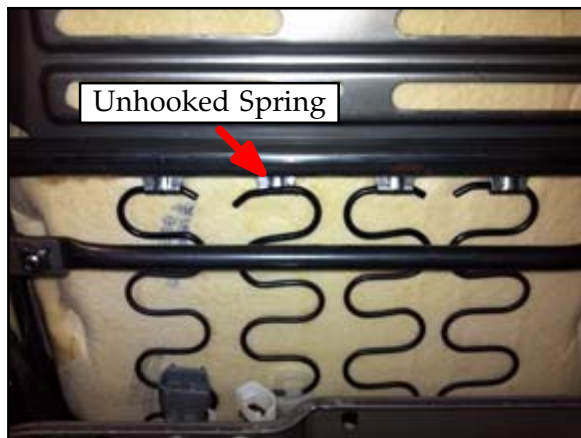
REPAIR OF UNHOOKED SEAT BOTTOM SPRINGS — 2013-15 Outlander Sport/RVR. It is possible for the spring assembly that supports the front seat cushion to be partially unhooked from the seat frame. This condition has the potential to cause abnormal sounds from the seat. If there is a complaint of noise from the seat, please inspect the spring assembly to ensure it is hooked securely to the frame. If an unhooked spring is discovered, please re-secure and confirm if the issue has been resolved.

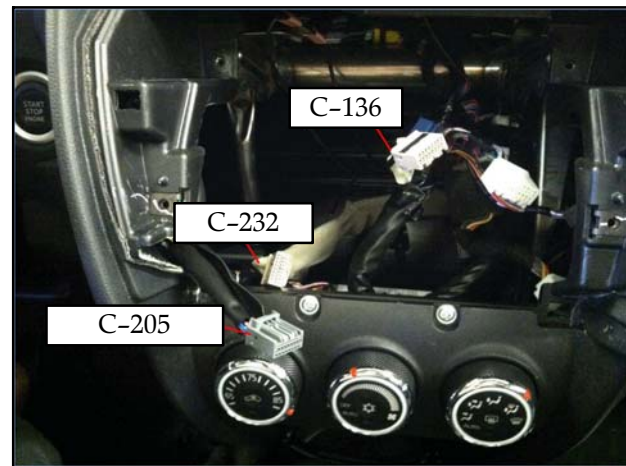
INTERCHANGEABLE CONNECTORS BEHIND CENTER INSTRUMENT PANEL — 2013-15 Outlander Sport/RVR. There are three 16-pin connectors behind the center instrument panel that are interchangeable. Improper connection may disrupt operation of the HVAC system, hands-free module / microphone and hazard switch. Warnings such as passenger air bag 'OFF' light (SRS DTC B1489), security light circuit, and seat belt warning light may also appear.

C-136 16-pin: Tan connector, part of navigation harness. Plugs into the back of the navigation unit for hands-free module / microphone operation.

C-232 16-pin: Tan connector, harness has foam shield and runs to the right side of instrument panel. Plugs into HVAC controller.

C-205 16-pin: Grey connector, harness has black shield and runs to the left side of instrument panel. Plugs into audio surround panel for hazard switch, air bag warning light and security light operation.

Reference the following information to confirm proper connection of the three interchangeable connectors.

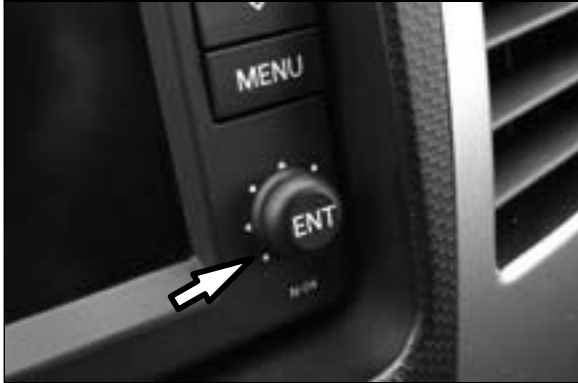
✓ **“ENT” BUTTON AVAILABLE FOR MMCS NAVIGATION UNIT** — 2008-13 Lancer based vehicles, 2007-13 Outlander, 2011-13 Outlander Sport/RVR. The enter button (ENT) for vehicles equipped with “NAVI” is available as a spare part (P/N 892L45510).

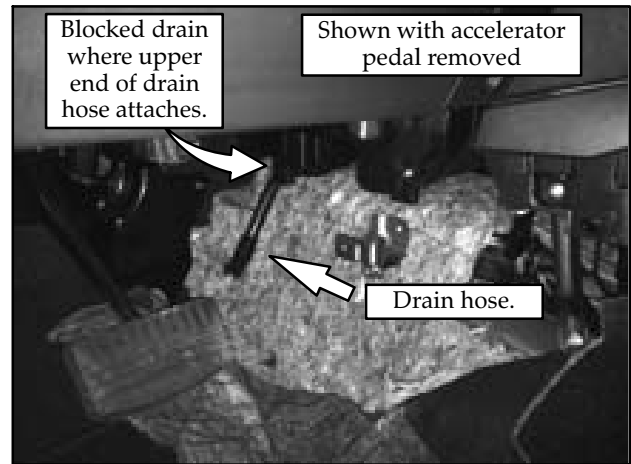
✓ **WATER SLOSHING SOUND, UNUSUAL SMELL OR WET CARPET/FLOOR MAT** — 2013-15 Outlander Sport/RVR. Subject vehicles may have a restricted HVAC drain outlet. Flashing from manufacturing may be partially (or completely) covering the drain inside the HVAC case. If a customer reports he has experienced these symptoms consistent with a blocked drain outlet, please remove the drain hose from the outlet (near the accelerator pedal) and use a mirror and light to examine the drain hole to determine if there is an obstruction. If you see an obstruction, clear the hole (a bent coat hanger works well) and insure proper flow from the drain with the A/C on.
