Technical Service Bulletin

SUBJECT:		No: TSB-15-42A-001	
LOWER LIFTGATE PANEL RUST		DATE: August, 2015	
		MODEL: 2011 – 2012 Outlander Sport/RVR	
CIRCULATE TO:	<input type="checkbox"/> GENERAL MANAGER	<input checked="" type="checkbox"/> PARTS MANAGER	<input checked="" type="checkbox"/> TECHNICIAN
<input checked="" type="checkbox"/> SERVICE ADVISOR	<input checked="" type="checkbox"/> SERVICE MANAGER	<input checked="" type="checkbox"/> WARRANTY PROCESSOR	<input type="checkbox"/> SALES MANAGER

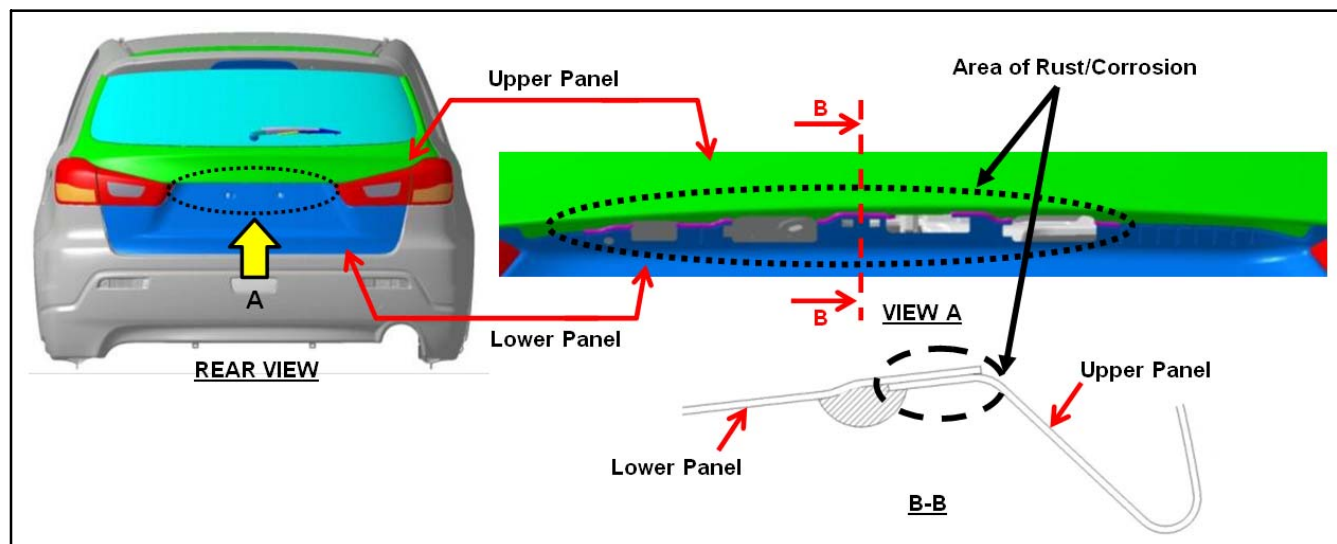
Customers of some affected vehicles may report rust or corrosion on the rear liftgate in the following areas:

- Section where liftgate upper panel meets the lower panel.
- Edge of the liftgate open switch on the lock release handle.

Rust between the upper and lower panels may be due to uneven sealant application that allows water to enter between the packing and the body sealant. Rust near the liftgate open switch may be due to inadequate clearance between the switch and upper panel, causing the edge of the switch to scratch the coating of the upper panel, leading to water intrusion and rust.

This TSB instructs dealers to repair any rusted areas, add sufficient sealant to prevent rust, repaint repaired areas, then apply protective film on the open switch area.
