Field campaign

Topic	Mulsanne engine and transmission control module software update (SC15/01)
Market area	Bentley: worldwide (2WBE)
Brand	Bentley
Transaction No.	2038952/1
Campaign number	EA22
Note	
Type	
US code

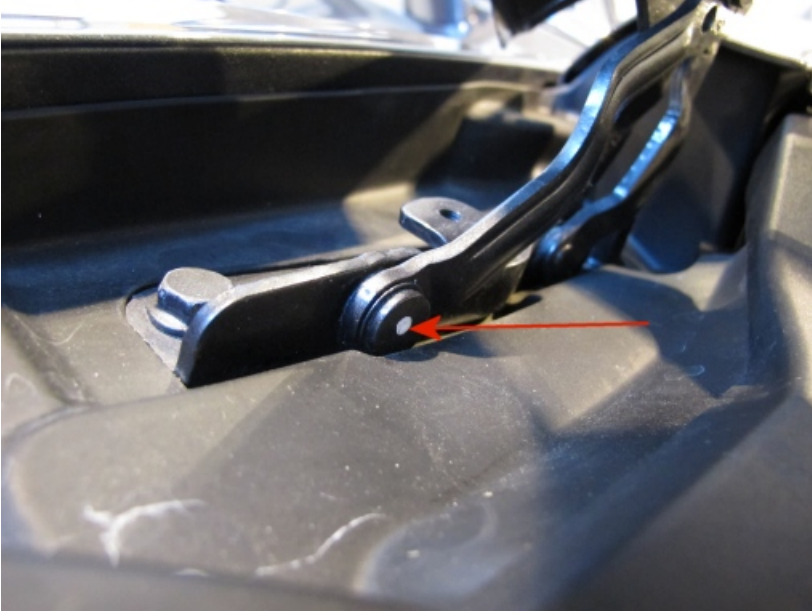
Figure 8

If the vehicle is not already listed as repaired in the "Repair history" (in Elsa Pro) check the bonnet hinge for the white completion mark (see Figure 8), if it is evident that the campaign has not been applied carry out the required work in accordance within these instructions.

White paint completion mark on the right hand bonnet hinge (see Figure 8).

- Use Guided Fault Finding to carry out a complete diagnostic sweep clearing and fault codes generated as a result of performing this procedure
- Once complete, place a white paint completion mark on the right hand bonnet hinge (see Figure 8).
