<b>Topic</b>	15MY power boot PDI check (SC15/05)
<b>Market area</b>	Bentley: worldwide (2WBE)
<b>Brand</b>	Bentley
<b>Transaction No.</b>	2039914/1
<b>Campaign number</b>	EA26
<b>Note</b>	
<b>Type</b>	
<b>US code</b>

### 15 MY Continental

### Technical background

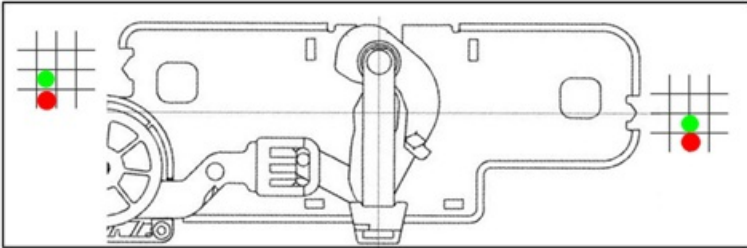
4. Record the position, using attached strikerlatchmarkup.pdf, of the powered striker in relation to the grid stamped into the rear panel (see Figure 1 for example)

5. Mark the starting position of the striker, red dots in example, and then slacken the fasteners securing the striker
6. Adjust the striker vertically upwards in half square increments in reference to the grid lines, tighten the fasteners and re test. Continue adjustment until 3 successful boot latching cycles are observed. Note: The striker plate should be adjusted equally so as to remain horizontal

7. Record the final position of the striker on the grid, green dots in example.
8. Finally torque tighten striker fasteners 20 Nm
9. Refit the boot sill finisher cover. "Refer to Boot aperture finishers - To remove and fit" Rep.Gr.70.
