| Topic | Interior monitoring enhancement - GT3-R (SC15/08) |
| Brand | Bentley |
| Campaign number | EA29 |

Interior monitoring enhancement

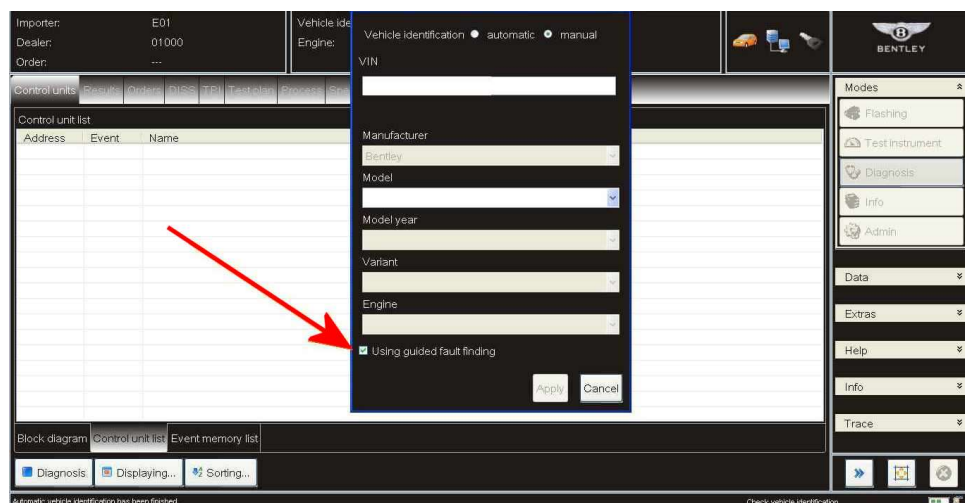
Figure 1

- Ensure the Using guided fault finding box is ticked (Figure 1) - follow all on screen prompts to allow the guided fault finding control module sweep to complete

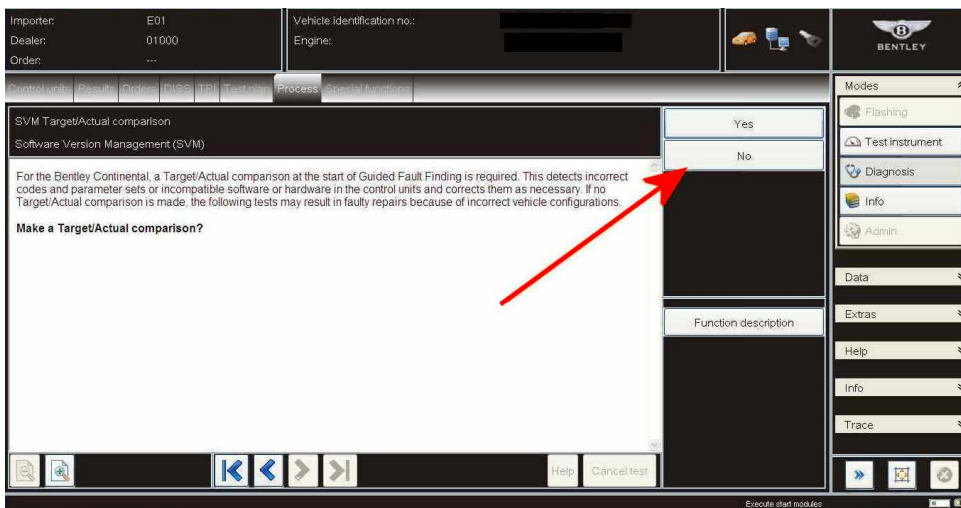
Figure 2

**IMPORTANT:** When requested to Make an SVM Target/ Actual comparison please select No (Figure 2)

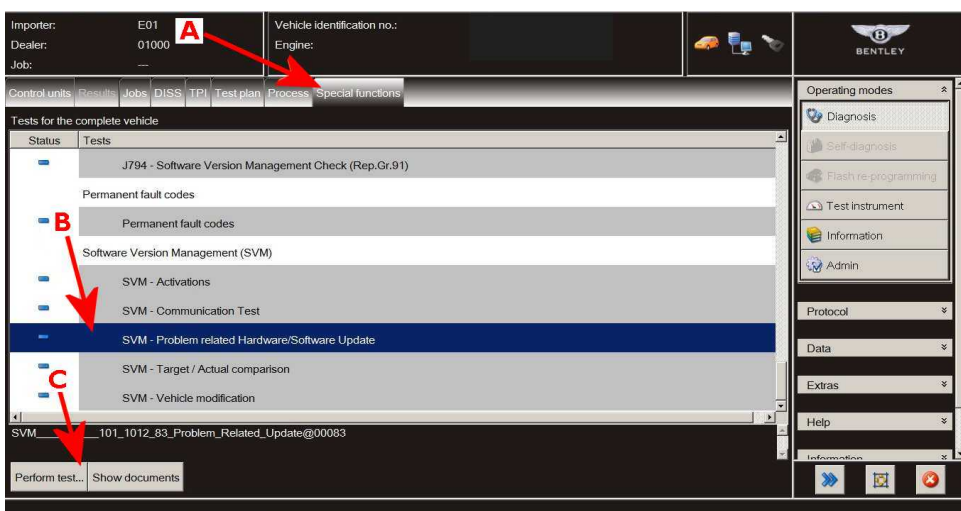
- Once the control module sweep within Guided Fault Finding is complete, Select – Special functions as shown in Figure 3 (point A)
- Select SVM - Problem related Hardware/Software Update (point B)
- Select Perform test (point C) and follow all on screen prompts

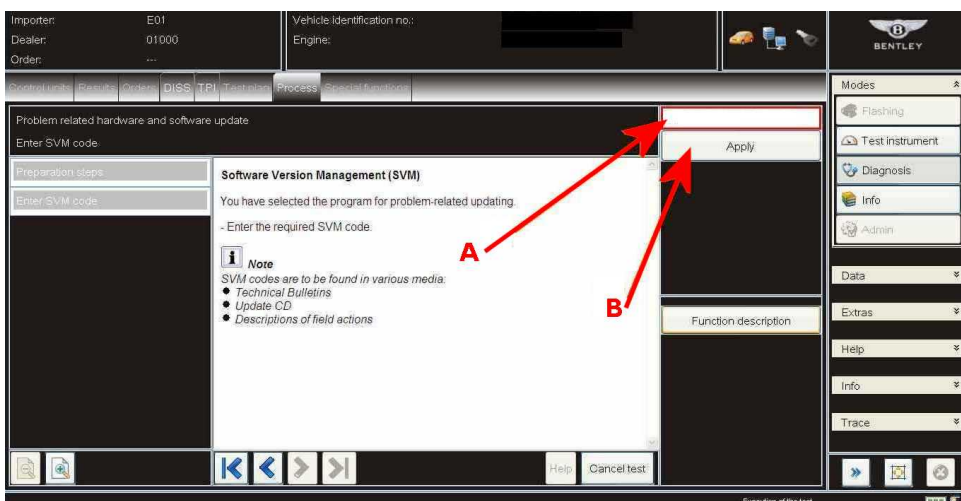
Figure 4

- Once at Figure 4, please insert the SVM code 39038REPLACE01 (point A) and select Apply/Adopt\_(point B) and follow all on screen prompts

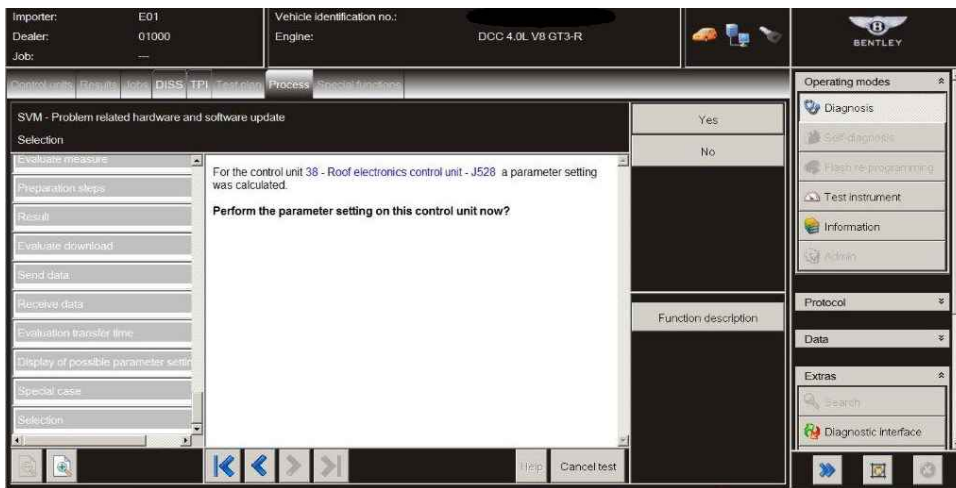
- When requested, enter your GEKO user ID and follow all on screen prompts to update the Roof electronics control unit – J528 as shown in Figure 5

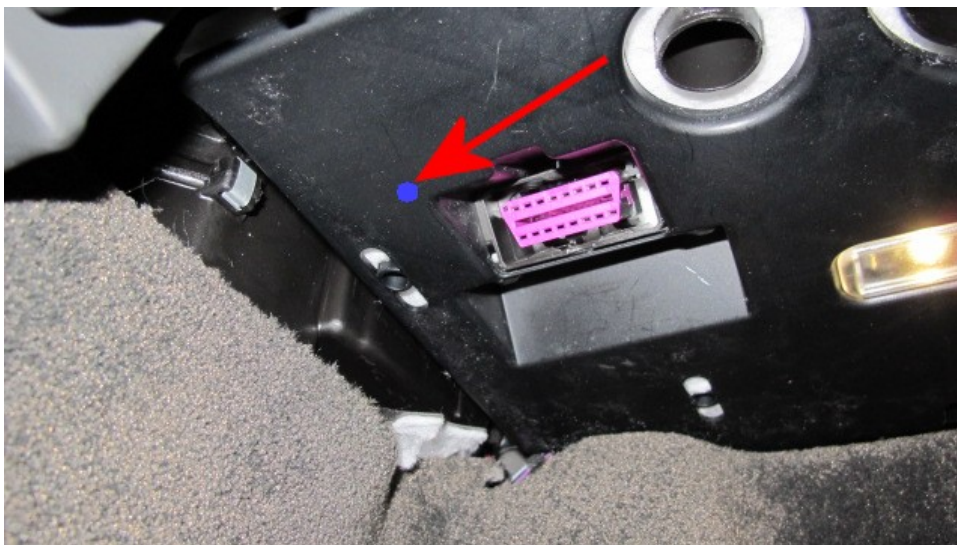
Figure 6

If the vehicle is not already listed as repaired in "Repair history" (in Elsa Pro) check the vehicle for the blue paint completion mark next to the diagnostic socket (Figure 6). If it is evident that the campaign has not been applied carry out the required work in accordance with these instructions.

- Use Guided Fault Finding to carry out a complete diagnostic sweep clearing and fault codes generated as a result of performing this procedure
- Once complete, place a blue paint completion mark next to the diagnostic socket (Figure 6)

Blue paint completion mark next to the diagnostic socket (Figure 6)
