## Technical product information

<b>Topic</b>	W12 GT - Rear armrest side panels adrift
<b>Market area</b>	Bentley: worldwide (2WBE)
<b>Brand</b>	Bentley
<b>Transaction No.</b>	2040071/1
<b>Level</b>	EH
<b>Status</b>	Approval
<b>Release date</b>

Rear armrest side trim panel dislodged / Rear armrest hide damage clash with ski hatch

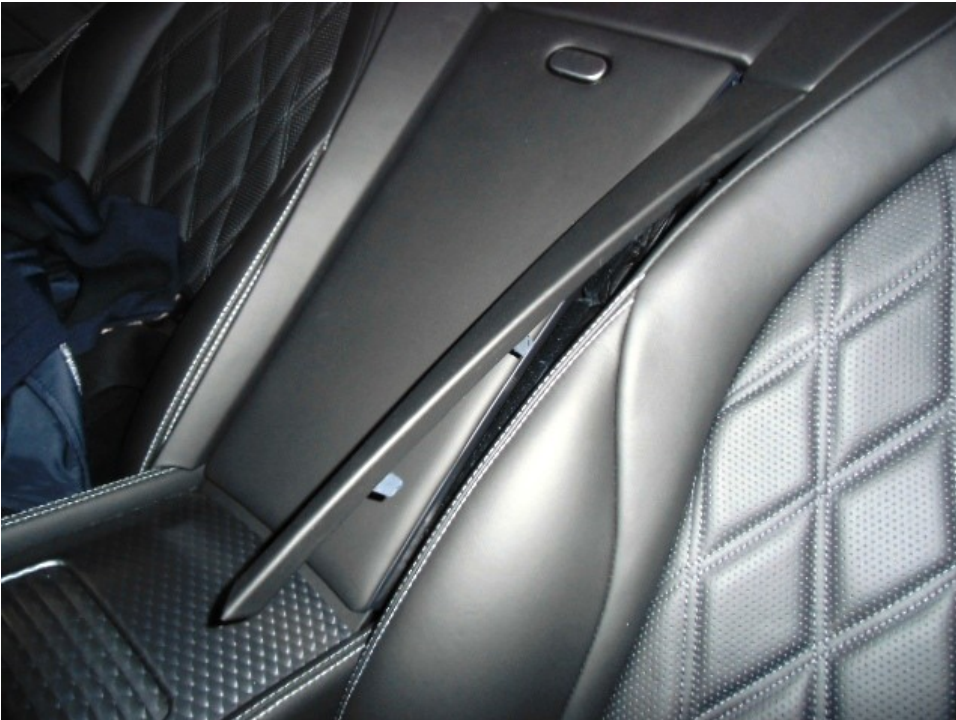
Figure 1

1. A discrepancy in material specification affecting the compliance of the retaining parts may result in the armrest side trim becoming partially detached (see Figure 1)
2. A clash issue has also been identified between the ski hatch and the rear armrest side trim that can result in trim damage. A modification to the substrate will avoid this clash. This modification is included in this TPI

In the event that one or both the centre rear armrest side trims become unclipped (see Figure 1) and or trim damage has occurred in the top corner of the ski hatch (see Figure 1a) then the following modifications should be carried out.
