Technical Service Bulletin

Topic	13.5 to 15MY infotainment unit (RNS) - fault rectification - restoration software
Market area	Russische Föderation (5RU),China 796 VW Import Comp. Ltd (Vico), Beijing (6796),Russian Federation 935 Volkswagen Group RUS (6935),United Kingdom E01 Bentley UK (6E01),Germany E02 Bentley rest Europe (6E02),Australia E04 Bentley rest Asia and Australia (6E04),United States E05 Bentley USA and rest America (6E05),United Arab Emirates E06 Bentley Middle East and Africa (6E06)
Brand	Bentley
Transaction No.	2039626/1
Level	EH
Status	Released for publishing
Release date	May 1, 2015

13.5 to15 MY Flying Spur & Continental GT derivatives

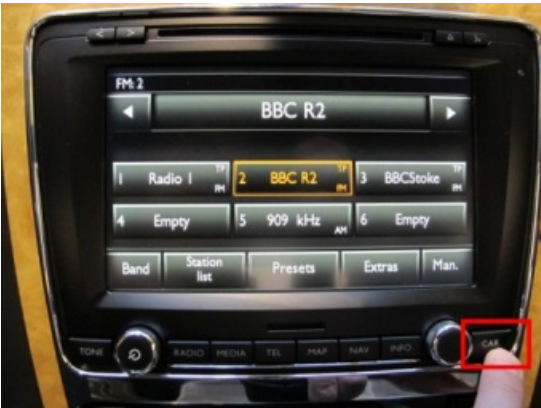
Figure 1

1. To check current software level
 - If not already powered up switch on Infotainment unit via ON/OFF button

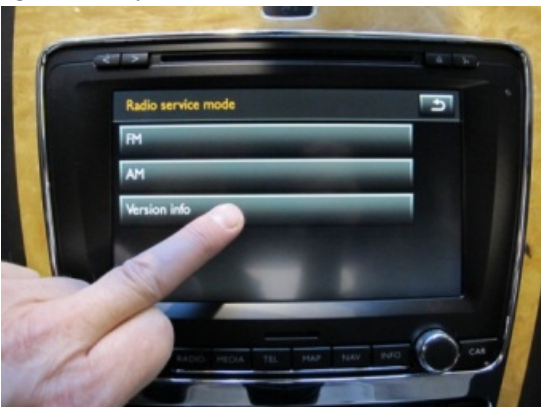
- Once the unit has powered up press and hold the CAR button for at least 5 seconds. That is until the screen displays *Radio service mode* (see Figure 2 and 3)

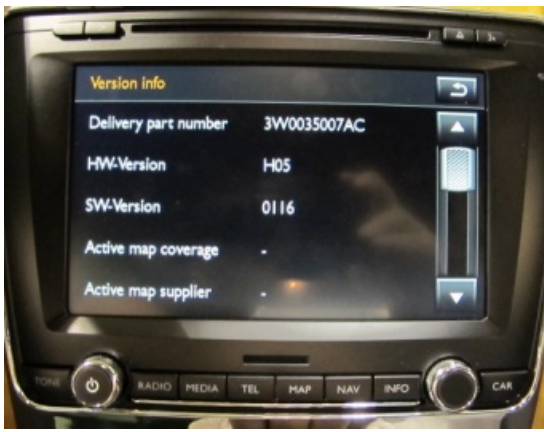
Figure 3

- In the *Radio service mode* screen select *Version info* (see Figure 3)

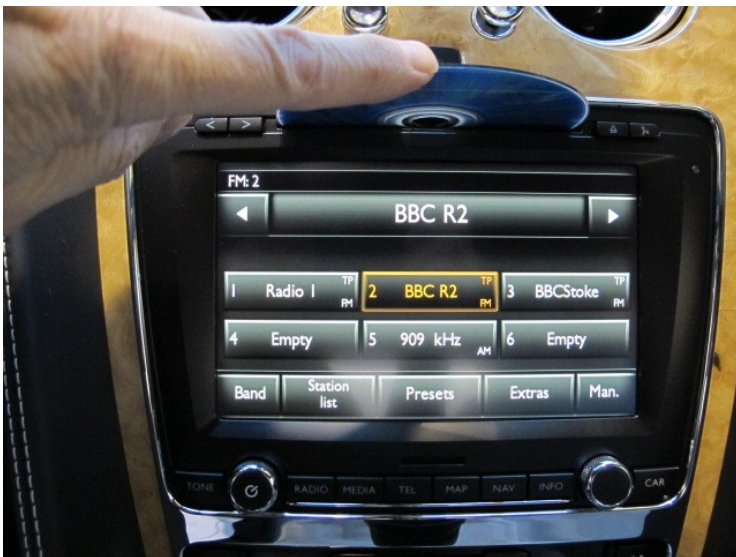
Figure 5

1. The navigation system will require re commissioning once the updated has been performed in some cases the navigation disc will need to be reloaded. Make a note of the customer preferences including home address details to enable them to re-entered into navigation system on completion of this update
2. Ensure Bentley diagnostic tool is not connect to the vehicle whilst the update disc is in the RNS unit
3. Ensure the ignition is switched **off** and the key is placed on the top roll
4. Switch on the infotainment unit via the ON/OFF button

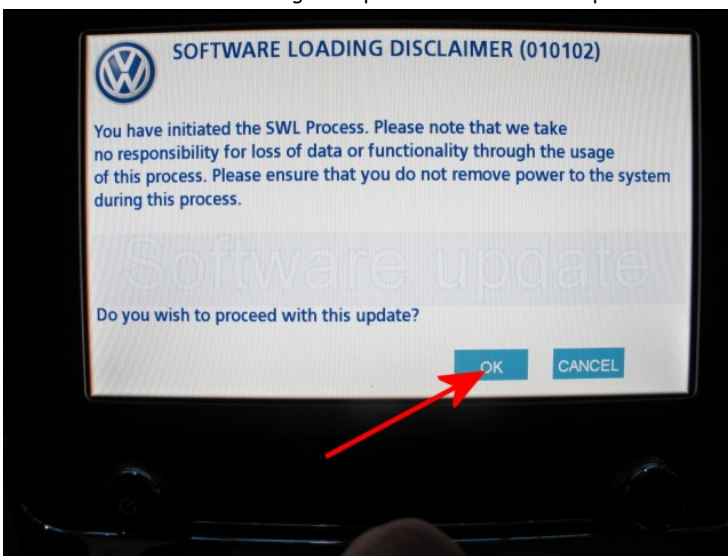
Figure 6

5. Select and insert the correct regional update disc for the build specification of the car, refer to *Parts information* table below (see Figure 26)

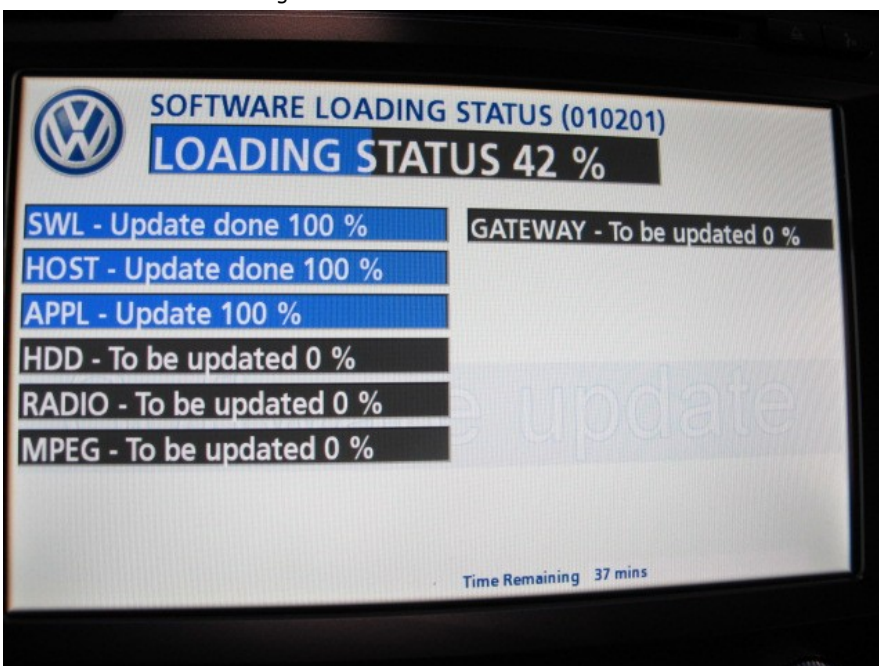
Figure 7

6. After inserting the disc wait until the "Software Loading Disclaimer/Version" screens are displayed, then press the "OK" button to proceed at each point (see Figure 27). **Note:** A DVD/CD error screen and other screens will briefly be displayed before the software loading disclaimer is shown these screens can be ignored

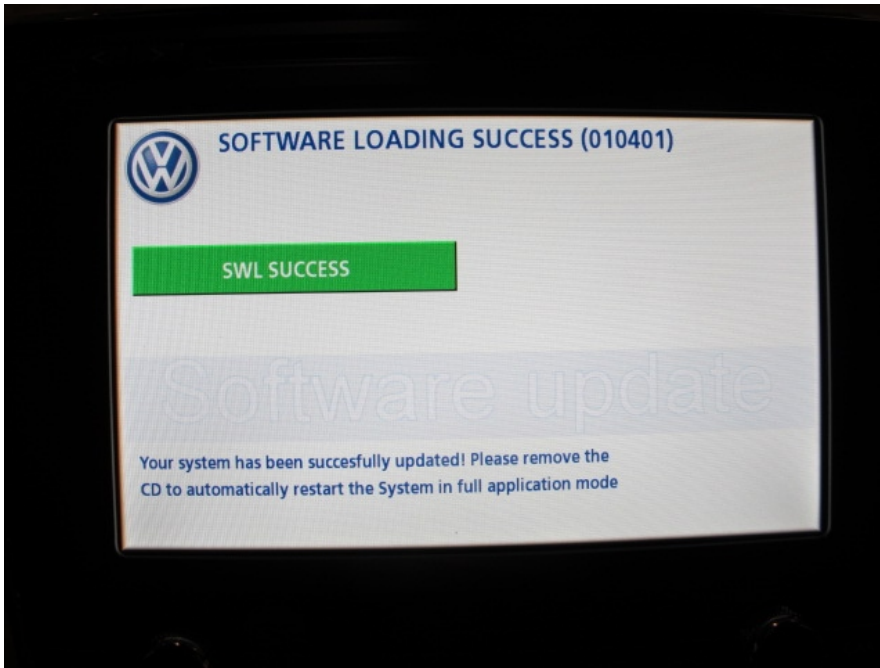
Figure 8

7. The software loading status screen will be displayed for the majority of the down load period, approximately 50 minutes. During this time the screen will briefly change state displaying occasional *black screen* do not operate the infotainment unit allow the process to continue

uninterrupted (see Figure 29)
