# Field campaign

| Topic | Incorrect fuel filler door and bowl assembly (SC15/14) | | | | |
| Campaign number | EA35 | | | | |

### Continental GTC

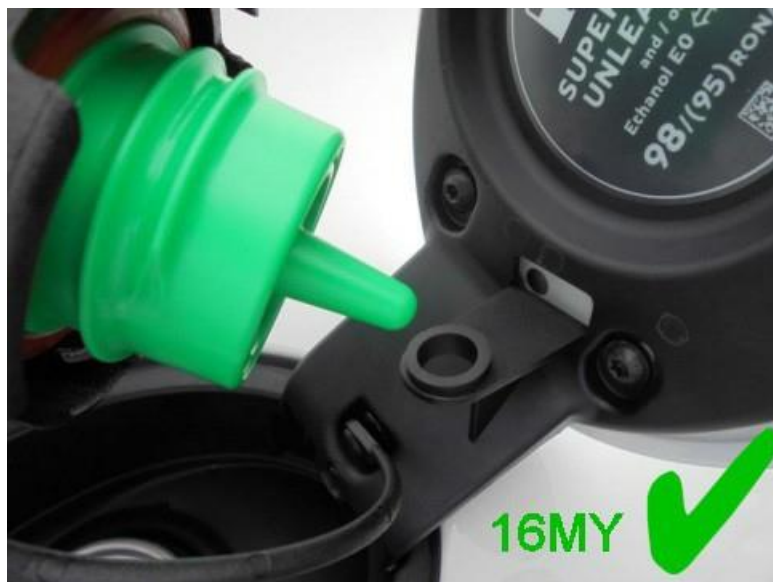
Fit the correct fuel filler flap and bowl assembly (part number 3W7809857K). Figure 1 shows the correct 16MY fuel filler flap and bowl assembly. Figure 2 shows the incorrect assembly for 16MY

If the vehicle is not already listed as repaired in the "Repair History" (in ElsaPro), check for the presence of the correct fuel filler bowl assembly (see Figure 1)

Fit the correct fuel filler flap and bowl assembly (part number 3W7809857K)

Fit the correct new label to the fuel filler flap and bowl assembly, use FIVIN search in ETKA for the correct label part number

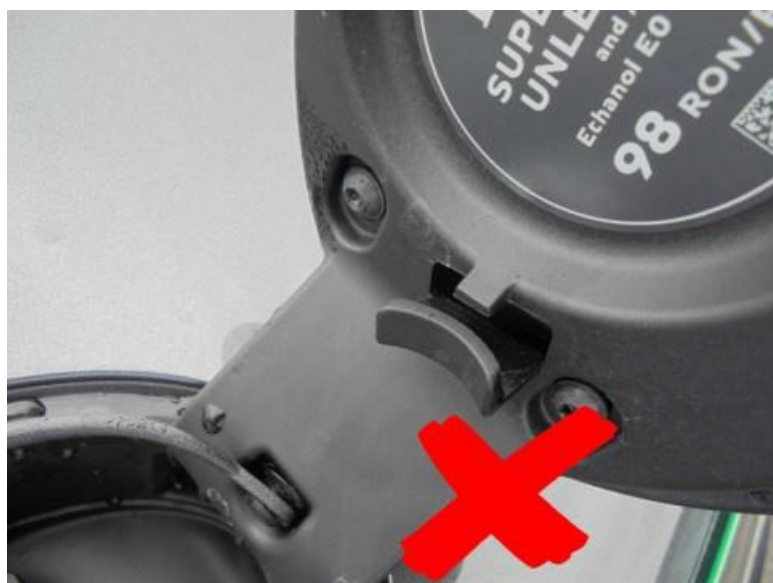
Figure 2

For 16MY the method of storing the fuel filler cap during refuel has changed. A small number of 16MY Continental GT Convertible cars have the incorrect fuel filler bowl assembly fitted
