## Technical product information

<b>Topic</b>	Vibration humming noise in cabin front bulkhead
<b>Market area</b>	Bentley: worldwide (2WBE),Hongkong-Macau (5HK)
<b>Brand</b>	Bentley
<b>Transaction No.</b>	2040820/2
<b>Level</b>	EH
<b>Status</b>	Released for publishing
<b>Release date</b>	30-Jun-2015

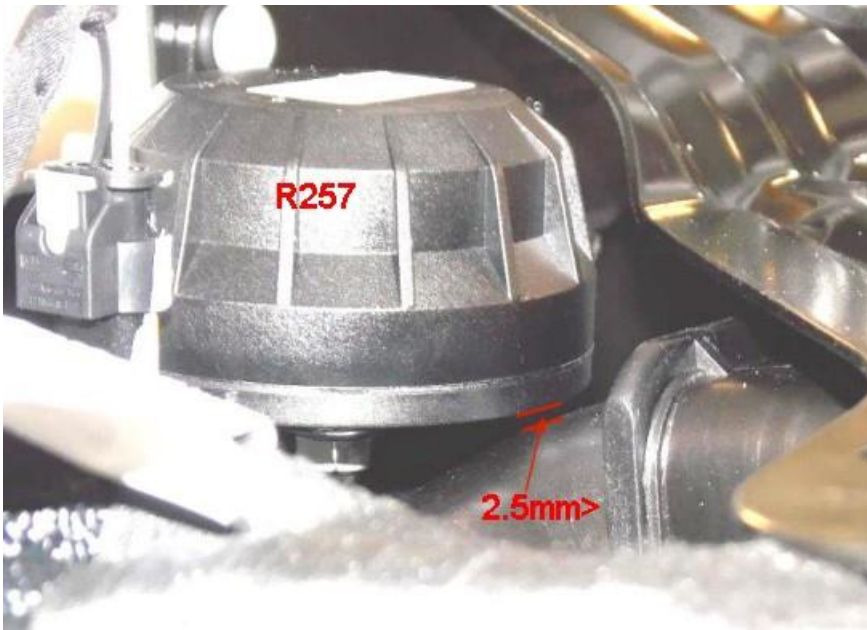
Figure 1

The engine sound actuator speaker (R257) and or associated wiring can, when operating 'Sport' mode only, foul on the HVAC casing or plenum cover. This component (R257) is located in the plenum adjacent to the HVAC system housing and when this foul occurs the vibration appears to emanate from behind the instrument panel

On occurrence of vibration (humming/rattle) being reported from inside the cabin and that noise is only present when 'Sport' mode is selected, then as part of your investigation first remove the plenum cover and check the clearance between the engine sound actuator (R257) and the HVAC system housing (see Figure 1). Refer to "Plenum cover - To remove and fit". Rep.Gr.87. Also check the harness is clear of the plenum cover when fitted (see Figure 2)

If the clearance is less than 2.5mm or there is evidence of a foul condition then contact Bentley Product Support raising a DISS query
