Field campaign

Topic	Rear Seat Entertainment - field update (SC15/09)
Market area	Bentley: worldwide (2WBE)
Brand	Bentley
Transaction No.	2039381/1
Campaign number	EA30
Note	
Type	
US code

Flying Spur

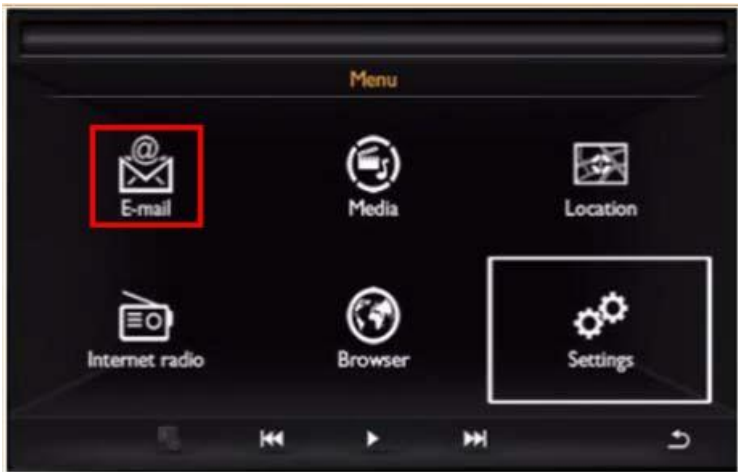
33. Switching on the RSE will now display the additional, online, icons. Figure 16a shows this updated system screen containing amongst others the E-mail icon

The presence of the additional, on-line, icons on the RSE rear screens (Figure 16a) will serve to identify this campaign has been performed

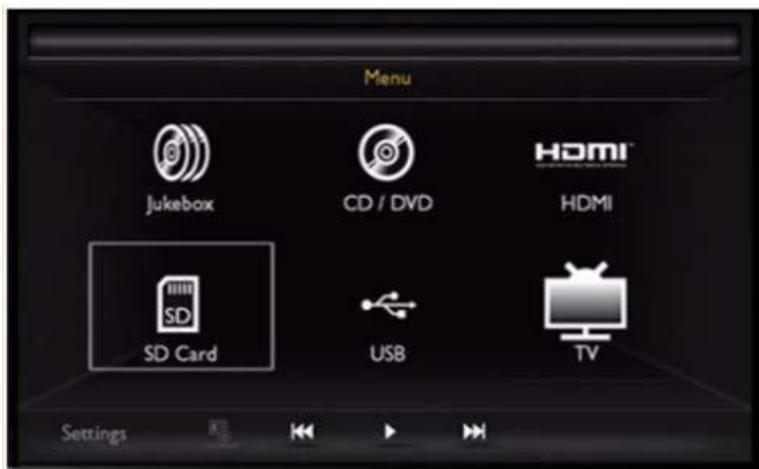
34. Figure 16b for reference shows the screen displayed on RSE systems that have yet to receive this update and therefore do not display any online icons. Car displaying this screen require this Rear Seat Entertainment - field update
