A number of Rear Seat Entertainment (RSE) functions were unavailable for release at vehicle launch

To enable the complete suite of functions a software update is available.

All vehicles fitted with RSE at time of manufacture up to VIN SCBEC9ZA0FC047407 should have the RSE system updated using the process detailed in this document

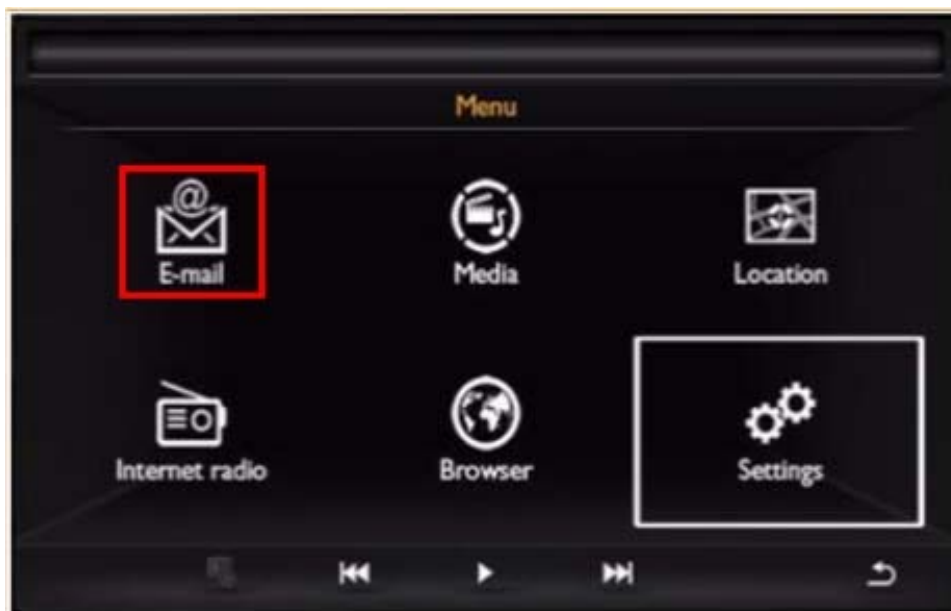
If the vehicle is not already listed as repaired in the "Repair history" (Elsa pro), check for the presence of additional, on-line, icons on the RSE rear screens (Figure 16a), should neither be evident carry out the required work in accordance with these instructions

33. Switching on the RSE will now display the additional, online, icons. Figure 16a shows this updated system screen containing amongst others the E-mail icon

The presence of the additional, on-line, icons on the RSE rear screens (Figure 16a) will serve to identify this campaign has been performed

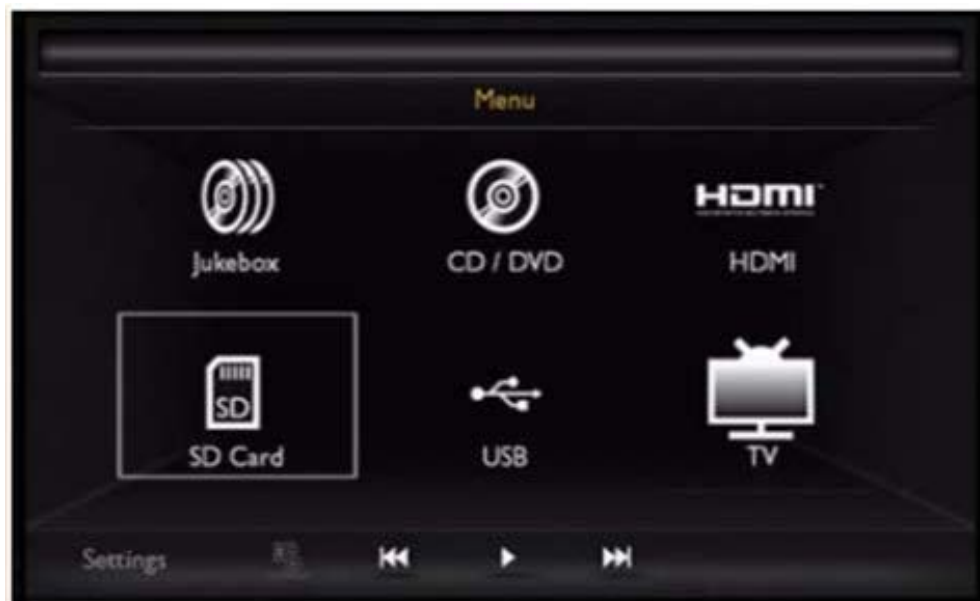
34. Figure 16b for reference shows the screen displayed on RSE systems that have yet to receive this update and therefore do not display any online icons. Car displaying this screen require this Rear Seat Entertainment - field update
35. Re instate Off board Diagnostic Information System minimised in operation 18 and *Exit* this will initiate a sweep all control modules
36. Once Off board Diagnostics Information System has carried out a sweep of the car and returned to the desk top then Perform an ignition off on cycle
37. Re start Off board Diagnostic Information System and perform a full sweep of the vehicle control modules NOTE: Again at this point when requested to *Make a Target/Actual comparison* do not perform this action select No. Instead a second *Replace control module* routine for 7F must be performed
