**SLINGSHOT**

ARTICLE: SLI-15-11-01

## SUBJECT: SLINGSHOT – REAR SPROCKET RETAINING NUT RUNNING CHANGE

### MODELS: ALL 2015-2016 SLINGSHOT MODELS

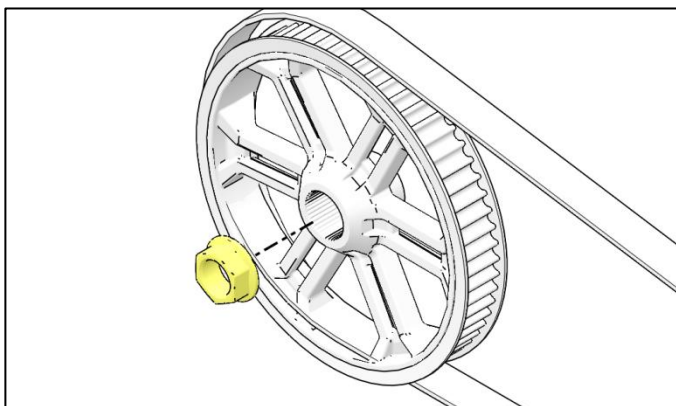
#### OLD (PN 7547617 – QTY 1)

The Slingshot Division of Polaris Industries has developed updated rear sprocket retaining nuts and Loctite® on 2016 Slingshot models manufactured after 11/02/2015. The single hex flanged-style nut has been replaced with two hex head nuts. Loctite® 641 (Yellow) applied to the rear axle splines and threads has been replaced by Loctite® 680 (Green).

1. A clicking or popping noise from the rear axle area during low speed operation  
**NOTE:** This noise is similar to and may be mistaken for a damaged rear wheel bearing
2. Reduced clamp force on the rear sprocket nut
3. A service procedure requiring removal of the rear sprocket is performed

#### TORQUE

250 lb-ft (339 Nm)

Loctite® 641 (Yellow)
