V-15-07-01

SUBJECT: VICTORY MAGNUM, X-1 - REPROGRAMMING (REFLASH) PROCEDURE

MODELS: MAGNUM, X-1

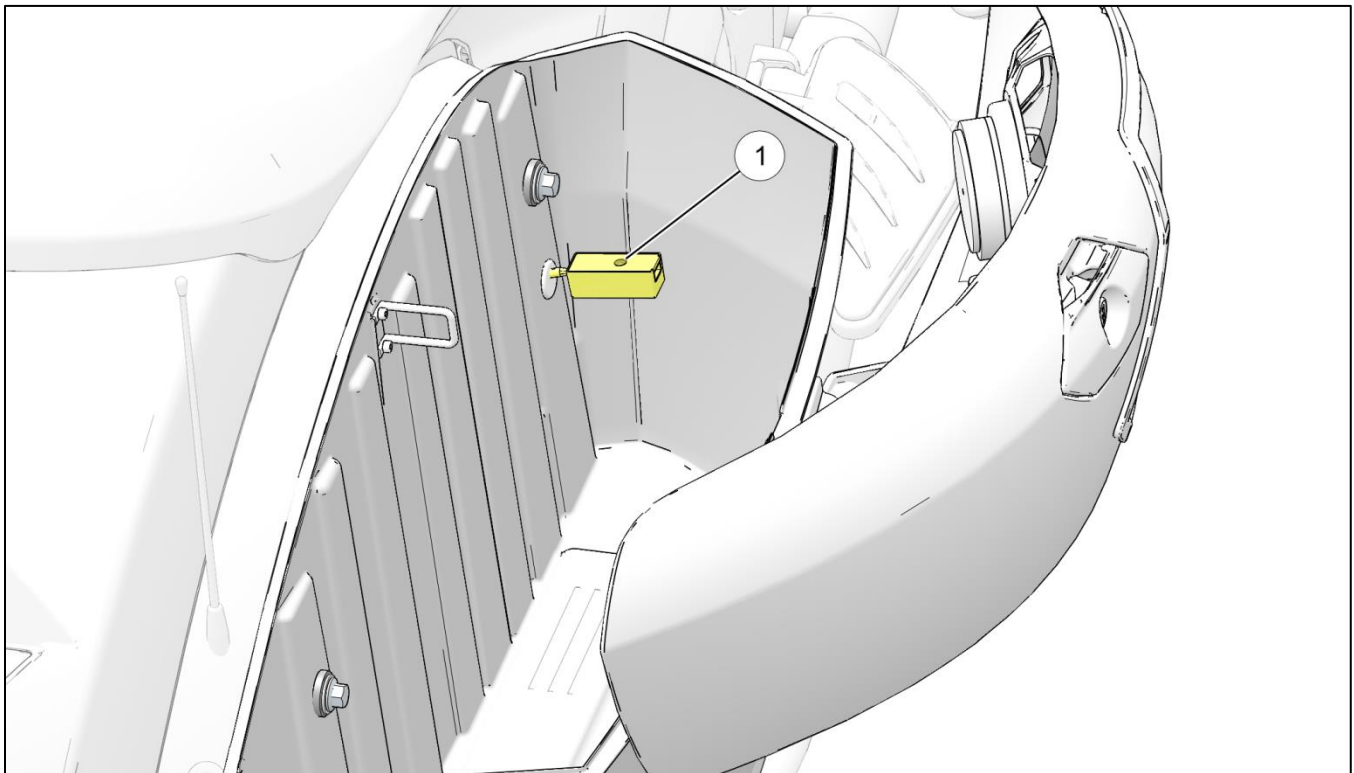
Victory Motorcycles has determined the reprogramming (reflash) procedure may be negatively affected if performed with a device connected to the USB connector.

It is important to disconnect all devices from the USB connector ① prior to performing an ECM, ABS Controller or Audio System reprogramming (reflash) procedure.
