# SMITTYBILT TECHNICAL UPDATE

SM-08.26.2015

APPLICATION JK 2 & 4 Door

PART NO. S/B76857

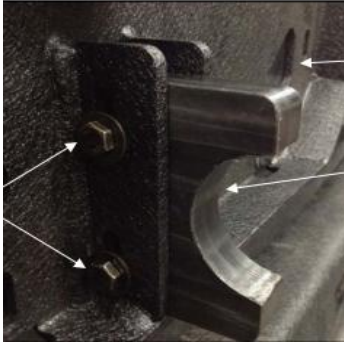
Fig A

Possible excessive movement or rattling (Gen 2 tire carrier) part# 76857. This could be caused by the heim joint being too long and incorrect heim joint bolts. The tire carrier must rest in the "C" bump stop properly to prevent movement. (Fig A,B)

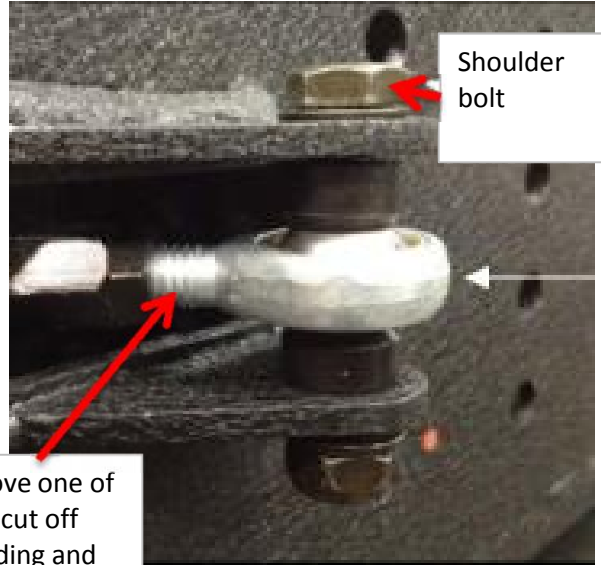
Fig C

You can remove one of  
the ends and cut off  
1/4" of threading and

- A. You can remove one of the ends and cut off 1/4" of threading and re-insert. (Fig C)
- B. We will have inventory of the shorter Heim joint (Part # 76857-03) ETA 8/27 and more coming 9/4
