SERVICE CAMPAIGN BULLETIN

| TITLE: | Turbo Coolant Feed Hose Replacement |
| DOCUMENT NUMBER: | 11 F 024 |
| AFFECTED VEHICLES: | McLaren 675LT |

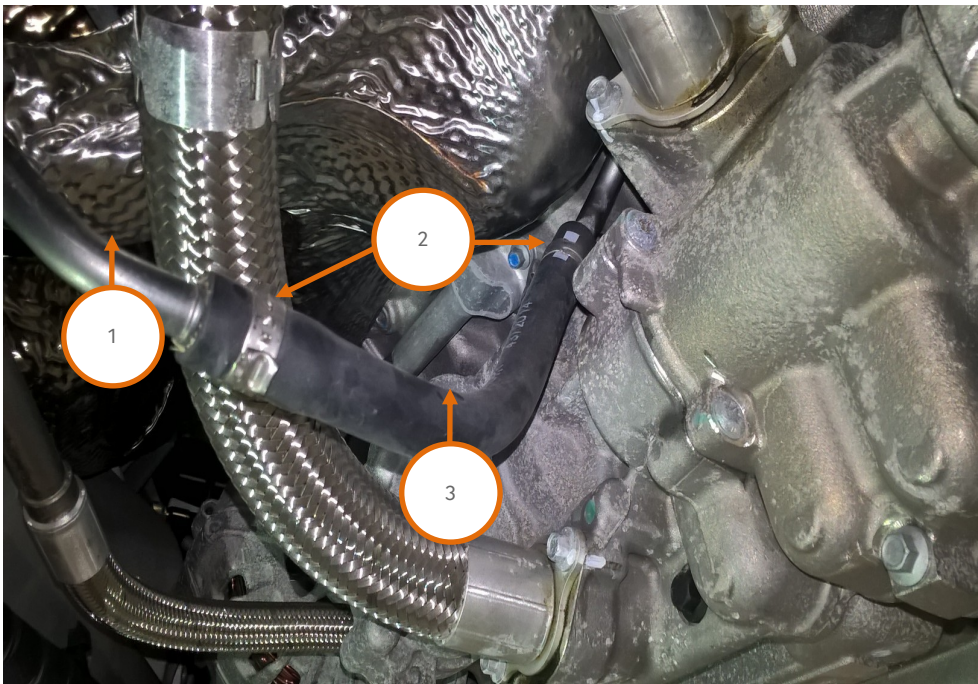
1. Locate the turbo coolant feed hose (1).
2. Remove both oetiker clips (2).

Care Point: During removal do not disturb the connection to the turbocharger. Movement of the turbocharger metal pipe may cause loosening of the turbo pipe hollow bolt and result to another minor leak patch.

3. Remove the rubber coolant hose (3) from the pipe assembly.
