## SERVICE CAMPAIGN BULLETIN

<b>TITLE:</b>	Vehicle Software Update to Platform 13
<b>CAMPAIGN REFERENCE</b>	02M
<b>DOCUMENT NUMBER:</b>	11 M 069
<b>AFFECTED VEHICLES:</b>	McLaren 12C Coupe and Spider
<b>SITUATION:</b>	<p>Quality Engineering at McLaren Automotive have released a new software platform for the 12C Coupe and Spider.</p> <p>The most noticeable changes of this software are;</p> <ul style="list-style-type: none"><li>• Fuel level full is now displayed when brimmed.</li><li>• Fuel Filler Actuator reset.</li><li>• HVAC flutter.</li><li>• Launch control improvement at altitude.</li><li>• Window Drop Ingress / Egress function included and only functional on vehicles with door buttons.</li><li>• Middle East Speed Warning - Tell-tale removal.</li><li>• DRS (Drag Reduction System) function included.</li><li>• Capability to retrofit Reverse Camera, DAB and SirrusXM to vehicles I installed with the model year 2014 IRIS.</li><li>• Intermittent loss of Meridian sound.</li><li>• Navigation day and night switching corrected.</li></ul> <p>In addition to this, to support our Customers McLaren Automotive have also created a 12C Technology Upgrade eBrochure.</p>

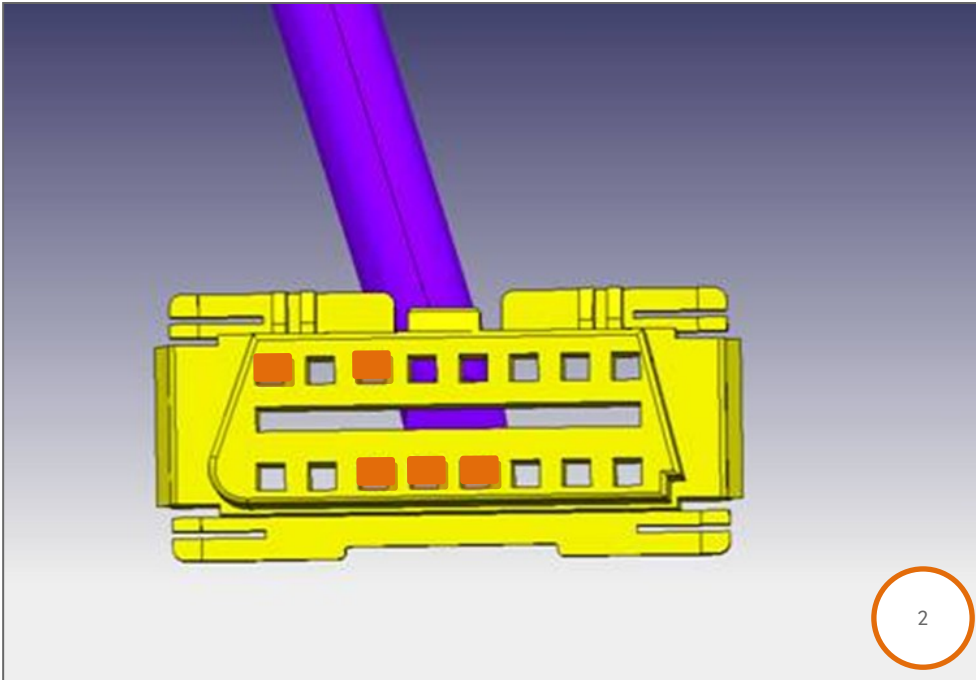
4. Check OBD connector pins 4, 5, 6, 14 and 16, as highlighted below are secure. Loose pins can cause module software download errors. If any of the pins are found to be loose these should be closed up before module reprogramming is carried out (2).
