TECH TIP

08MY-16MY Headlamp Condensation or Water Intrusion

SUBJECT VEHICLES: 08MY-16MY Conventional trucks

Group:	0-General
Bulletin No.:	TT-15-002
Issue Date:	2-04-2015

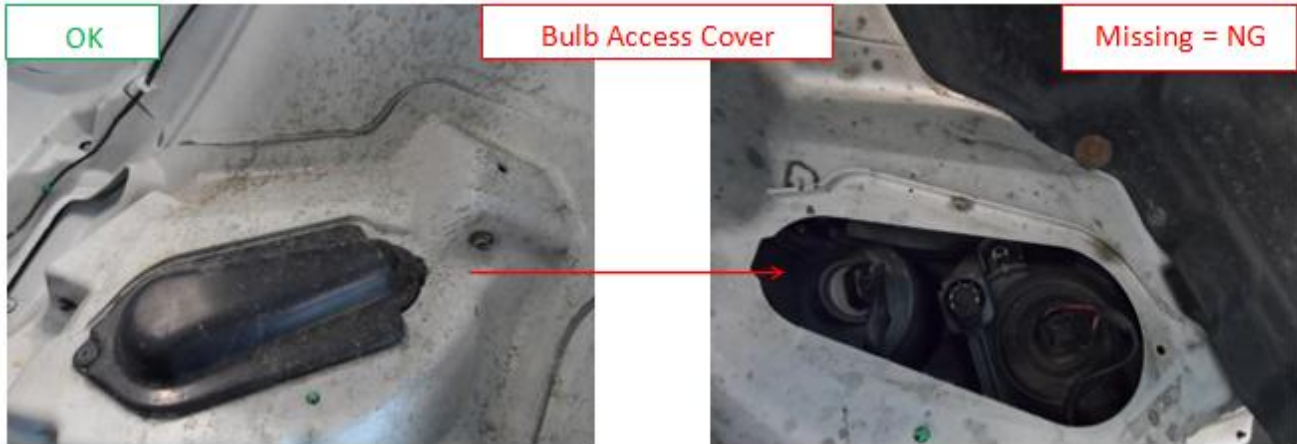
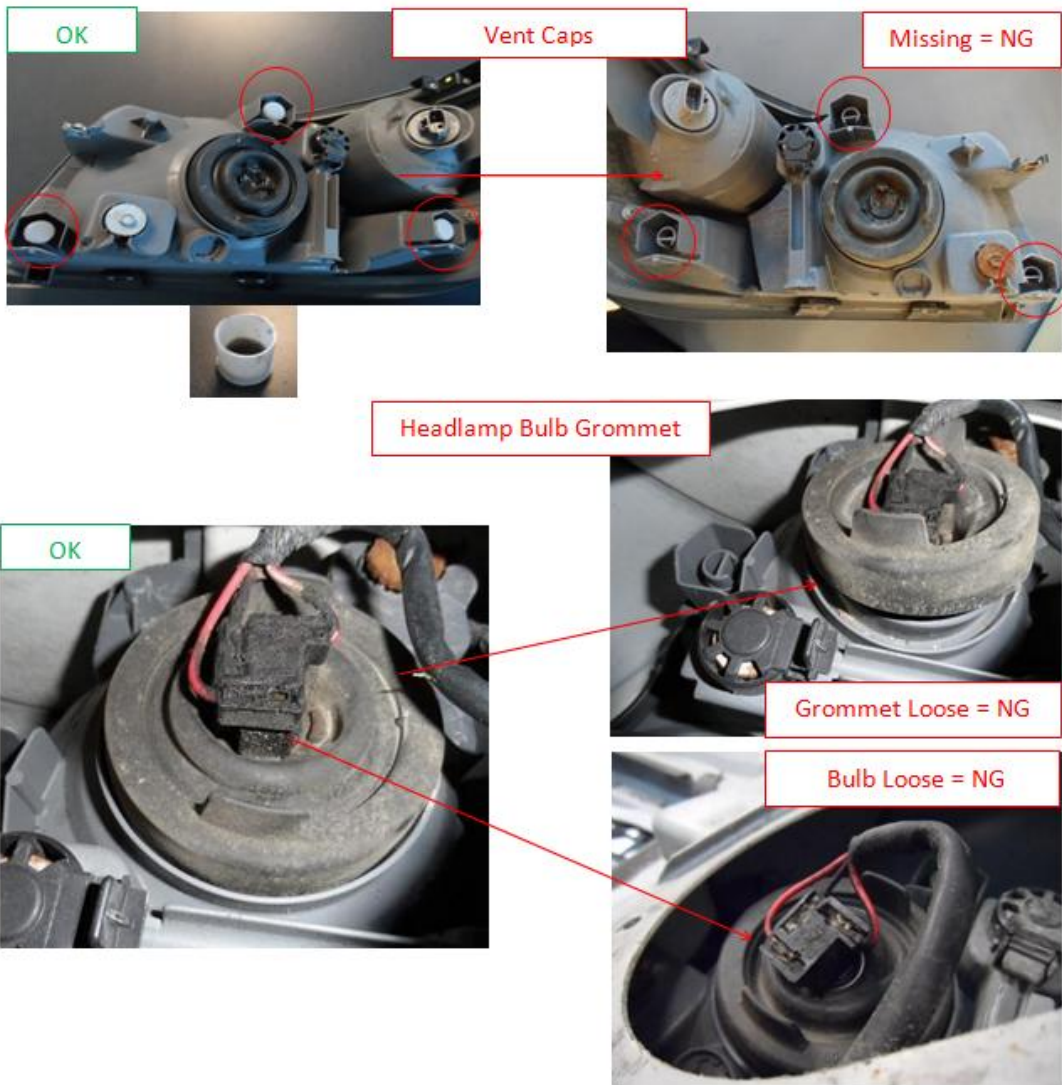
The customer may complain of water or condensation within the headlamp assembly. If the vehicle exhibits this condition, it is necessary to first verify that all of the protective covers and caps are installed before suspecting a problem with the headlamp assembly. Any loose or missing caps or covers on the headlamp will result in water entry. Note that some condensation within the headlamp at times should be considered normal.

NOTICE: If any of the above components are found to be loose, missing, or improperly installed, this will not be a warrantable repair. Headlamp assemblies which are returned through warranty that are missing any of the components, which are shown above, will not be reimbursable within the terms and policies of the Hino Truck limited warranties. Headlamp assemblies must be complete with all bulbs and caps installed to be eligible for warranty coverage.

NOTICE: Some condensation forming within the headlamp assembly is normal due to humidity in the air which can condense on the inner surface of the headlamp lens. Headlamps are not designed to be air tight. If all of the components, which are shown above, are in place at the time of inspection and the customer is complaining of condensation in the headlamp assembly, it is recommended to operate the headlamps with the high beams on for a minimum of 40 minutes. If the condensation dissipates after 40 minutes of operation, this is a normal characteristic and no repairs should be made.
