# WARRANTY BULLETIN

Campaign no.: 2015-0001

Subject: **Oil Sweating from SE6 Clutch Cover HCM Connector**

No. **2015-1**

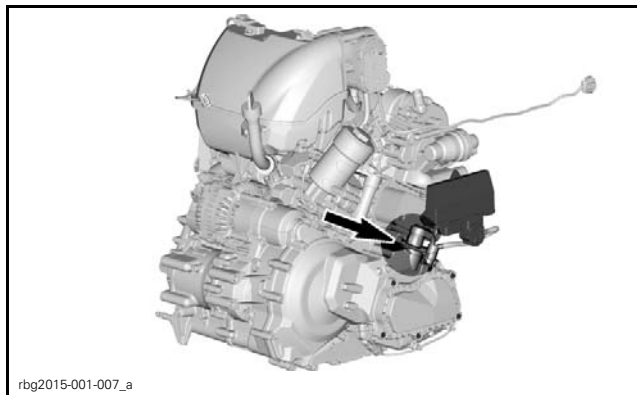
The HCM wiring harness nut on top of the SE6 clutch cover may not have been properly tightened during assembly. This may lead to oil sweating past the o-ring.

Tighten the HCM wiring harness nut to specification. See *PROCEDURE* in this bulletin.
