## ROADSTER 2015 Product Reference Article - 108572

Up-to-date technical information on the 2015 Roadster product. Destined for dealer service department staff.  
This document may change without notice, always consult the latest version available.

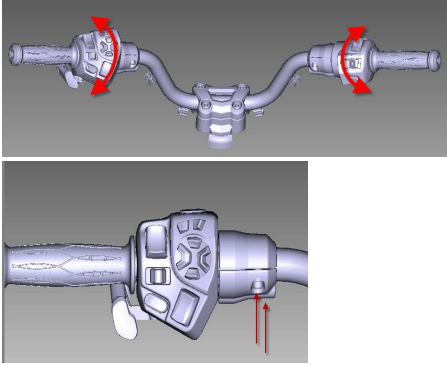
| | | | | On a few F3 units the handlebar commodo (multi-function switches) may rotate, this is due to the handlebar end clamp not being fully torqued. Simply torque the clamp bolts to 11 ±1 Nm. | | |

| 2015 | F3 | Handlebar commo movement - clamp not torqued enough | No Case needed | | | 11-02-2015 |
