To: Official After Sales Network Subject: AC System software update

Date: 02/20/2015

AC System software update

All Lamborghini Huracán 2015 Right Hand drive starting from VIN 00163 to FLA01968

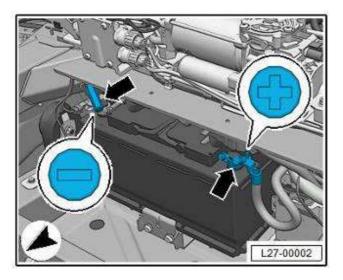
2. Please connect a battery charger to the recharge points available in the front luggage compartment, as shown in picture.

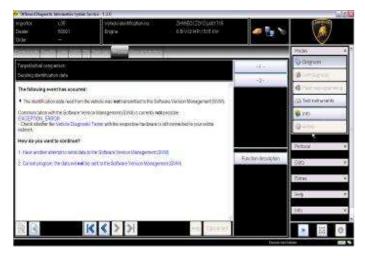
- **D.** If the incorrect identification message is shown as in the picture below (error code: ODS1007E):
 - be sure that your Geko account is valid;
 - be sure that the label "Geko" is written on the token that you are using for the authentication;
 - be sure the Password inserted is correct;
 - click on Cancel and perform the application test (see document
 "ODIS_Checking_ConnectionServer_SV
 M_2.0" (*)).
