| L624-A.06.15 | <b>To:</b> Official After Sales Network<br><b>Subject:</b> SMLS software update<br><b>Date:</b> 02/20/2015<br><b>Pages:</b> 12 | |

SMLS software update

All Lamborghini Huracan 2015 starting from VIN **FLA00163 To FLA00752.**

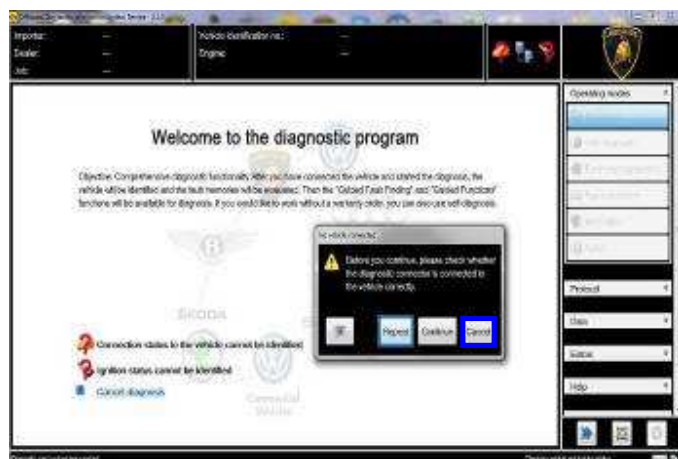
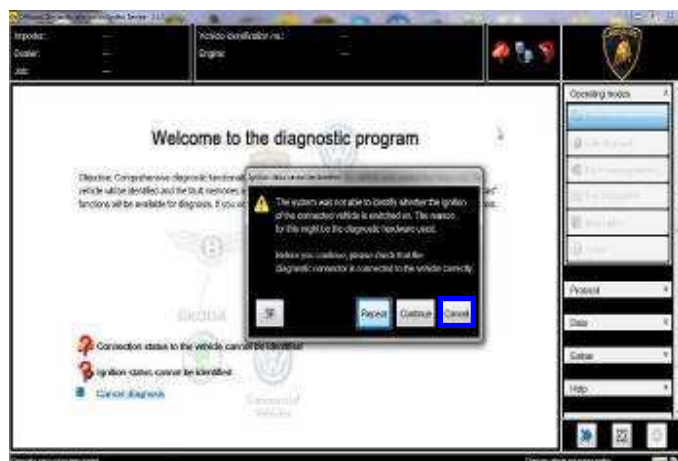
- A.** If the error message regarding the VAS5054 interface and the 2 icons for status of on board connection and key on are shown as in the picture below:
- Click “Cancel”;
  - Repeat the VAS5054 HW interface installation following the procedure (\*) “VCI Manager v2.0”, by entering in the menu “Extras” on the right side and clicking on “Diagnostic interface”.

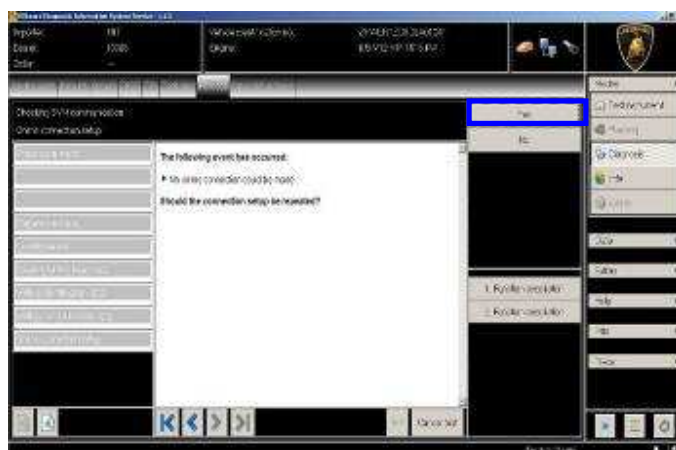
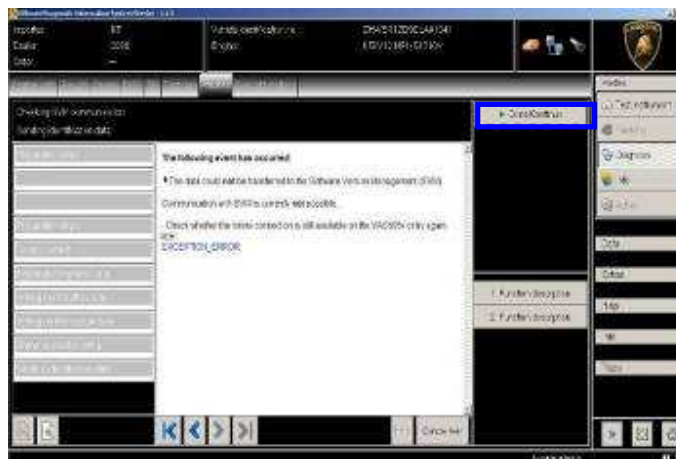
- B.** If one of the connection errors screens is shown as in the pictures below:

- it is not possible to establish a connection with the central server. Please check carefully that the diagnosis laptop is properly connected to the internet network and retry clicking “Yes” or “Done/Continue”

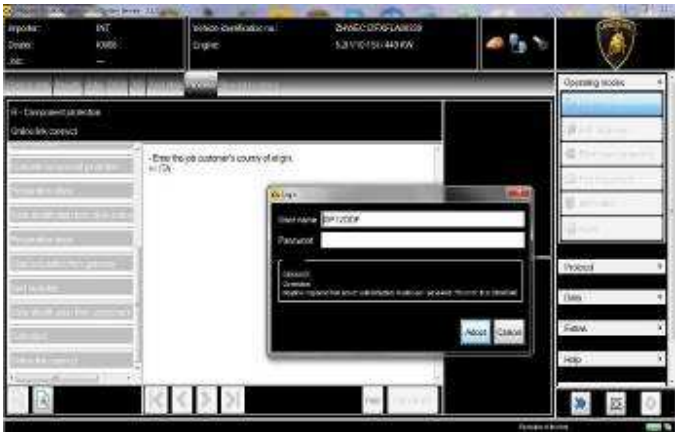
D. If the incorrect identification message is shown as in the picture below (error code: ODS1007E):

- be sure that your Geko account is valid;
- be sure that the label “Geko” is written on the token that you are using for the authentication;
- be sure the Password inserted is correct;
- click on Cancel and perform the application test (see document “ODIS\_Checking\_ConnectionServer\_SVM\_2.0” (\*)).

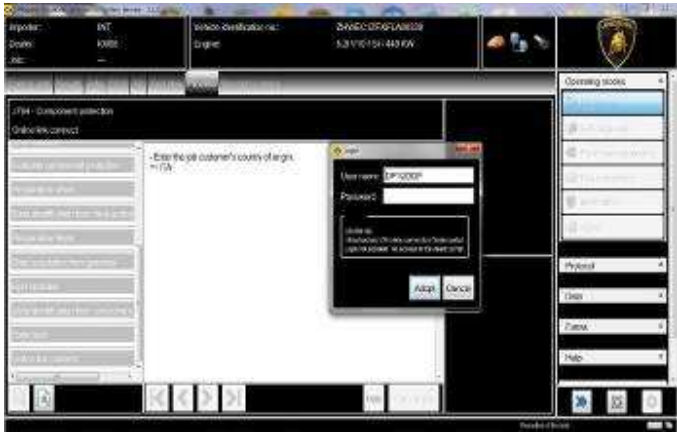
E. If the infrastructure error message is shown as in the picture below (error code: ODS9212E):

- be sure that your Geko account is valid
- be sure that the label “Geko” is written on the token that you are using for the authentication
- verify in ODIS settings you have “Internet” instead of “CPN” (see document “ODIS\_Initial\_Setup\_2.0” (\*))
- click on Cancel and perform the application test (see document “ODIS\_Checking\_ConnectionServer\_SVM\_2.0” (\*))

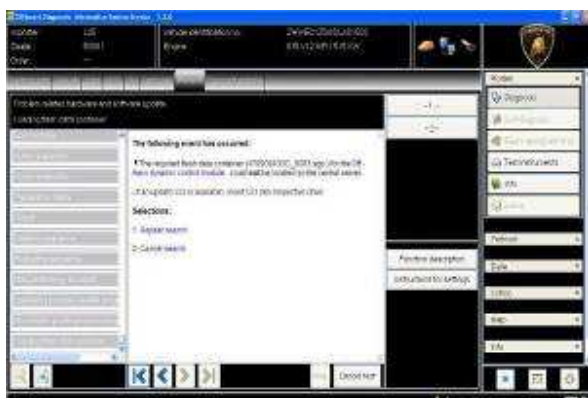
- F.** In the case the flash container is not detected (see figure):

- Make sure to be recently synchronized with Mirrorserver by checking the last date of Sync under:  
<http://mirrorserver/welcome>  
or under  
[http://IP\\_address/welcome](http://IP_address/welcome)  
if you don't have previously defined the “mirrorserver” IP address alias.
- Make sure to be correctly connected with Mirrorserver.
