| L624-A.09.15 | <b>To:</b> Official After Sales Network<br><b>Subject:</b> Instrument Cluster (Kombi) software update<br><b>Date:</b> 02/20/2015<br><b>Pages</b> 16 | |

Instrument Cluster (Kombi) software update

All Lamborghini Huracán 2015 From VIN FLA00163 to FLA02216.

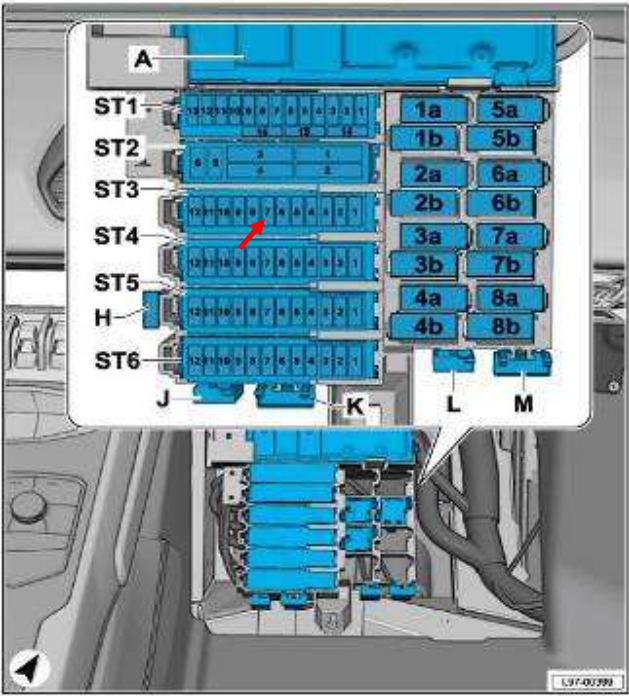
Position of the fuse on Left Handdrive cars

- Close the ODIS session;
- Turn the ignition OFF;
- Disconnect the locked Instrument Cluster, by removing the SC7 fuse on black fuse holder ST3 (see below images)

| 7 | - Fuse 7 on fuse holder C-SC7- | 5 A |

- Wait at least 10 minutes and reconnect the Instrument Cluster, by inserting the SC7 fuse before removed.
- Turn the ignition ON;
- Restart ODIS and repeat the procedure from step 11, checking that ODIS is the only application running on the diagnosis laptop.

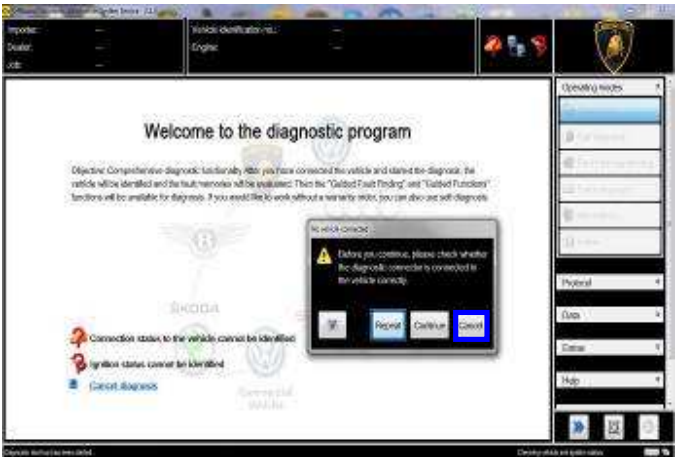
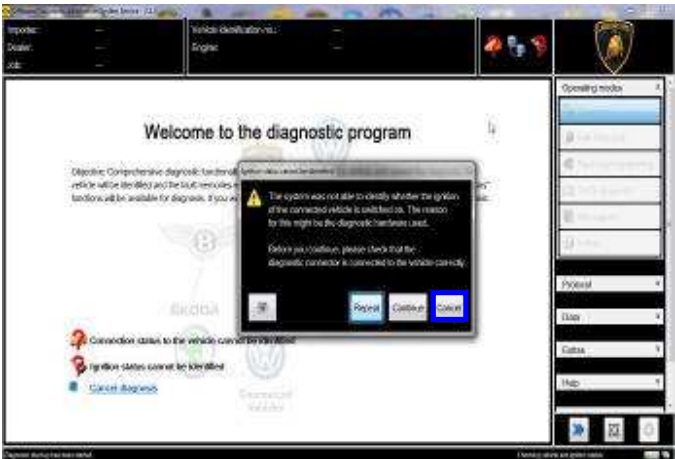
- A. If the error message regarding the VAS5054 interface and the 2 icons for status of on board connection and key on are shown as in the picture below:
- Click **“Cancel”**;
  - Repeat the VAS5054 HW interface installation following the procedure (\*) **“VCI Manager v2.0”**, by entering in the menu **“Extras”** on the right side and clicking on **“Diagnostic interface”**.

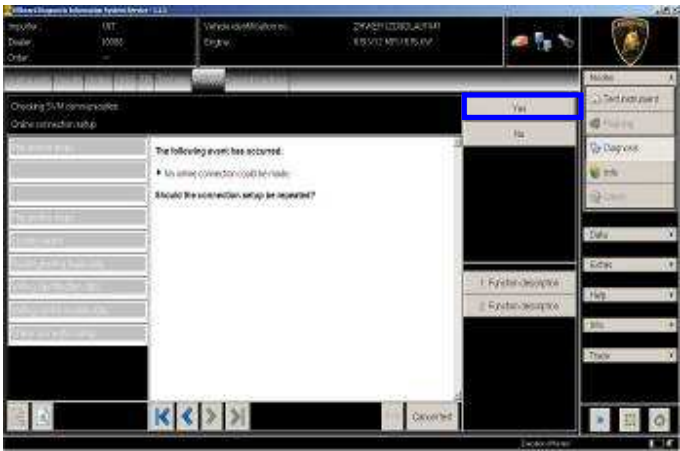
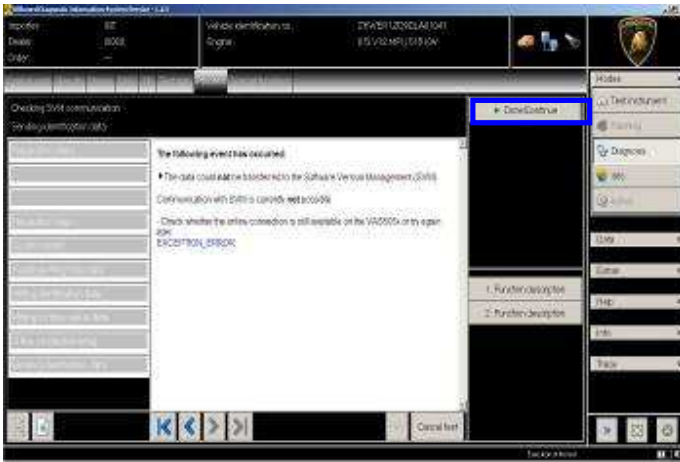
B. If one of the connection errors screens is shown as in the pictures below:

- it is not possible to establish a connection with the central server. Please check carefully that the diagnosis laptop is properly connected to the internet network and retry clicking “Yes” or “Done/Continue”.

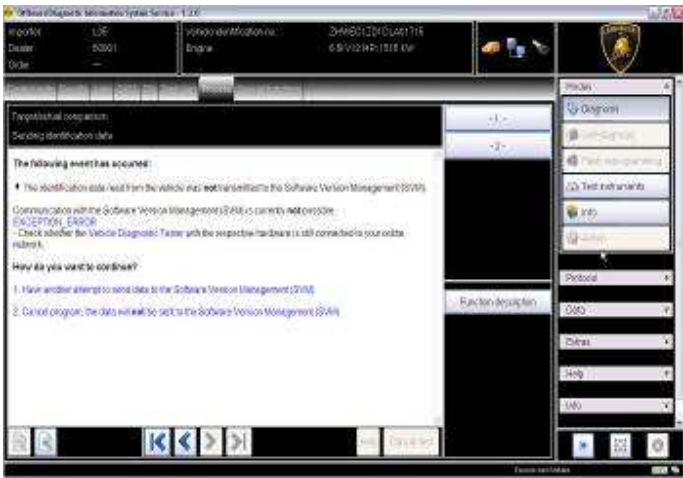
C. If the loss of connection happens during the target/actual comparison.

- It is not possible to connect to central server, check the working connection of internet and retry by clicking “1”.

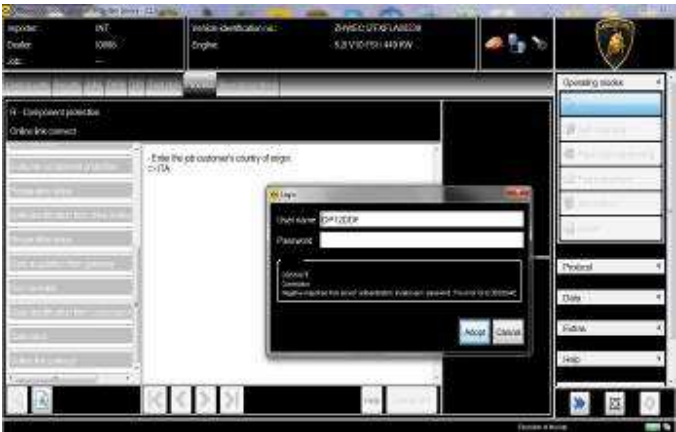
D. If the incorrect identification message is shown as in the picture below (error code: ODS1007E):

- be sure that your Geko account is valid;
- be sure that the label “Geko” is written on the token that you are using for the authentication;
- be sure the Password inserted is correct;
- click on Cancel and perform the application test (see document “ODIS\_Checking\_ConnectionServer\_SV M\_2.0” (\*)).
