NUMBER: 13-001-15 REV. A

Right Front Side Rail Inner Panel Stamping Deformity

2015 (JC) Dodge Journey

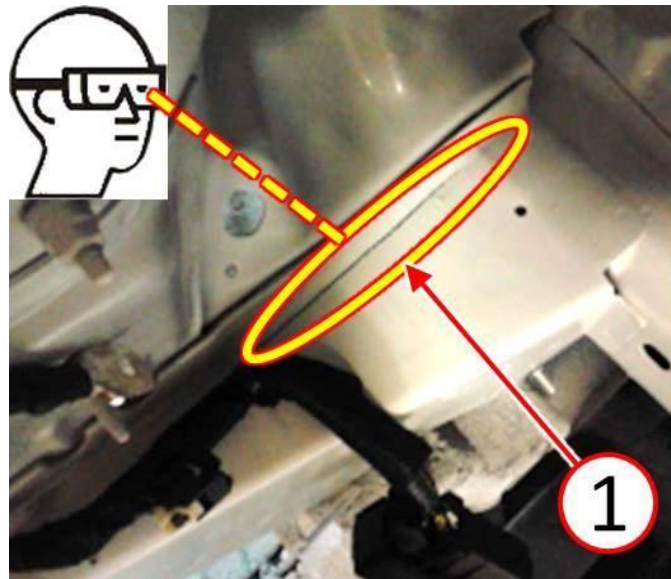
Fig. 2 Inspect Right Front Side Rail Inner Panel For Deformities

2. Push aside wire harness that hides the top of the right front side rail inner panel from view.
3. Inspect right front side rail inner panel for any cracks or splits (1) as shown in (Fig. 2).

1 - Inspection Area

- 4. Were any cracks or splits found in the right front side rail inner panel?
 - a. YES>>> Contact your Area Manager or Business Center Customer Relations/Warranty Manager for buy back instructions and perform [Step #5](#).
 - b. NO>>> This bulletin does not apply. Perform [Step #5](#).
- 5. Reposition wire harnesses and install the engine cover.
