2014 Sentra (B17) Front Strut Insulator
Dealer Service Action

Reference: PM552

Date: January 15th, 2015

PM552 Sentra (B17) Strut Insulator

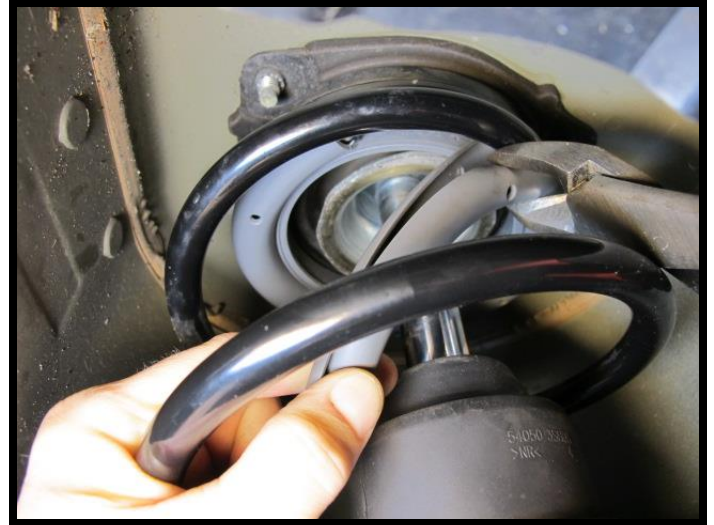
Figure 4

The excess insulator material is being removed to eliminate potential front end noise from the strut area.

7. Cut approximately (minimum) 90mm off the front strut insulator and discard (Figure 4).

- Hold front strut insulator end and cut with angled side cutter (or suitable tool).
