# RECALL CAMPAIGN BULLETIN

NTB15-005

## VOLUNTARY SAFETY RECALL CAMPAIGN 2013-2014 PATHFINDER; SECONDARY HOOD LATCH

**CAMPAIGN ID #:** PC343  
**APPLIED VEHICLE:** 2013- 2014 Pathfinder (R52)  
2014 Pathfinder hybrid (R52)

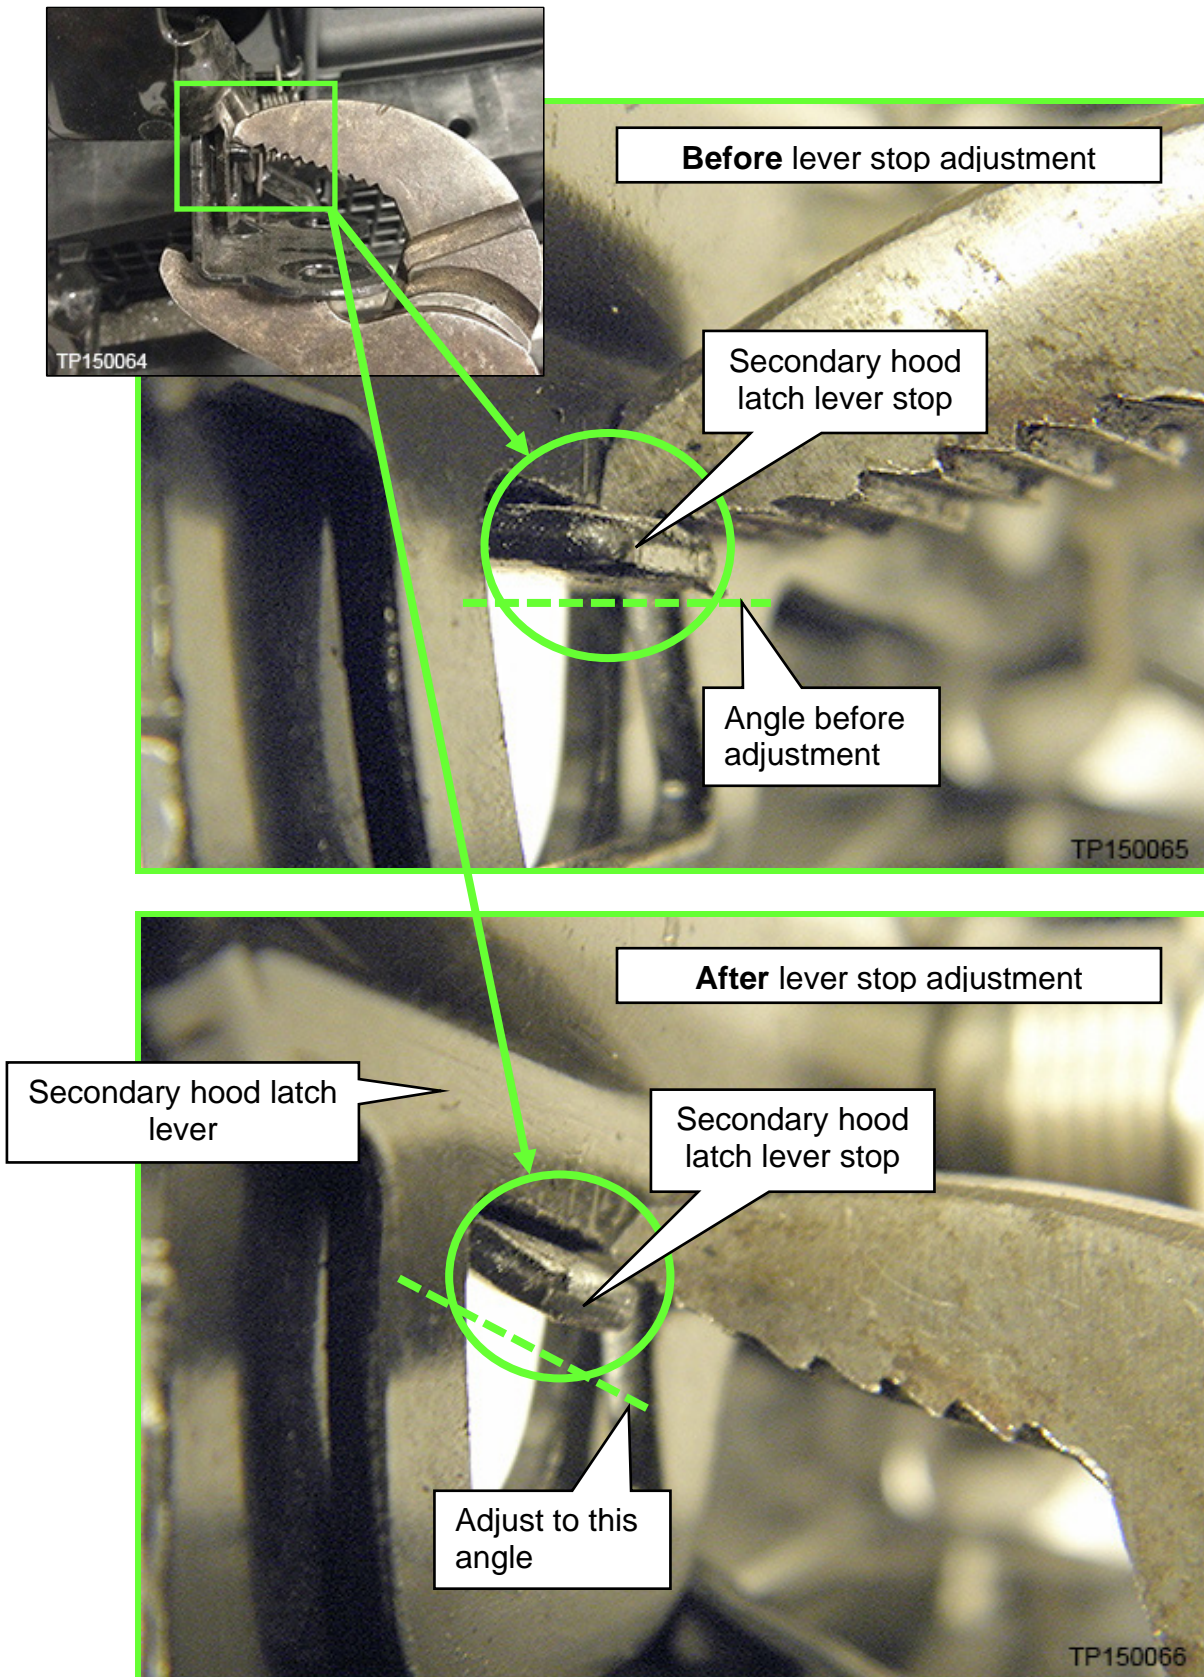
Figure 3

Nissan is conducting a Voluntary Safety Recall Campaign on certain specific Model Year 2013 - 2014 Nissan Pathfinders to adjust the lever stop for the secondary hood latch lever at no charge for parts or labor.

- Using a suitable tool, bend the “secondary hood latch lever stop” down (Figure 3) so that the bottom of the lever rests on the base of the hood lock assembly bracket (Figure 5, page 4).
