SERVICE BULLETIN

EC12-012j NTB12-051j January 30, 2015

MIL ON WITH DTC P0101

APPLIED VEHICLES: 2011-2012 Altima Coupe (CL32)

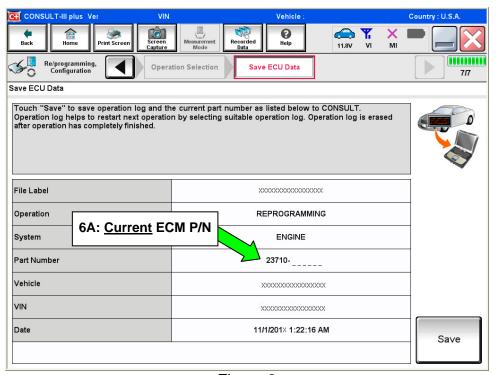
Figure 2

- 6. When you get to the screen shown in Figure 2, confirm this bulletin applies as follows.
 - A. Find the ECM **Part Number** and write it on the repair order.

NOTE: This is the <u>current</u> ECM Part Number (P/N).

- B. Compare the P/N you wrote down to the numbers in the **Current ECM Part Number** column in **Table A** on the next three pages.
 - If there is a <u>match</u>, this bulletin <u>applies</u>. Continue with the reprogramming procedure.
 - If there is <u>not a match</u>, this bulletin <u>does not apply</u>. Close C-III plus and refer to ASIST for further diagnostic information.

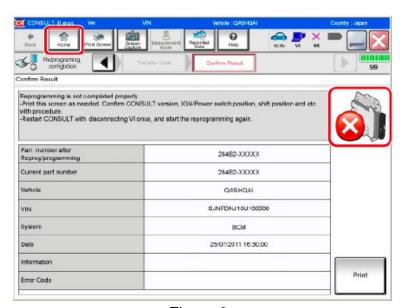
Figure 6

If reprogramming does <u>not</u> complete and the "X" icon displays as shown in Figure 6:

- Check battery voltage (12.0 – 15.5 V).
- CONSULT A/C adapter is plugged in.
- Ignition is ON, engine OFF.
- Transmission is in Park.
- All C-III plus / VI cables are securely connected.
- All C-III plus updates are installed.
- Select <u>Home</u>, and restart the reprogram procedure from the beginning.
