# SERVICE BULLETIN

Classification: EL13-055c	Reference: NTB14-001c	Date: March 11, 2015
------------------------------	--------------------------	-------------------------

## 2013 - 2014 LEAF; INSUFFICIENT HEATER OUTPUT

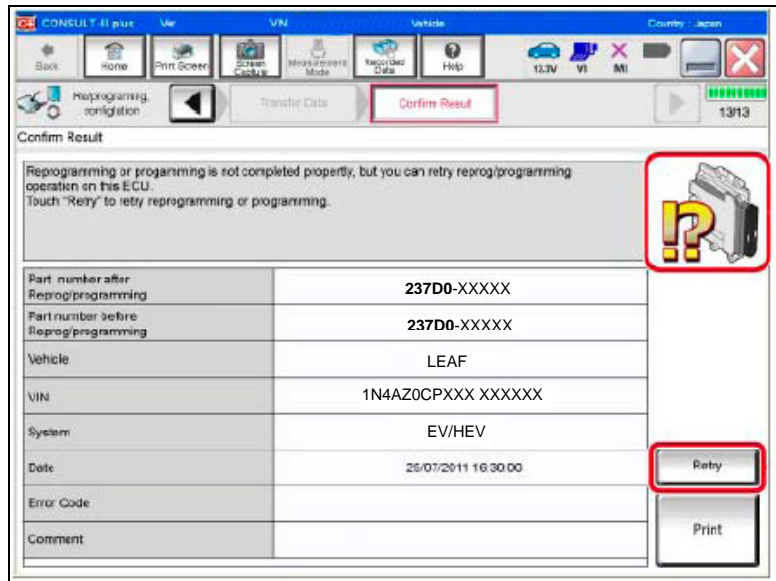
Figure 19

**If reprogramming does not complete and the “!” icon displays as shown in Figure 19:**

- Check battery voltage (12.0 – 15.5 V).
- Ignition is ON, Ready Mode is OFF.
- External Bluetooth® devices are OFF.
- All electrical loads are OFF.
- **Select retry and follow the on screen instructions.**
- “Retry” may not go through on first attempt and can be selected more than once.

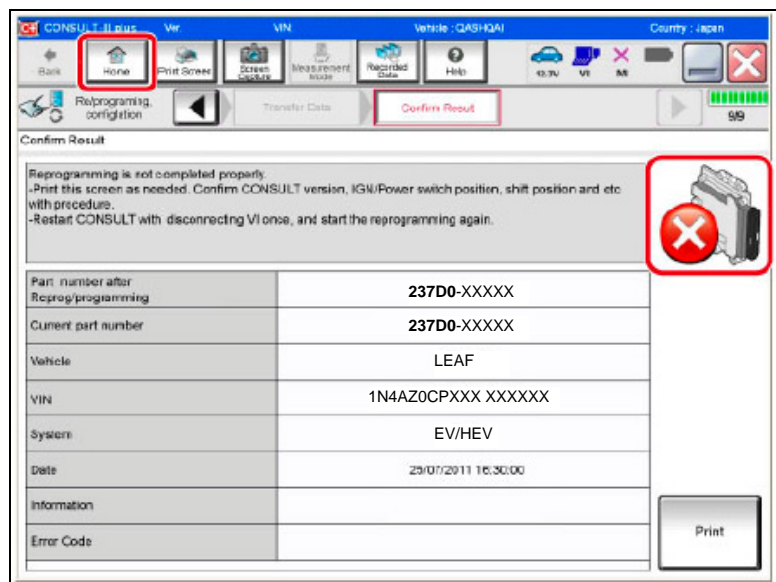
Figure 20

**If reprogramming does not complete and the “X” icon displays as shown in Figure 20:**

- Check battery voltage (12.0 – 15.5 V).
- CONSULT A/C adapter is plugged in.
- Ignition is ON, Ready Mode is OFF.
- Transmission is in Park.
- All C-III plus / VI cables are securely connected.
- All C-III plus updates are installed.
- **Select Home, and restart the reprogram procedure from the beginning.**

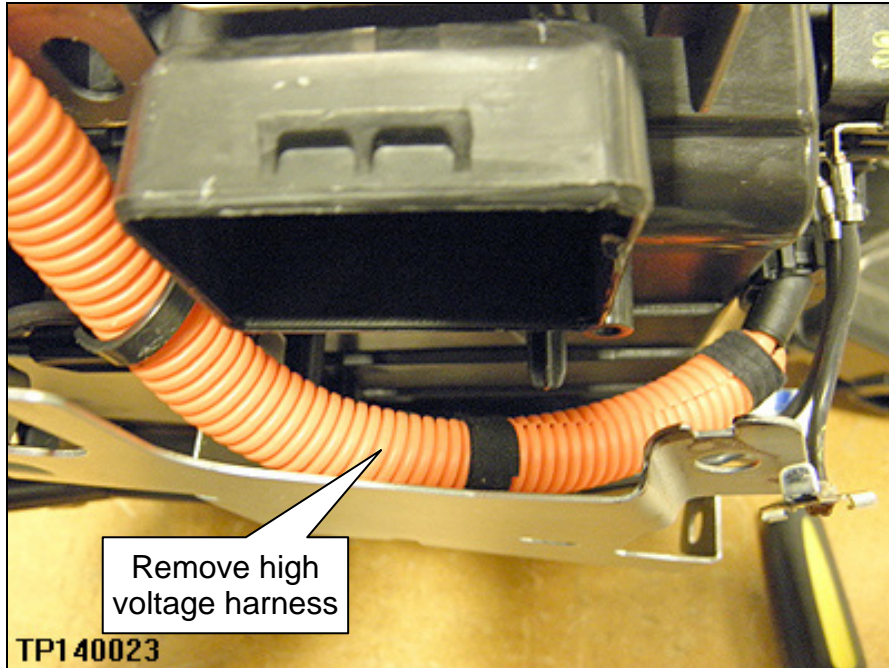
Figure 30

6. Remove high voltage harness (shown in orange) from under the lower shield (Figure 30).

**WARNING:** This harness must be returned to this position under this shield on reassembly.

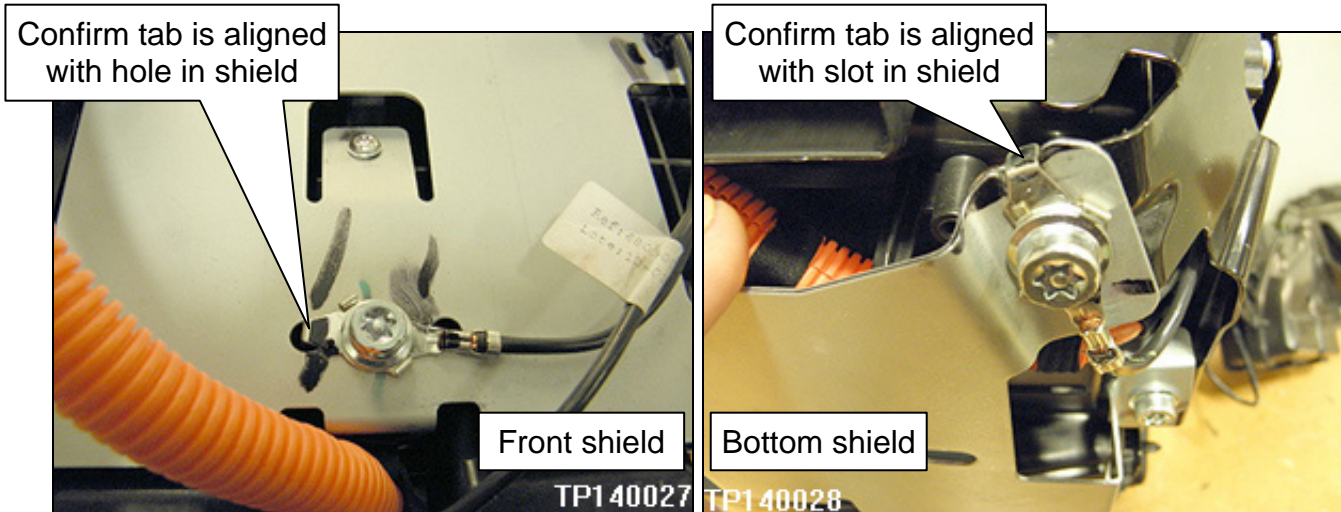
11. Verify that the ground harness connectors are correctly aligned (shown in Figure 34 and Figure 35).

- If not as shown, loosen bolts and realign then retighten.
