## SERVICE BULLETIN

TF15-001

### 2013 – 2014 PATHFINDER 4WD ERROR DISPLAYED AND DTC C1204 STORED

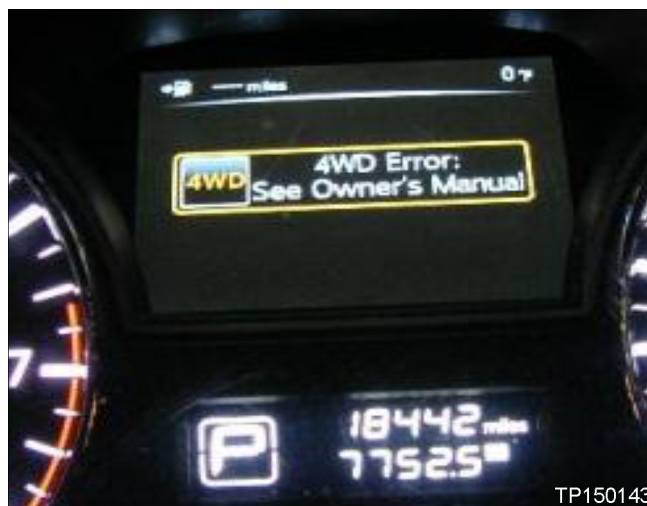
Figure 1

4WD ERROR is displayed in the Vehicle Information Display.

DTC C1204 (4WD Solenoid) is stored.

Replace the 4WD Control Unit with the one listed in the Parts Information of this bulletin.
