2014-15 Armada Seat Belt Buckle
Dealer Inventory Inspection

Reference: PC380
Date: June 12, 2015

NISSAN DEALER INSPECTION

PC380 Armada Seat Belt Buckle

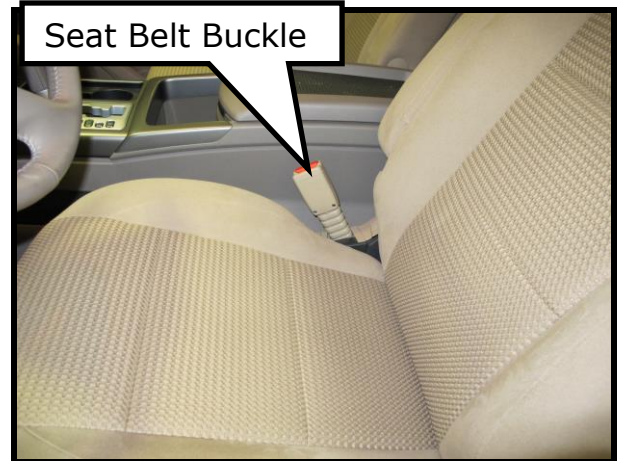
Figure 1

1. Open left front (Driver) door.
2. Locate left front (Driver) seat belt buckle as shown in Figure 1.

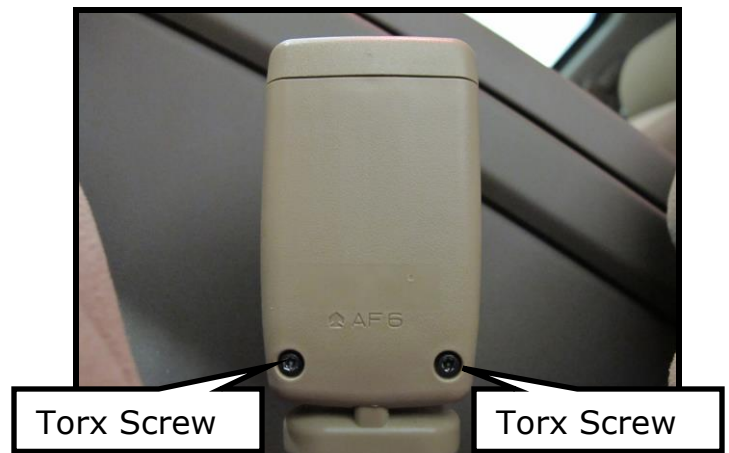
Figure 2

3. Remove (2) T-10H (tamper proof) Torx screws on the left front seat belt buckle, refer to Figure 2.

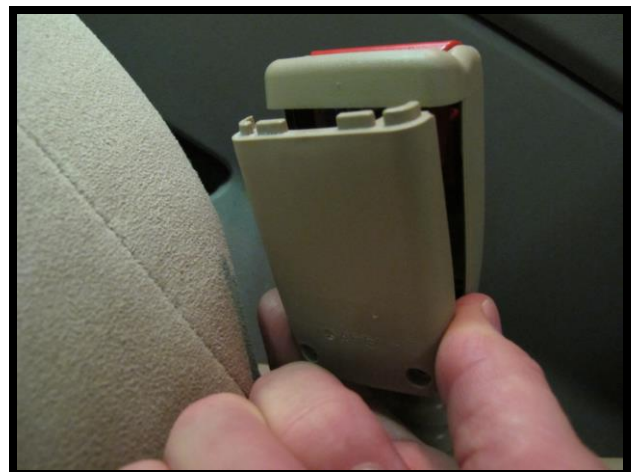
Figure 3

4. Open the buckle cover to inspect buckle latch mechanism.
 - Gently pull cover out from the bottom, then push down to release the buckle cover, refer to Figure 3.
 - Pivot the top of the buckle cover out leaving the bottom still touching the buckle due to the wire harness inside as shown in Figure 4.

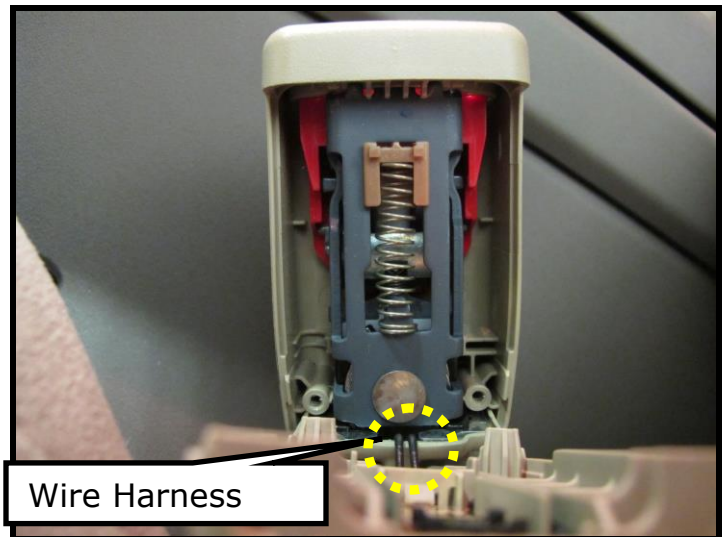
Figure 4

Take care to not damage the wire harness at the bottom of the buckle cover.

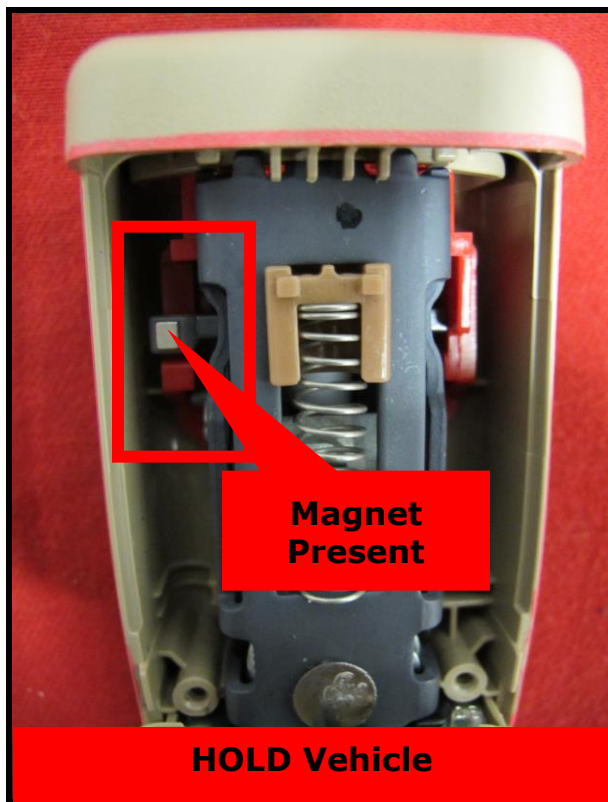
Figure 5

- 5. Inspect the buckle latch mechanism for presence of a magnet. See Figures 5 and 6 below.
- 6. Repeat inspection (Steps 1-5) for right front (Passenger) seat belt buckle.

8. If a magnet **IS** present in either front seat belt buckle mechanism as shown in Figure 5, then:

- **HOLD** the vehicle and **DO NOT** submit a warranty claim.
- Send an E-mail to the below address:
