SERVICE BULLETIN

Classification: EC14-002c	Reference: NTB14-009c	Date: June 17, 2015
------------------------------	--------------------------	------------------------

2014 VERSA NOTE; MIL ON WITH DTC P059F STORED

APPLIED VEHICLE: 2014 Versa NOTE (E12)

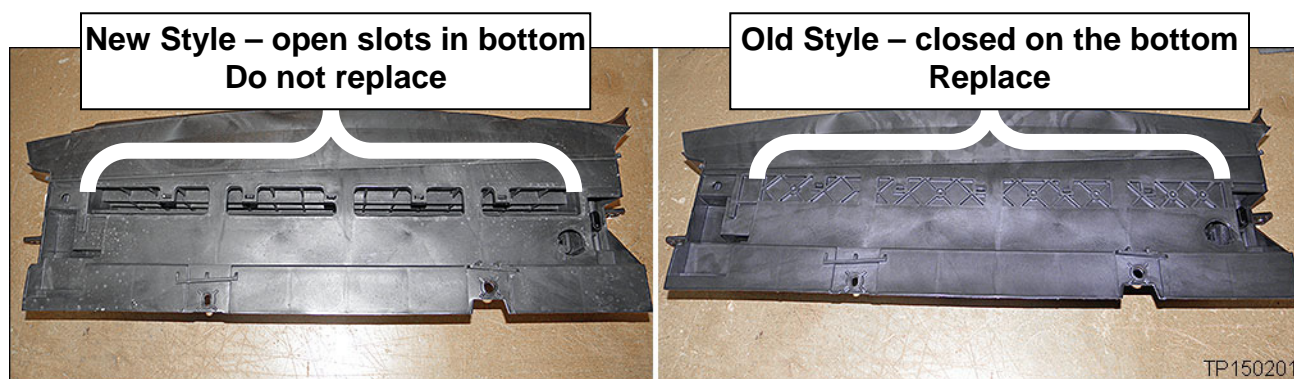
Figure 8

NOTE: If the front undercover is removed from the vehicle, the bottom of the shutter is visible. You can see if the bottom is closed or if it has open slots.

- Refer to the **FLOWCHART** on page 2 for shutter replacement applicability.
 - Replace the shutter only if OP code **CX23AA** or **CX24AA** has **not** been performed on this vehicle.
 - Check Service COMM; if either one of the above OP codes has already been performed, the new style shutter is already installed on the vehicle.

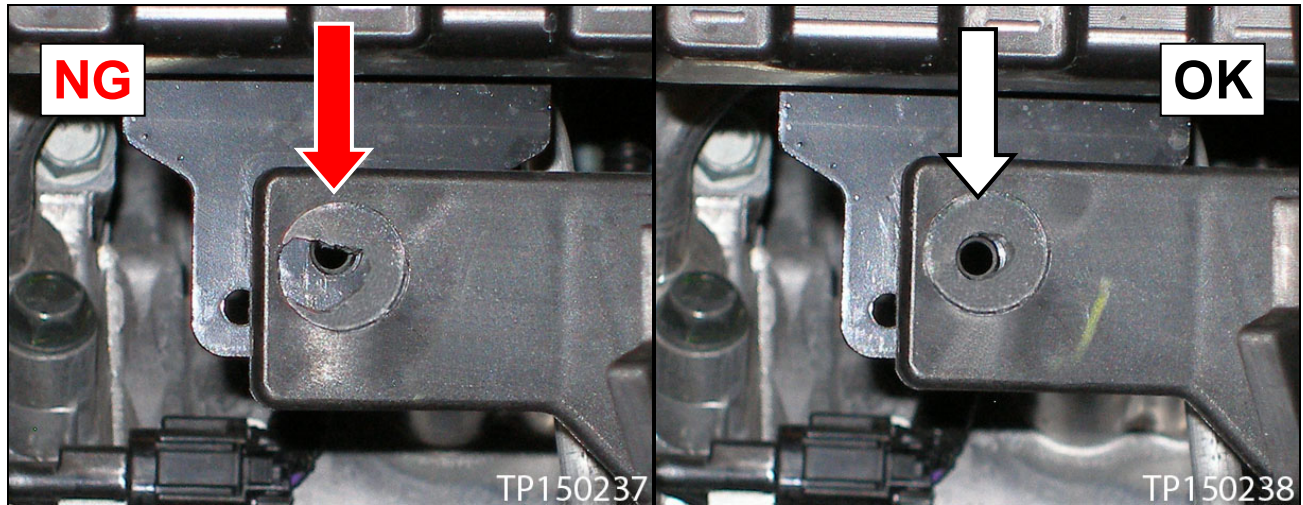
Figure GS6

- Do not use excessive force. The intent is to locate the shutter back to its original position without distorting or binding.
3. If the upper bolts cannot be reinstalled easily (the bolt holes interfere - see Figure GS6), loosen the two (2) lower radiator core support bolts (see Figure GS8 further below).
 - Loosen the bolts – do not remove.

2. To adjust the shutter bolt holes from interfering, raise the lower radiator core support (core support) as needed.
 - Raise at the center of the core support.
 - Use a “pole” jack or other suitable support tool.
