SERVICE BULLETIN

Classification: EC15-014	Reference: NTB15-058	Date: June 30, 2015
-----------------------------	-------------------------	------------------------

370Z COUPE AND ROADSTER; MIL ON WITH DTC P0101 AND/OR P010B

APPLIED VEHICLES: 2011 - 2015 370Z Coupe (Z34)
2011 - 2015 370Z Roadster (Z34)

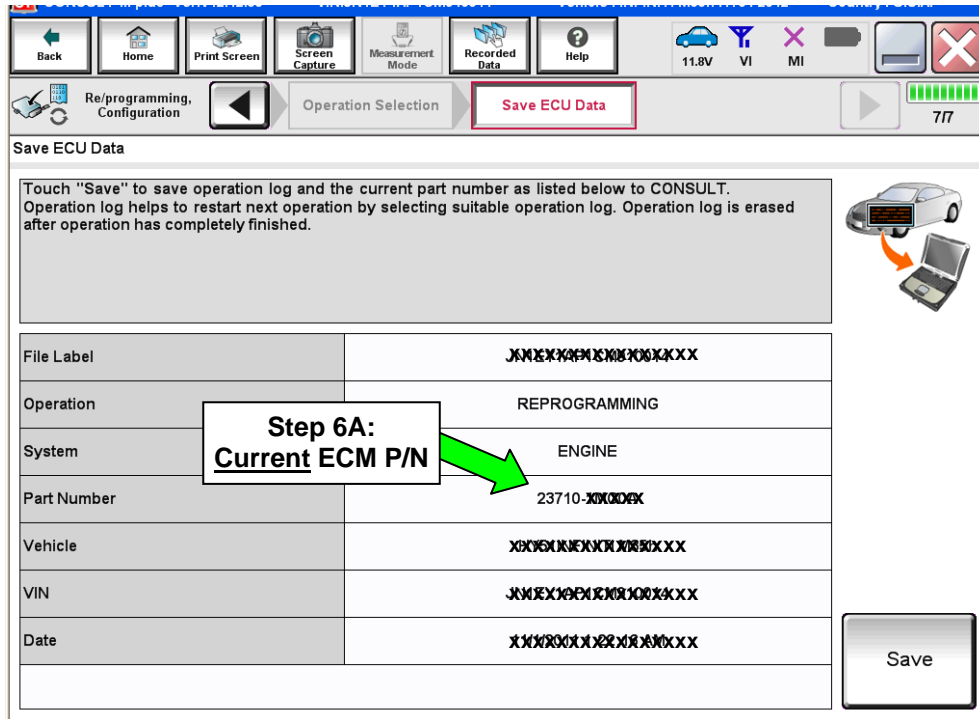
Figure 2

6. When you get to the screen shown in Figure 2, confirm this bulletin applies as follows.

A. Find the ECM **Part Number** and write it on the repair order.

NOTE: This is the current ECM Part Number (P/N).

B. Compare the P/N you wrote down to the numbers in the **Current ECM Part Number** column in **Table A** on the next page.

- If there is a match, this bulletin applies. Continue with the reprogramming procedure.
- If there is not a match, this bulletin does not apply. Close C-III plus and refer to ASIST for further diagnostic information.

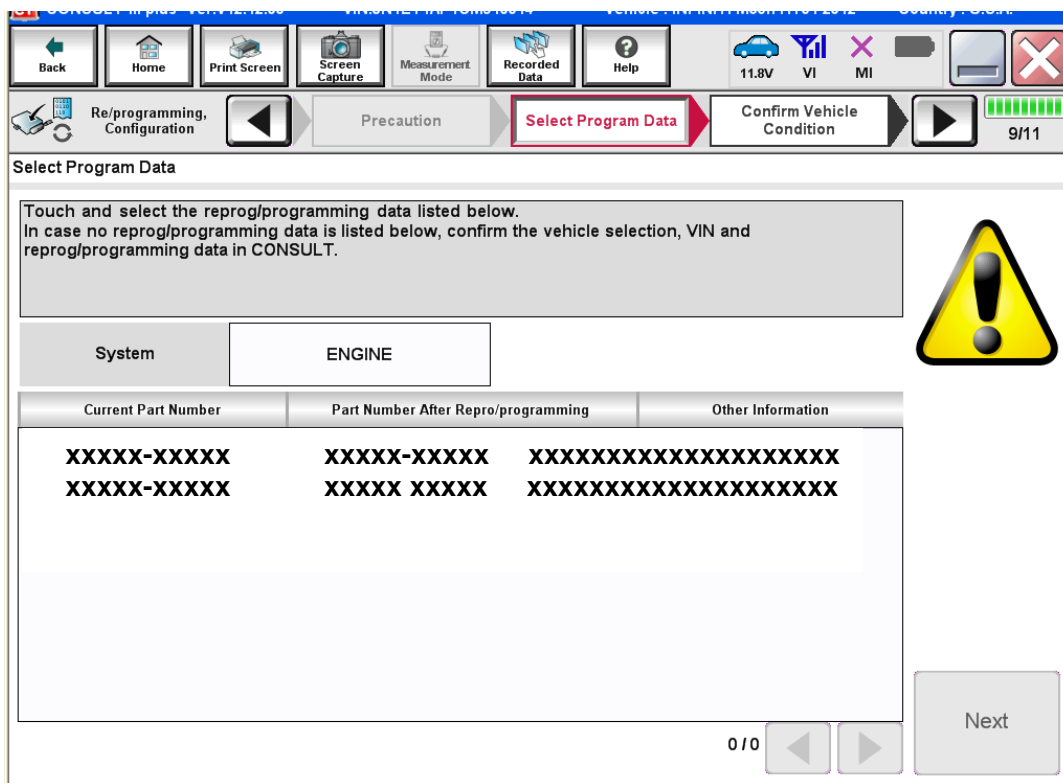
- In some cases, more than one new P/N for reprogramming is available.
 - If more than one new P/N is available, the screen in Figure 3 displays.
 - Select and use the reprogramming option that **does not** have the message “Caution! Use ONLY with NTBXX-XXX”.
- If you get this screen and it is blank (no reprogramming listed), it means there is no reprogramming available for this vehicle. Close C-III plus and refer back to ASIST for further diagnosis.

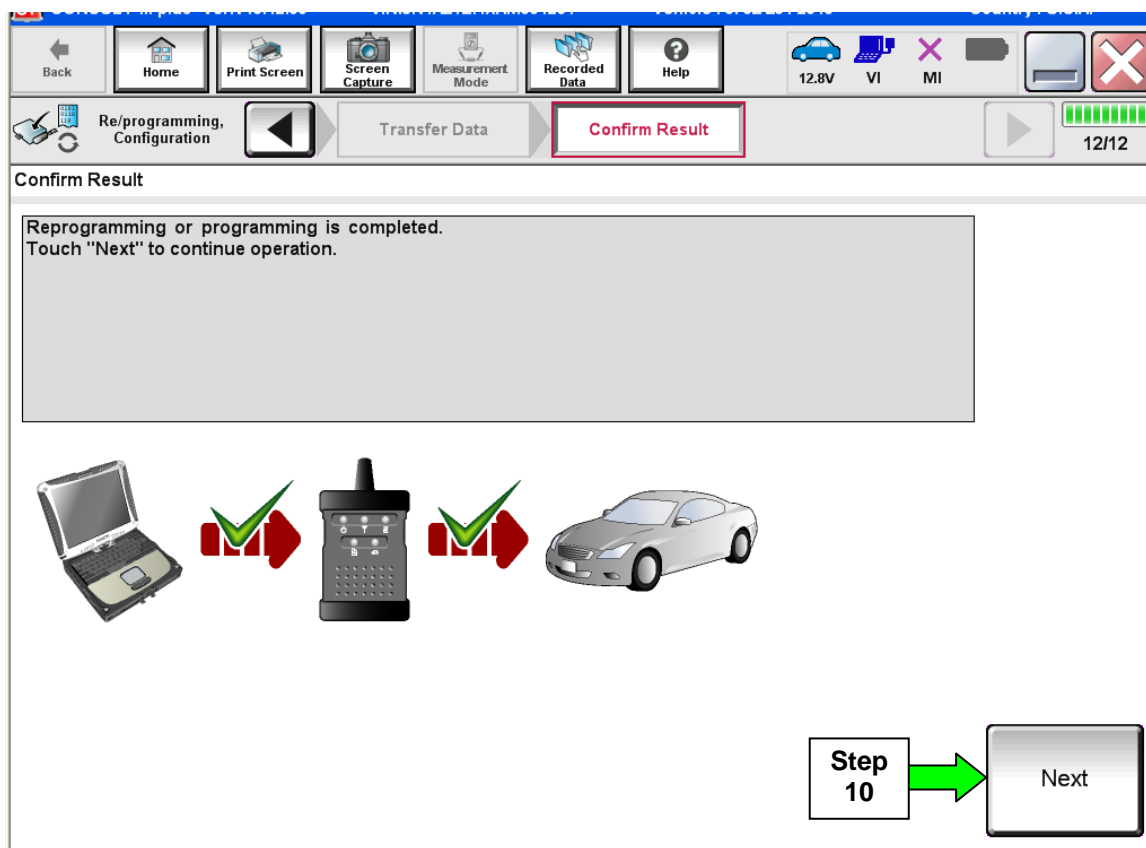
8. When the screen in Figure 4 displays, reprogramming is complete.

NOTE: If the screen in Figure 4 does not display (reprogramming does not complete), refer to ECM recovery on the next page.

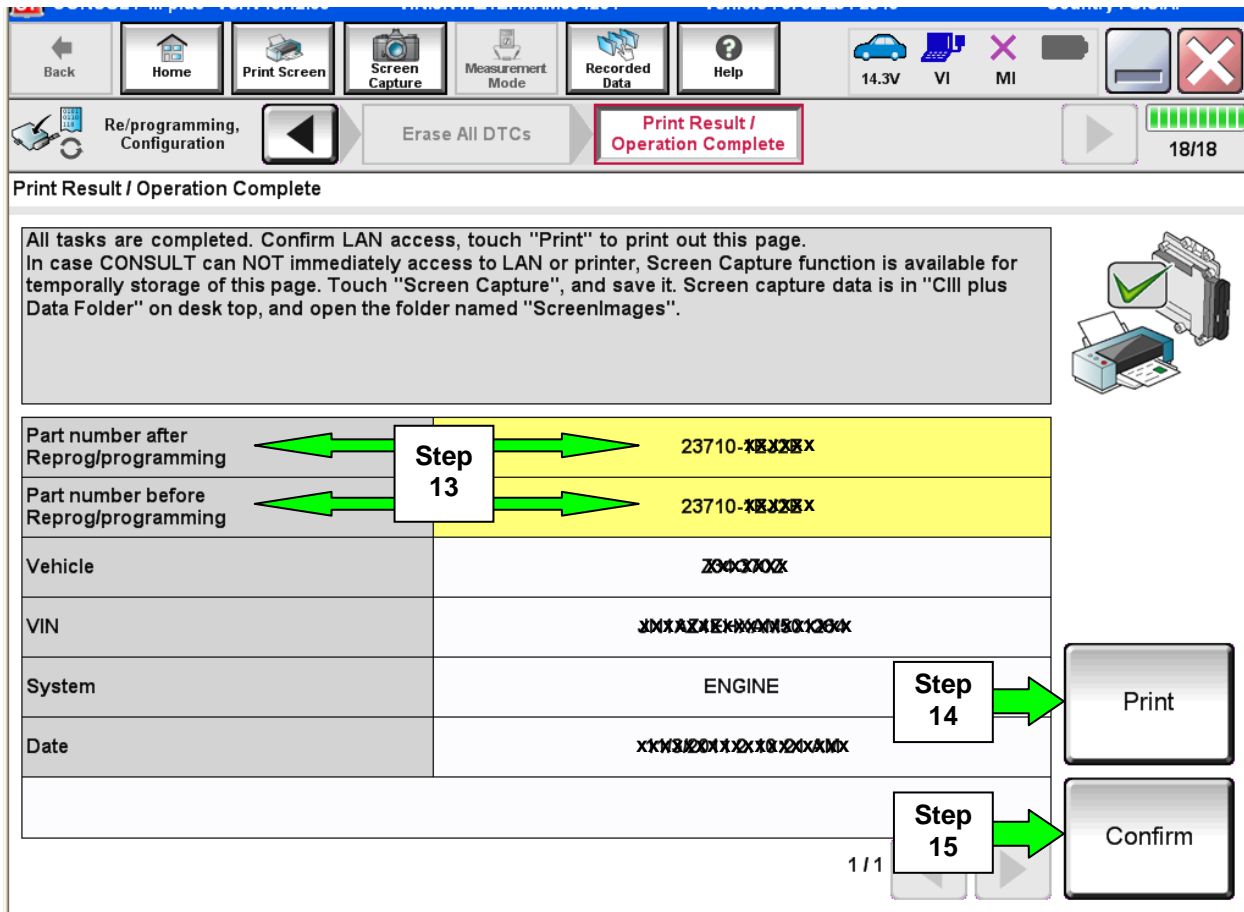
12. When the entire reprogramming process is complete, the screen in Figure 7 will display.

13. Verify the before and after part numbers are different.

14. Print a copy of this screen (Figure 7) and attach it to the repair order for warranty documentation.
