SERVICE CAMPAIGN BULLETIN Date:

NTB15-069

VOLUNTARY SERVICE CAMPAIGN 2013-2014 SENTRA, 2012-2014 VERSA SEDAN, AND 2014 VERSA NOTE; CVT REPROGRAMMING

CAMPAIGN ID #: PM562 **APPLIED VEHICLES:** 2013 – 2014 Sentra (B17) 2012 – 2014 Versa Sedan (N17) 2014 Versa NOTE (E12)

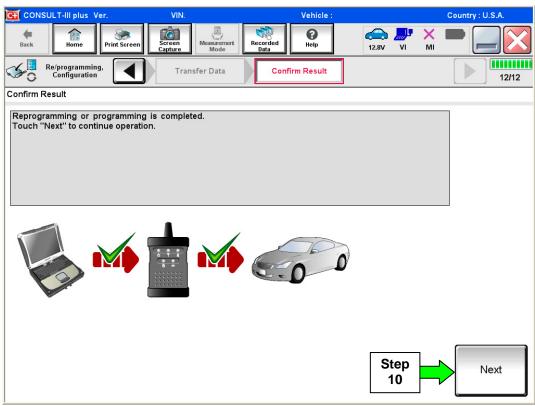
8. When the screen in Figure 4 displays, reprogramming is complete.

- 9. Disconnect the battery charger from the vehicle.
- 10. Select Next.

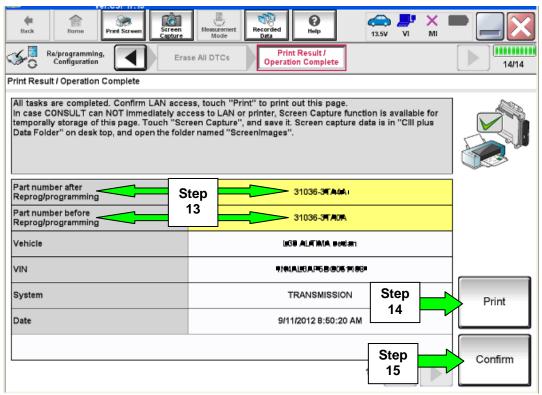
- 11. Follow the on-screen instructions to Erase DTCs.
- 12. When the entire reprogramming process is complete, the screen in Figure 7 will display.
- 13. Verify the before and after part numbers are different.
- 14. Print a copy of this screen (Figure 7) and attach it to the repair order for warranty documentation.
- 15. Select Confirm.
