NISSAN BULLETIN ECM Reprogram Dealer Service Action

Reference: PC404
Date: October 23, 2015

Affected Models/Years:	Affected Population:	Dealer Inventory:	SERVICE COMM Activation date:
MY16 Rogue (T32)	NA	3,195	October 23 rd , 2015

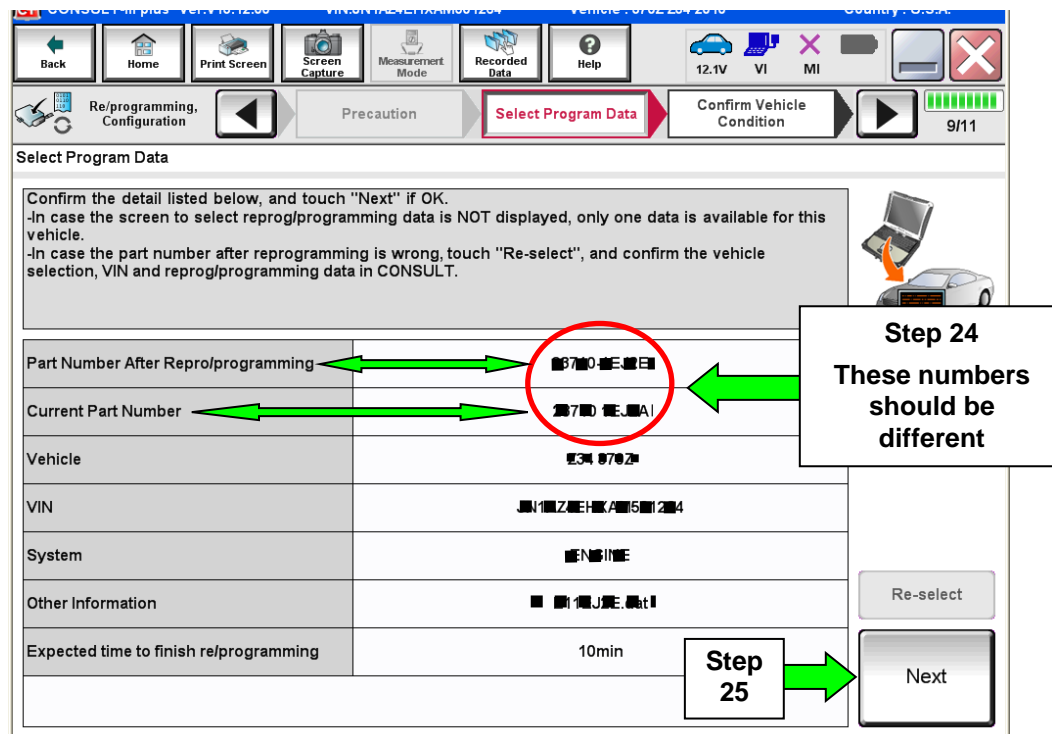
Figure 11

- If you get this screen and it is blank (no reprogramming listed), it means there is no matching ECM reprogramming available for this vehicle. If there is not a match, refer to the Claims Information and submit a claim using OP-CODE PC4041 (ECM Reprogram Not Needed).

24. Read the **Current Part Number** and **Part Number After Reprogramming**. They should be different.
25. Select **Next**.

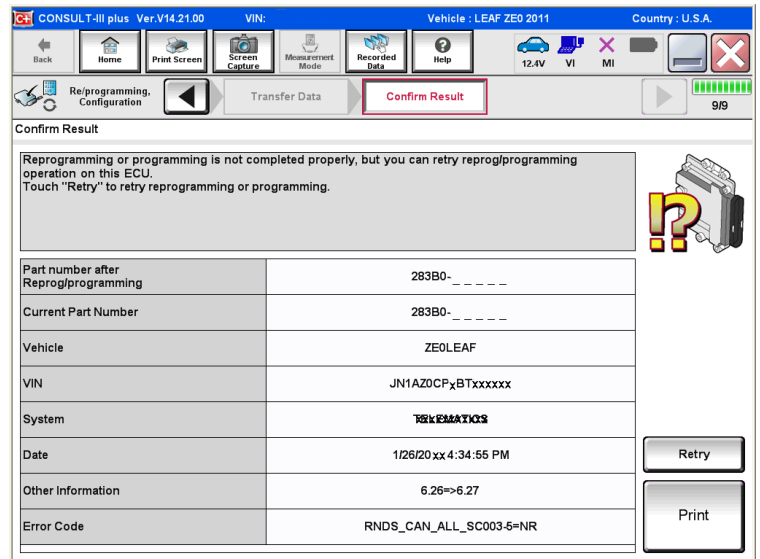
Figure 18

If reprogramming does not complete and the “!?” symbol displays as shown in Figure 18:

- Check battery voltage (12.0 – 15.5V).
- Ignition is ON, Ready Mode is OFF.
- External Bluetooth® devices are OFF.
- All electrical loads are OFF.
- **Select Retry and follow the on screen instructions.**

NOTE: Retry may not go through on first attempt and can be selected more than once.

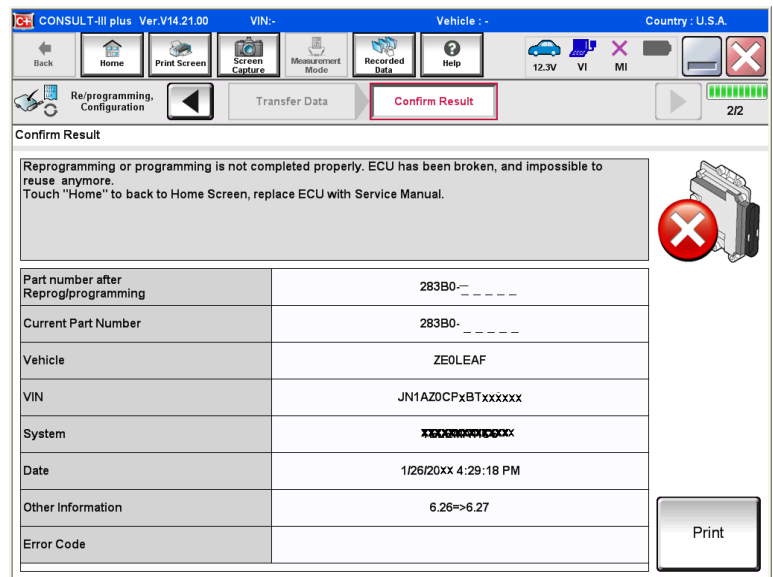
Figure 19

If reprogramming does not complete and the “X” symbol displays as shown in Figure 19:

- **Do not disconnect the plus VI or shut down C-III plus if reprogramming does not complete.**
- Check battery voltage (12.0 – 15.5V).
- CONSULT A/C adapter is plugged in.
- Ignition is ON, Ready Mode is OFF.
- Transmission in Park.
- All C-III plus / plus VI cables are securely connected.
- All C-III plus updates are installed.
- **Select Home, and then restart the reprogram procedure from the beginning.**
