# SERVICE BULLETIN

Classification: EL15-002c	Reference: NTB15-009c	Date: November 12, 2015
------------------------------	--------------------------	----------------------------

## NAVIGATION SYMPTOMS WHEN SD CARD IS MISSING OR WRONG CARD INSTALLED

**APPLIED VEHICLES:**                    2015 Murano (Z52)  
    2016 LEAF (ZE0)  
    2016 Maxima (A36)

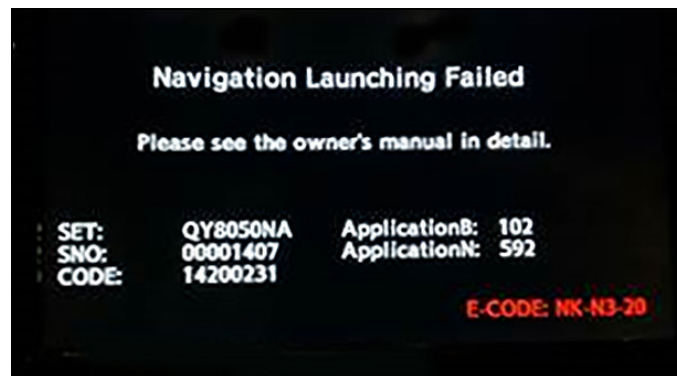
**If the wrong SD Map Card has been inserted into the Navi/audio unit:**

- A “**Navigation Launching Failed**” screen will be shown (Figure 1). For example, this will occur if a “596” SD Map Card is installed in a version “592” vehicle (ApplicationN, Figure 1).

- **Mixed up with other SD Map Cards**  
Continue to insert individual SD Map Cards until one can be found that the error message in Figure 1 is not displayed.  
**NOTE:** There are no visual differences printed on the outside of individual SD Map Cards to distinguish between the different versions.
- **Lost**  
Order a new SD Map Card from Nissan. This is not covered under warranty.
