# SERVICE BULLETIN

Classification: EL15-016a	Reference: NTB15-066a	Date: December 16, 2015
------------------------------	--------------------------	----------------------------

## 2015 MURANO; AV CONTROL UNIT AND A/C SWITCH ASSEMBLY SERVICE INFORMATION

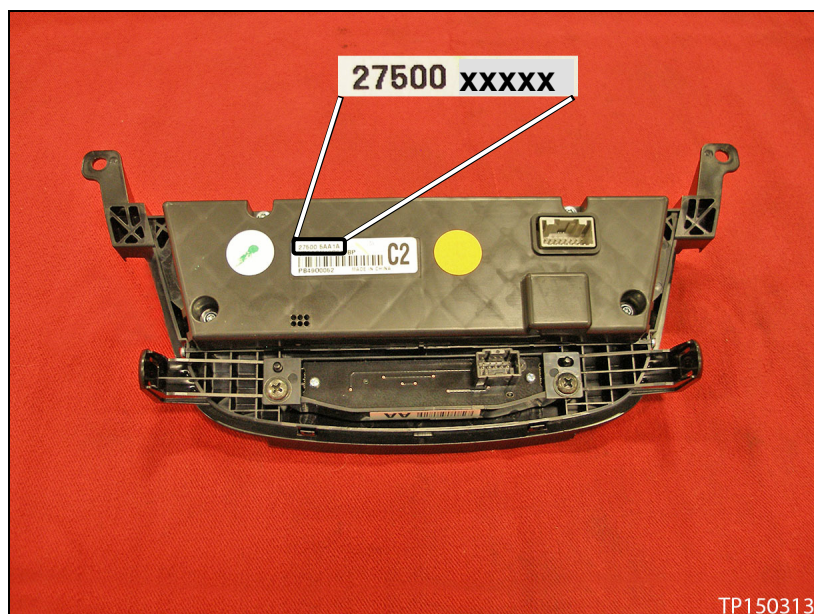
Figure 1: Location of A/C switch assembly P/N

Whenever an AV control unit on an applied vehicle is replaced for any reason, check the part number (P/N) of the A/C switch assembly (A/C Controller Assembly).

- If the P/N is 27500-5AA1**A**, replace the A/C switch assembly with 27500-5AA1**B**.
- If the P/N is NOT 27500-5AA1**A**, do NOT replace the A/C switch assembly.

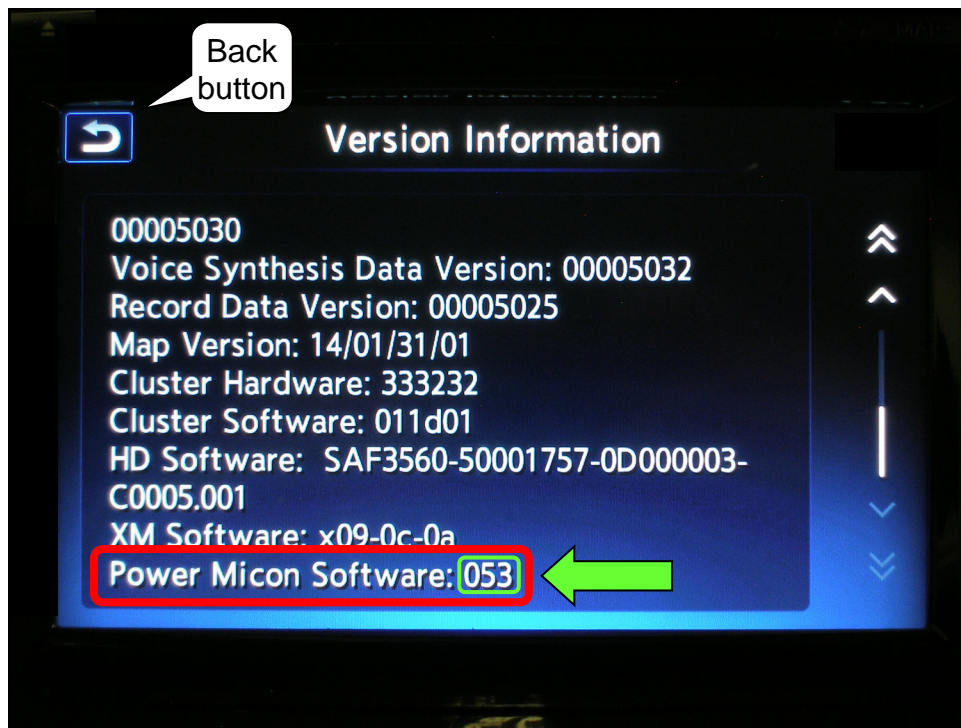
Figure 5

6. Check the software number next to **Power Micon Software**.

- If **054** or higher, a software update is not needed, or has been successfully performed.
- If less than **054**, a software update needs to be performed.
- If a software update needs to be performed, leave the screen as is, and then go to page 6, **AV Control Unit Software Update with Software Update SD Card**.

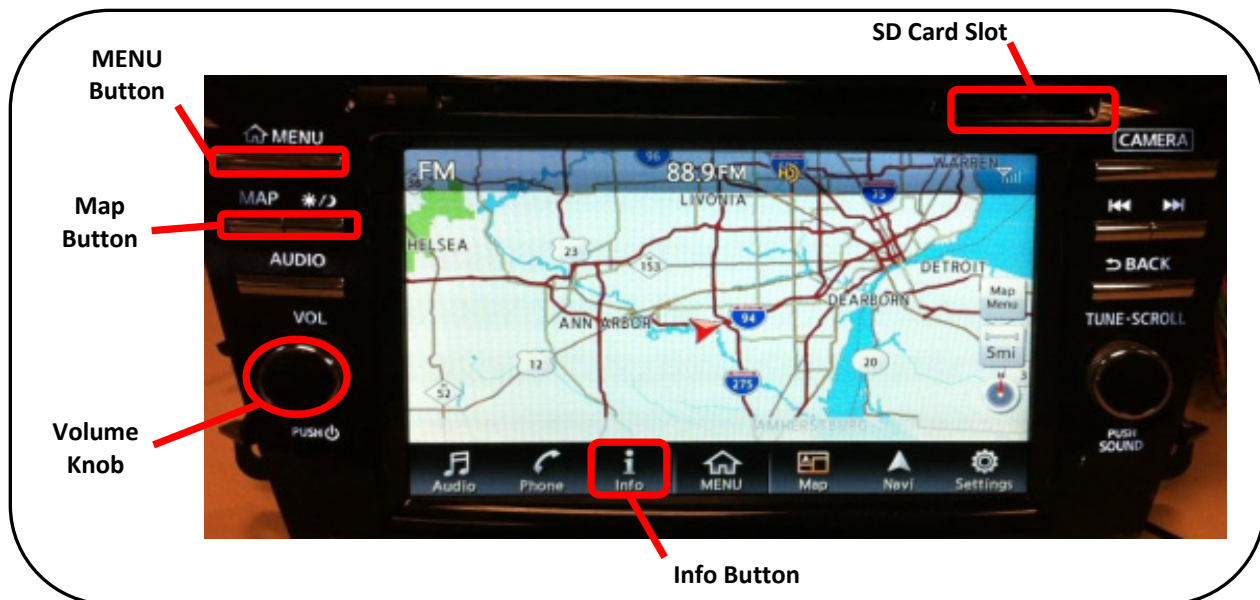
- This software update procedure applies only when the A/C switch assembly is replaced on applied vehicles built before the VIN and date specified on the first page of this bulletin.
- Refer to Figure 6 below for location of controls and SD card.
- Make sure the vehicle's Map SD card (not the update card) is inserted in the SD card slot before starting the software update procedure.
