SERVICE BULLETIN

EC15-019

December 17, 2015

2015 ALTIMA WITH 4 CYL ENGINE; MIL ON WITH A/F SENSOR DTC STORED

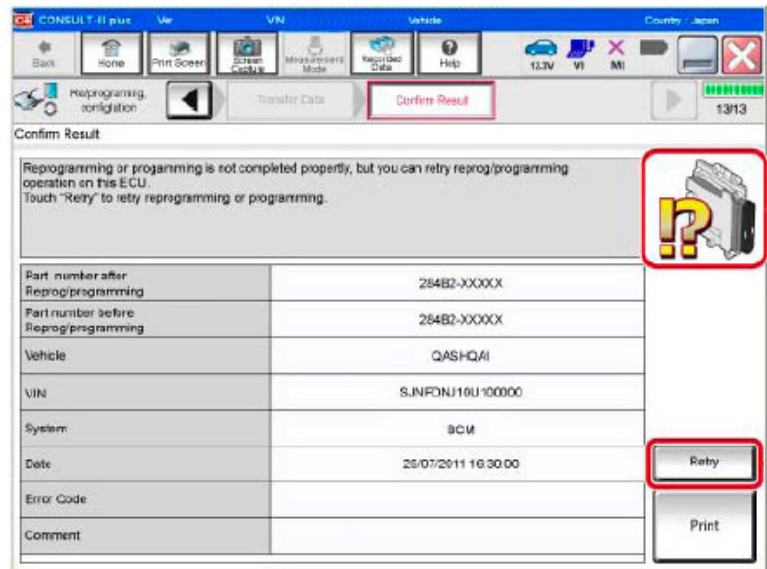
Figure 5

If reprogramming does not complete and the “!” icon displays as shown in Figure 5:

- Check battery voltage (12.0–15.5 V).
- Ignition is ON, engine OFF.
- External Bluetooth® devices are OFF.
- All electrical loads are OFF.
- **Select retry and follow the on screen instructions.**
- “Retry” may not go through on first attempt and can be selected more than once.

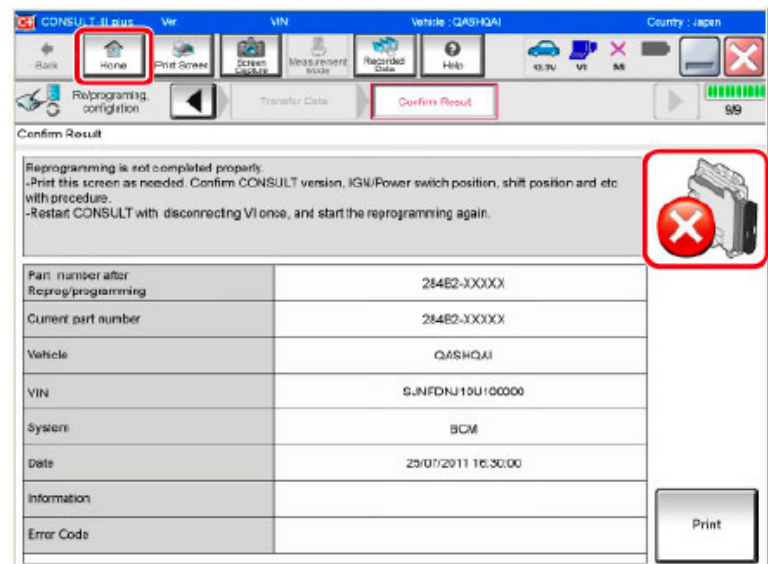
Figure 6

If reprogramming does not complete and the “X” icon displays as shown in Figure 6:

- Check battery voltage (12.0 – 15.5 V).
- CONSULT A/C adapter is plugged in.
- Ignition is ON, engine OFF.
- Transmission is in Park.
- All C-III plus / VI cables are securely connected.
- All C-III plus updates are installed.
- **Select Home, and restart the reprogram procedure from the beginning.**
