## Service Bulletin 522

### Issue 1 - February 2015

| Subject: Secondary Air Injection Solenoid Retaining Bracket | | | | |

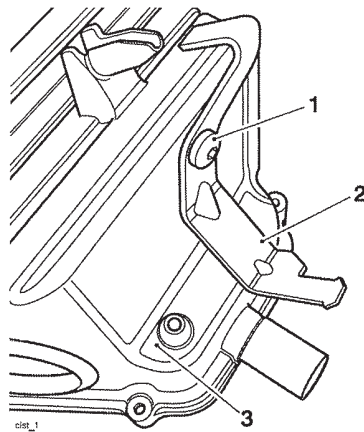
1. Fixing
2. Secondary air injection solenoid retaining bracket
3. Airbox

1. Remove the fuel tank as described in the Service Manual.
2. Remove the airbox as described in the Service Manual.
3. Install the secondary air injection solenoid retaining bracket to the airbox using the fixing. Tighten the fixing to **3 Nm**.

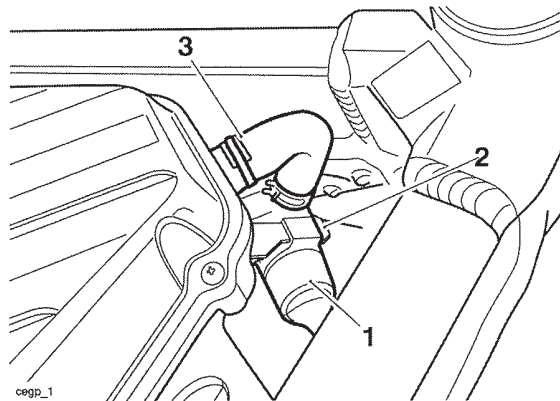
1. Secondary air injection solenoid valve
2. Secondary air injection solenoid retaining bracket
3. Hose

4. Check the orientation of the secondary air injection solenoid valve prior to fitting to retaining bracket. If necessary, disconnect the secondary air injection solenoid valve from hoses, and rotate 180° to align with retaining bracket. Re-install hoses.
5. Install the airbox as described in the Service Manual. Ensure secondary air injection solenoid valve is connected to the retaining bracket.
