**Technical News 161**  
**January 2015**  
**Strictly Confidential**

| <b>Contents</b> | | |

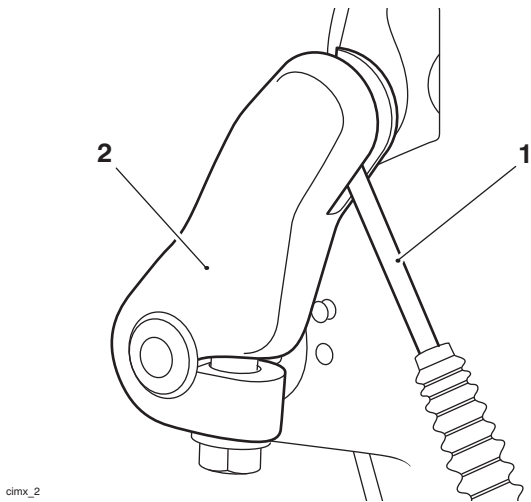
The difference between the original and new condition clutch cable is that the inner cable's free length at the clutch actuation lever is 18 mm longer than the original. The additional length is to allow the repositioning of the clutch actuation lever to eliminate any possibility of clutch drag.

- 1. Clutch cable free length
- 2. Clutch actuation lever

A new clutch cable has been introduced to the above models from VIN 693388 and is retrofittable. Parts no longer support the original clutch cable.

The fitting of the new condition clutch cable is the same as for Thunderbird Commander as described in the Service Manual and Technical News 158 issued 07/2014.

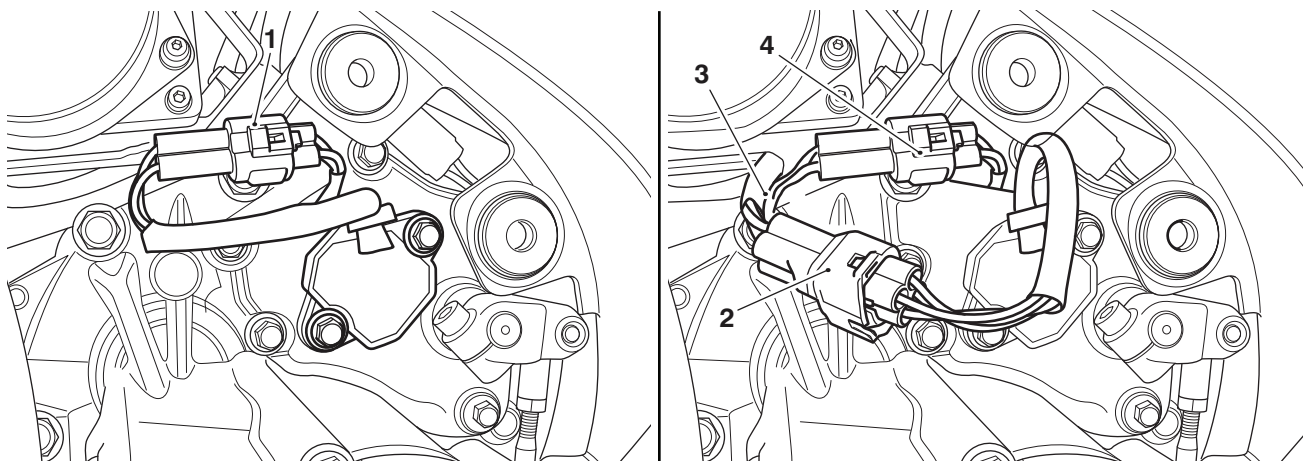
1. Three-pin multiplug (up to engine number 596480)

2. Four-pin multiplug (from engine number 596480 to engine number 693352)

3. Fly lead

4. Fly lead three-pin multiplug

If the gear position sensor has the four-pin multiplug, only replace the main wiring harness.

If the gear position sensor has the three-pin multiplug, the gear position sensor must also be replaced using the parts kit T2500837.

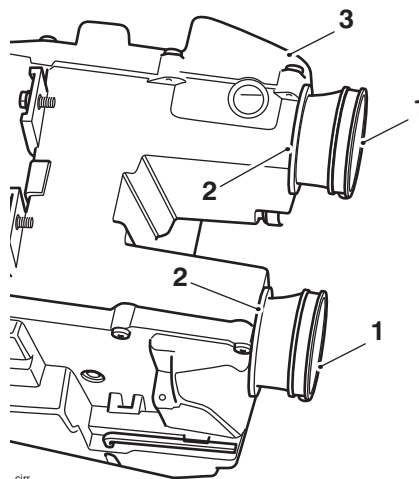
During manufacture, the throttle body intake rubbers are sealed to the airbox housing to eliminate external air leaks into the inlet ports.

1. Throttle body intake rubber (Bonneville shown)
2. Sealed area
3. Air box

If the throttle body rubbers are removed or replaced for any reason the intake rubbers must be sealed to the air box using either Cemedine 540, U-Pol Tigerseal (Black) or equivalent.

1. Use high flash-point solvent to clean the airbox and intake rubber mating faces. Wipe the surfaces clean with a lint-free cloth.
2. Apply a thin bead of Cemedine 540, U-Pol Tigerseal (Black) or an equivalent sealant to the intake rubber mating face.

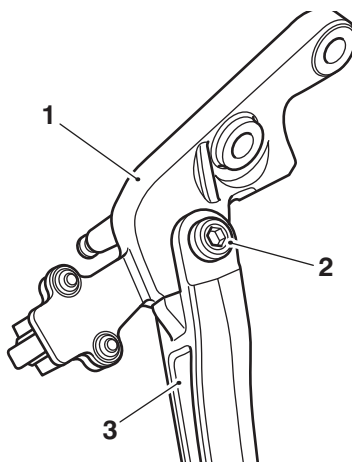
A revised bolt has been introduced on the above models from VIN 670401. If removed or replaced for any reason tighten the bolt and lock nut as described below.

1. Side stand bracket
2. Fixing
3. Side stand

1. Tighten the side stand bolt to **20 Nm**.

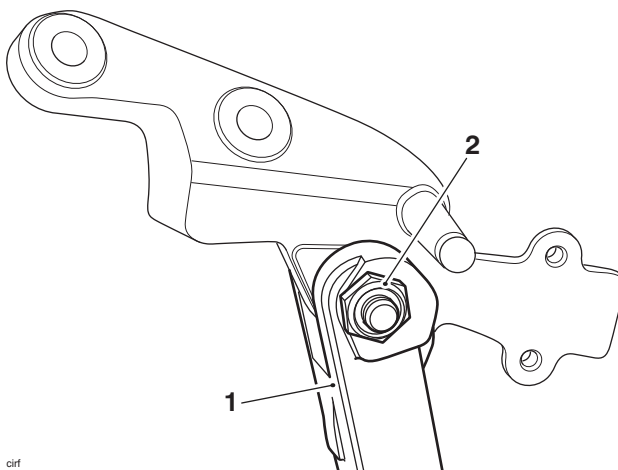
1. Side stand
2. Lock nut

2. Whilst ensuring the bolt does not turn, tighten the lock nut to **9 Nm**.

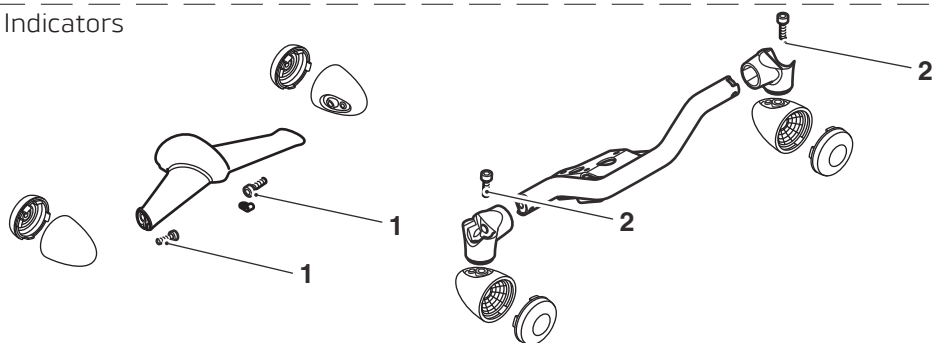
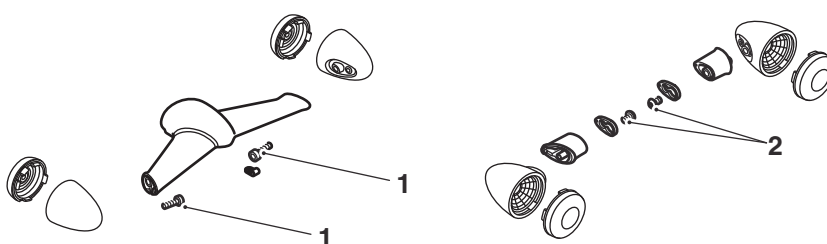
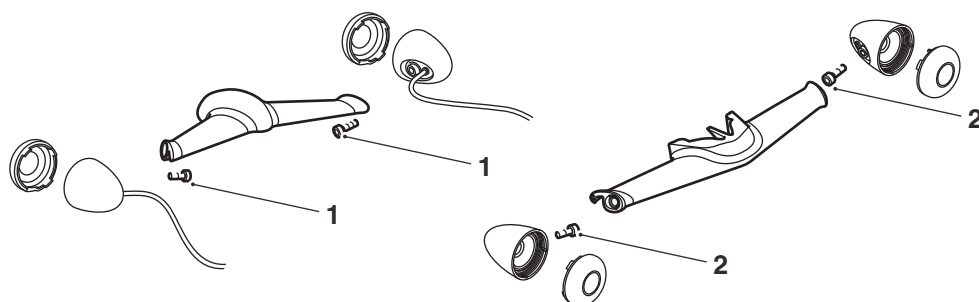
The fixings for the front and rear direction indicators have changed to encapsulated fixings on the above models.

1. Rear direction indicator fixings
2. Front direction indicator fixings

The torque figure for these fixings has changed to **25 Nm**. These fixings must be replaced if they are loosened or removed.

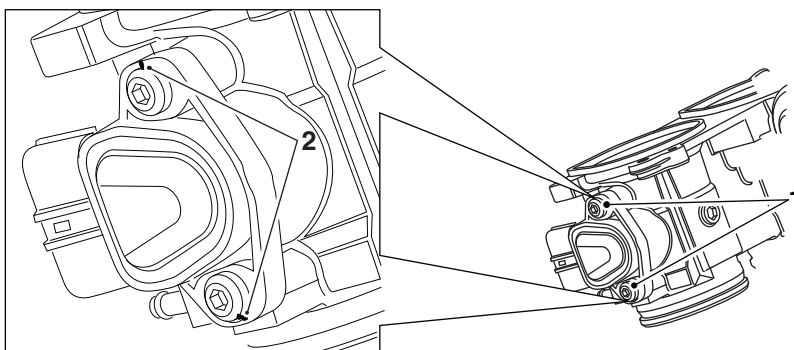
If the fixings have been loosened or removed the throttle body assembly must be replaced as there are no means to reset the throttle position sensor to its correct position.

1. Throttle position sensor fixings
2. Paint mark (yellow)

The fixings for the throttle position sensor are marked with yellow paint and must not be loosened or removed.

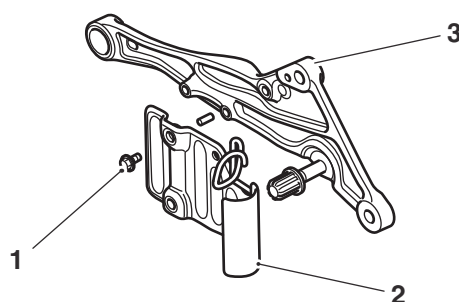
A revised fixing securing the regulator rectifier bracket to the rear footrest has been introduced on the above models. The revised fixing is pre-encapsulated and is retrofittable to earlier models.

1. Fixing
2. Regulator rectifier bracket
3. Silencer hanger

1. Tighten the regulator rectifier bracket fixing to **7 Nm**.

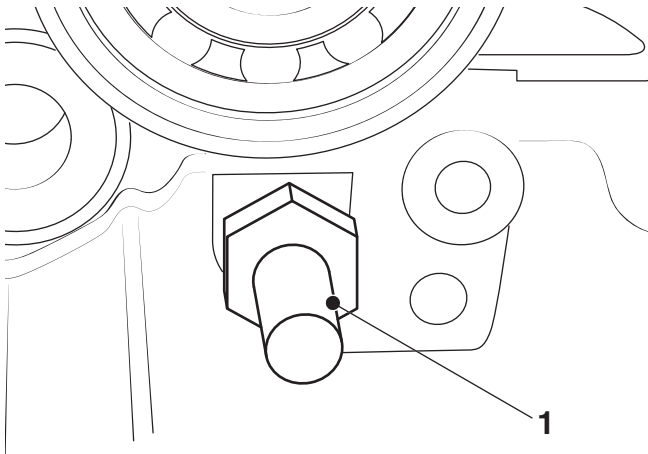
A revised abutment bolt has been introduced on the models listed in the table above. The revised abutment bolt is pre-encapsulated and is retrofittable to earlier models.

1. Gear change return spring abutment fixing, Tiger Sport shown  
Please mark your copy of the Service Manual with this information.

1. Tighten the abutment bolt to **15 Nm**.

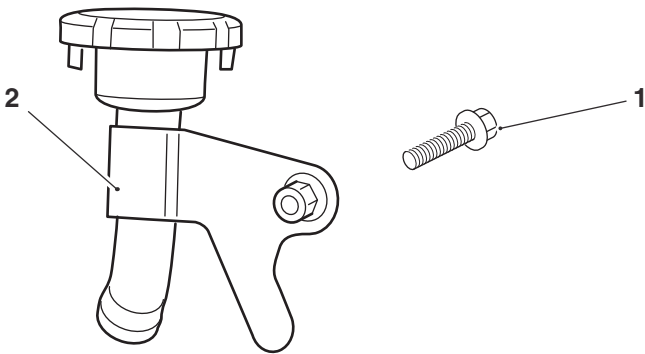
A revised fixing securing the coolant filler neck to the frame has been introduced on the above models. The revised fixing is pre-encapsulated and is retrofittable to earlier models.

1. Fixing
2. Coolant filler neck

1. Tighten the coolant filler neck fixing to **9 Nm**.
