**Technical Service Note 31-10**

**SUBJECT:** Inverted U End of Frame Closing Crossmember Fastener Replacement.

**PRODUCTS:** Cascadia vehicles equipped with the inverted U end of frame closing crossmember.

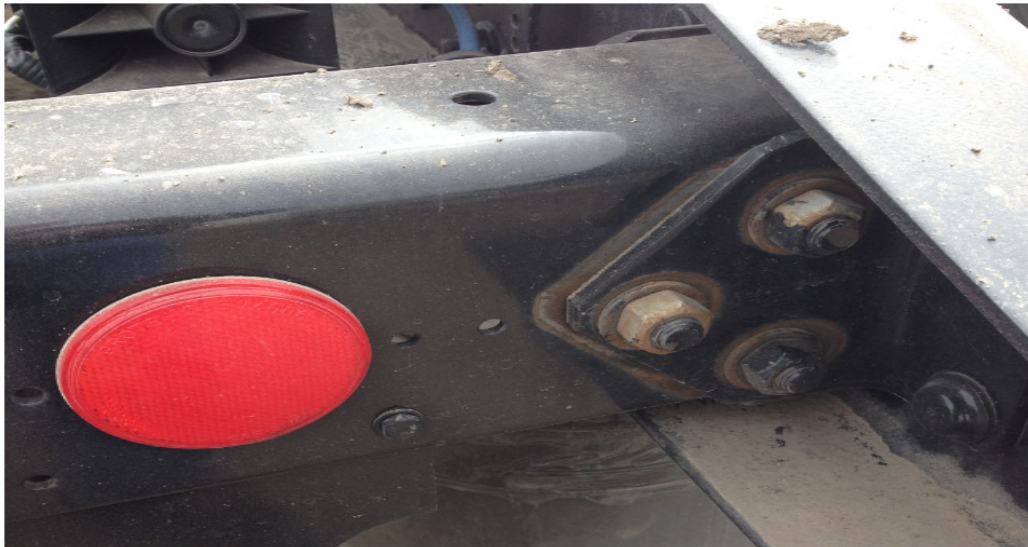
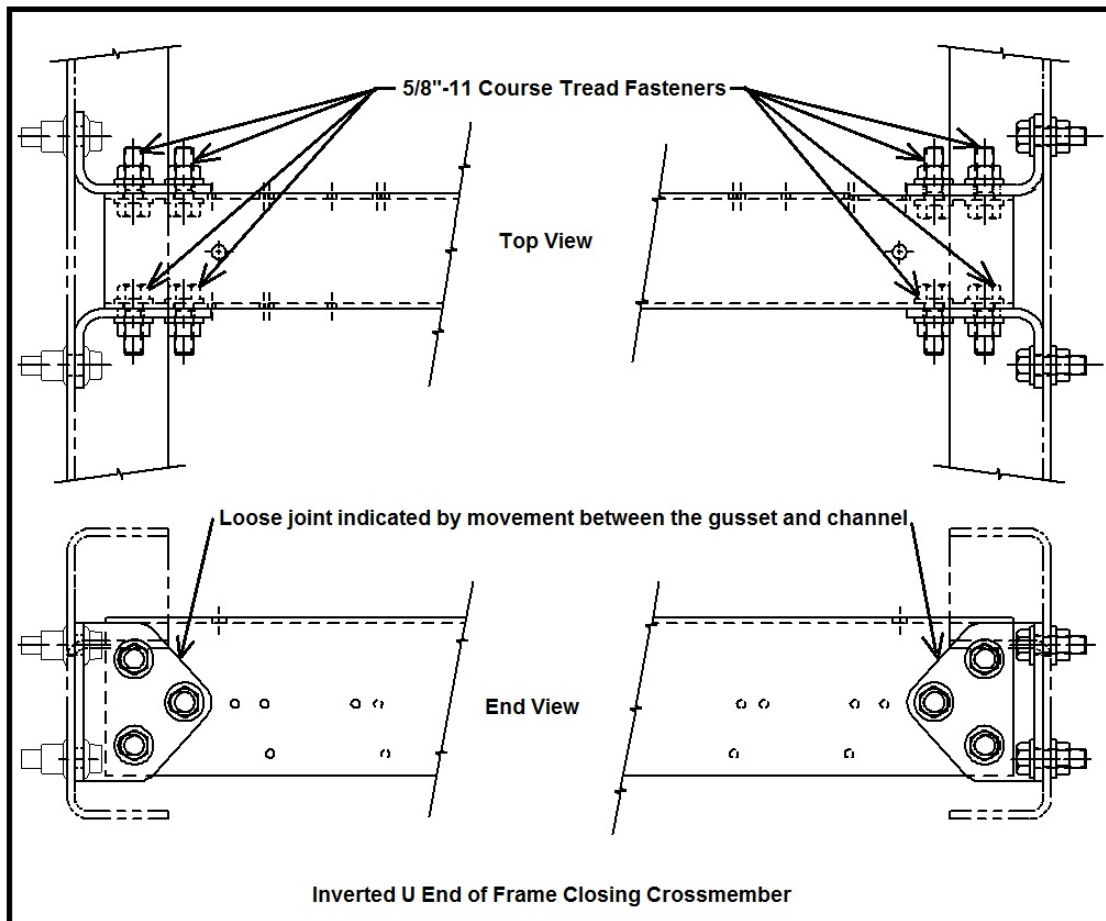
**PROBLEM / SYMPTOMS:** Customer complaints of loose fasteners at the end of frame closing crossmember where the c-channel attaches to the gussets.

Inspect the c-channel and gusset for any relative movement. Check the 5/8” fasteners to confirm they are torqued to the appropriate specification. Reference the following illustrations:

**If there is any indication that the any of the fasteners are loose, replace all 12 fasteners with new hardware.**

When tightening from the **bolt head** torque to **136 ft-lbs**

When tightening from the **nut** torque to **128 ft-lbs**
