## **Technical Service Note 31-11**

**SUBJECT:** Driveline Midship Support Crossmember Fasteners.

**PRODUCTS:** Cascadia vehicles equipped with a driveline center bearing midship support. Reference the following illustration:

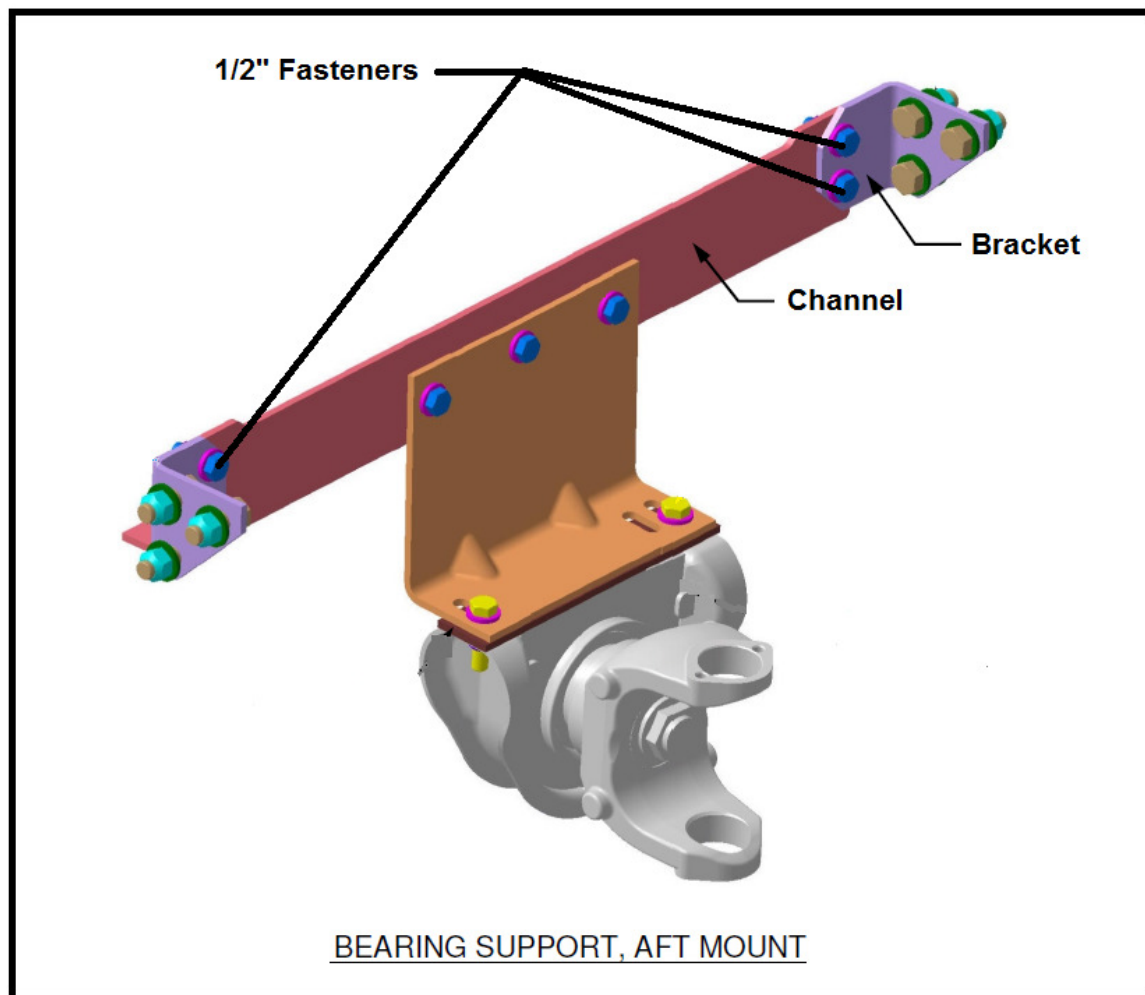
**PROBLEM / SYMPTOMS:** Customer complaints of loose fasteners at the bracket to channel bolted connection.

Inspect the four 1/2"-13 course thread fasteners that attach the channel to the gussets to confirm they are torqued to the appropriate specification.  
Reference the following illustration:

**If any of the fasteners are below the minimum torque, replace all four fasteners with new 1/2"- 20 fine thread hardware.**

**If there is any indication of slippage between the bracket and channel replace all four fasteners with new 1/2"- 20 fine thread hardware.**

**Note: Torque from the nut side to 64 ft-lbs.**
