SI B51 04 15  
Body Equipment

**Rear Spoiler Makes Rattling Noise Against Rear Window**

I01(i3, i3 REx)

Produced to April 29, 2014

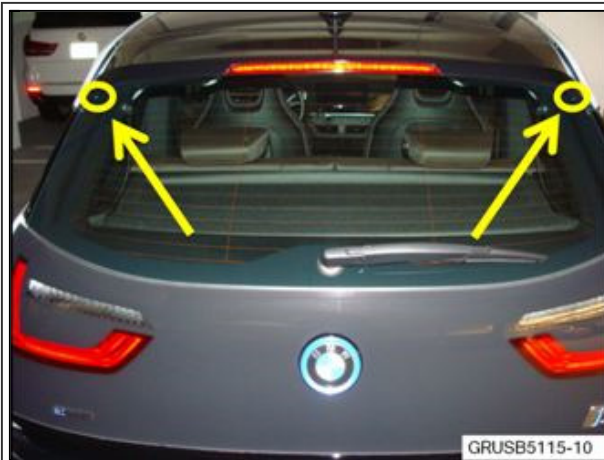
The left and right corners of the rear spoiler rattle against the rear glass.

1. Locate the rear hatch spoiler. Look at the clearance gap between the spoiler and glass in these two areas. If the gap is less than 3.2 mm, the buffers stops in the spoiler must be replaced with a new design flat head buffer.

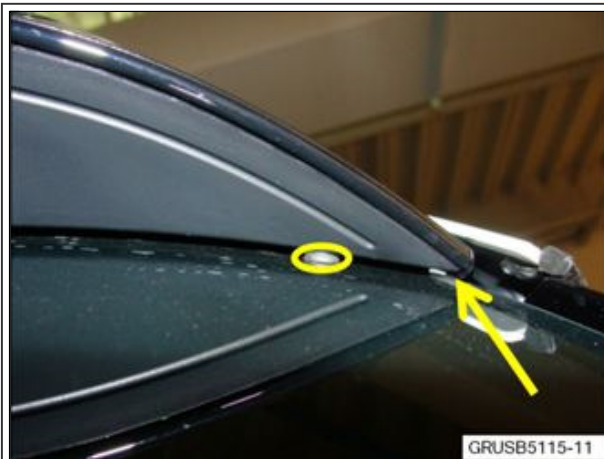
2. Shown is a close-up of the right side buffer. Check if both left and right side buffers are providing enough clearance between the extreme corners of the rear spoiler and the rear glass.

If the gap between the glass and spoiler (at the bump stop) is less than 3.2 mm, both rear spoiler bump stops must be replaced.

Refer to Repair Instruction 51 71 412 and the B510415 attachment.
