TECHNICAL SERVICE INFORMATION BULLETIN

TSIB 15-07, rev A		December 18, 2015
TO:	All operators	
TITLE:	Alternator Power Cable Support Inspections	
APPLICABILITY:	All New Flyer Xcelsior and LF Buses

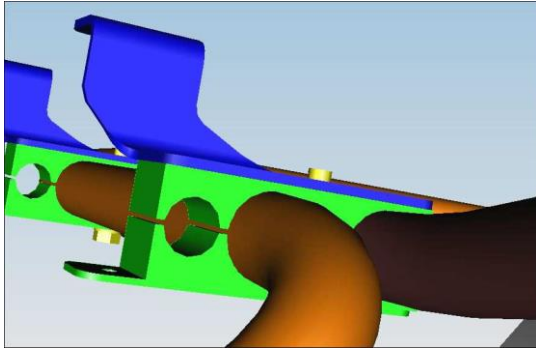
Figure 1. Nylon Split Block Clamp.

Note that the bolt attachment of the nylon split block clamp may become loose as a result of vibration if it is not adequately torqued, or if Loctite thread locker is not used during re-installation after maintenance. Also inspect for chafing of the power cable insulation on the edge of the nylon block.

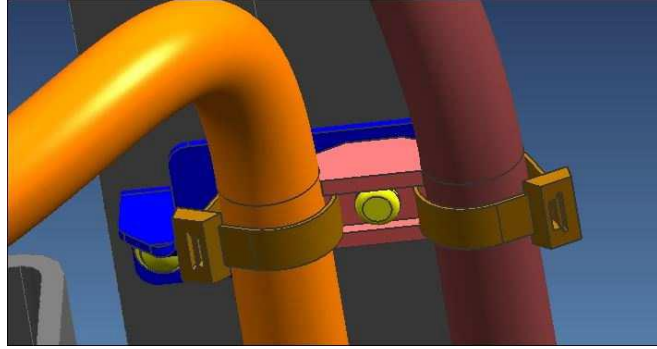
Figure 2. Hellerman saddle clamp with Panduit zip-ties.

With respect to the Hellerman saddle clamp installation, New Flyer has observed that maintenance technicians have at times used common narrow zip-ties in place of the wider Panduit style zip-ties (New Flyer PN 351161). New Flyer advises against the use of the narrow zip-ties as they may break or damage the cable insulation because the load being distributed over the narrow zip-tie is too great. The larger width of the specially designed Panduit zip-tie is more appropriate for this application and only the Panduit zip-tie should be used.
