Technical Service Bulletin

Bulletin No.: TSB-010

Subject: OMB Automatic Valve Plunger Failure

Models: OMB Lyra Automatic Valves

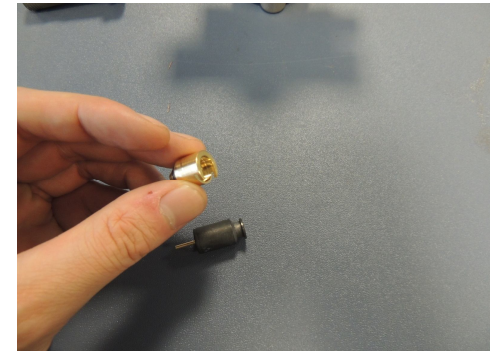
In some cases, the soft parts on the plunger may wear depending on use and the quality of the fuel or the screw retaining the seal may loosen.

Replace the plunger and core assembly using Quantum PN 116503.

DISMOUNT THE PIVOT AND
REPLACE WITH THE NEW ONE
