GROUP BOD	MODEL 2015MY Optima (QF)
	NUMBER 115	DATE September 2015
<b>TECHNICAL SERVICE BULLETIN</b>		
<b>SUBJECT: SERVICE ACTION: EXTERIOR DOOR HANDLE TRIM CAP REPLACEMENT (SA198)</b>

**SUBJECT:** SERVICE ACTION: EXTERIOR DOOR HANDLE TRIM CAP REPLACEMENT (SA198)

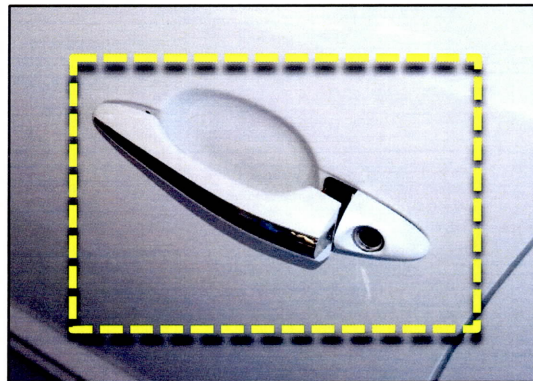
This bulletin provides the procedure to replace the exterior door handle trim cap of some 2015MY Optima (QF) vehicles, produced from September 2, 2014 through August 24, 2015, which may experience an inoperative driver's side exterior door handle. Kia is requesting the completion of this Service Action on all affected vehicles, including dealer stock, prior to delivery. Before conducting the procedure, verify the vehicle is included in the list of affected VINs.
