| | GROUP<br>ENG | MODEL<br>2014~2015MY<br>Cadenza (VG) |
| | NUMBER<br>148 | DATE<br>September 2015 |
| <p align="center"><b>TECHNICAL SERVICE BULLETIN</b></p> | | |
| <p><b>SUBJECT: CHATTER/RATTLE NOISE FROM ENGINE AFTER COLD SOAK</b></p> | | |

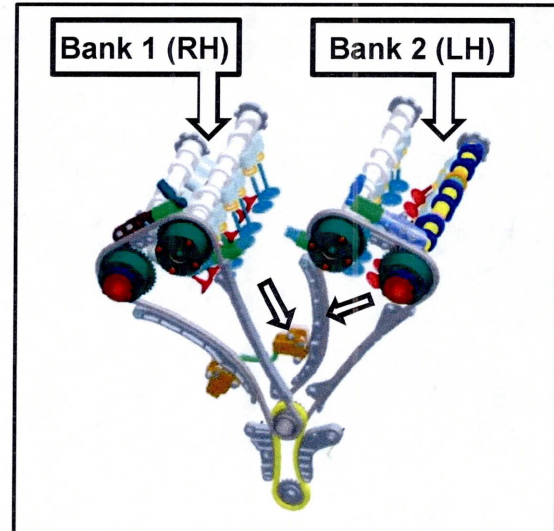
This Service procedure should ONLY be performed on engine bank 2 (LH), as shown.

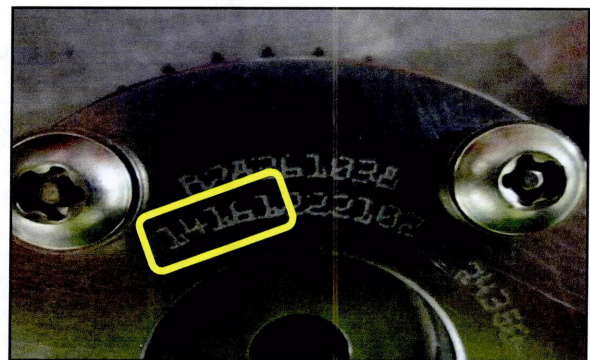
1. Refer to the “Engine Mechanical System → Timing System → Timing Chain” section in the applicable Workshop Manual on KGIS, to install the improved parts. **NOTE: prior to installation, refer to steps 2~4 for supplementary inspection/installation information.**
2. After removal of timing chain cover, inspect CVVT’s on both engine banks to ensure the first five (5) digits of the eleven (11) digit serial number is equal or greater than “14111”, on both Intake and Exhaust CVVTs. If the serial number is greater than 14111, proceed to step 4. If the serial number is less than “14111”, replace the CVVT(s) prior to performing the remainder of this TSB procedure.

Additionally, inspect the replacement CVVTs to ensure the first five (5) digits of the serial number are greater than “14111”.

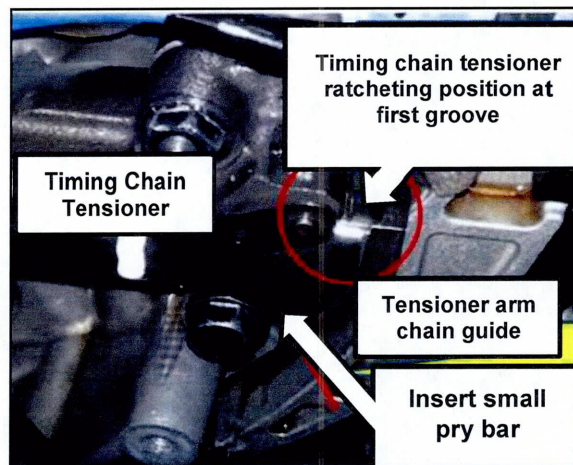
Prior to removing chain tensioners/adjusters, note position of the timing chain tensioner pawl to the rack grooves and count the number of teeth/grooves extending from the tensioner, as shown below. Make sure to record the count for later reference.

3. After installing the new tensioner, and timing chain guide, manually rotate the crankshaft three (3) full revolutions to securely seat the tensioner, then, check the number of grooves extending from the tensioner. When compared to the initial count, it should now be one (1) groove further out towards timing chain.

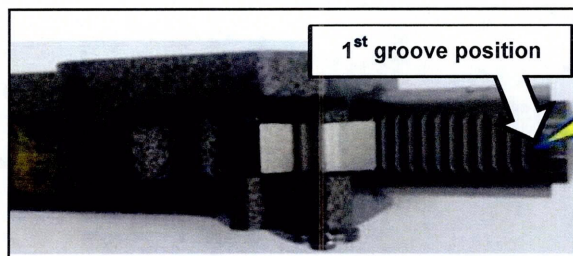
4. If after tensioner and guide replacement the tensioner pawl rack is not extended one tooth/groove further out than before the repair, use a small pry bar to extend the tensioner out one (1) tooth/groove further towards timing chain, as shown.

Do **NOT** extend the tensioner pawl rack out more than one tooth/groove or damage to timing chain may occur.
